# Caseys Creek – Baseline Water and Sediment Quality

July 2017

Marlborough District Council

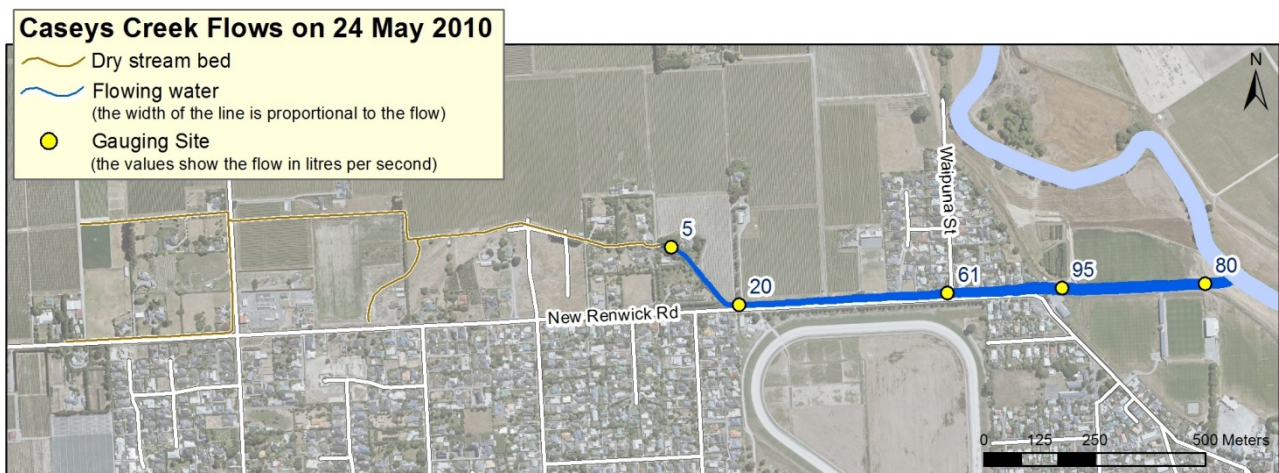
Figure 2: Flow measurements on 24 May 2010 at several sites along Caseys Creek.

Gaugings of several sites on Caseys Creek were carried on 24 May 2010 during base flow conditions (Figure 2). The most upstream gauging site marks the location of a relatively large spring that discharges into a small pond (Figure 3). During dryer conditions this is usually the location at which the first surface flow appears. Downstream of this point the inflow of groundwater appears to be relatively constant until the stream reaches Waipuna Street Bridge at which point the flow increases at a slightly higher rate. Along the lowest reaches, the stream appears to be losing water before flowing into the Ōpaoa River. In May 2010 the flow increased from 5 L/s at the most upstream gauging site to 95 L/s at the Waipuna Street Bridge and then decreased to a flow of 80 L/s upstream of the Opaoa River.

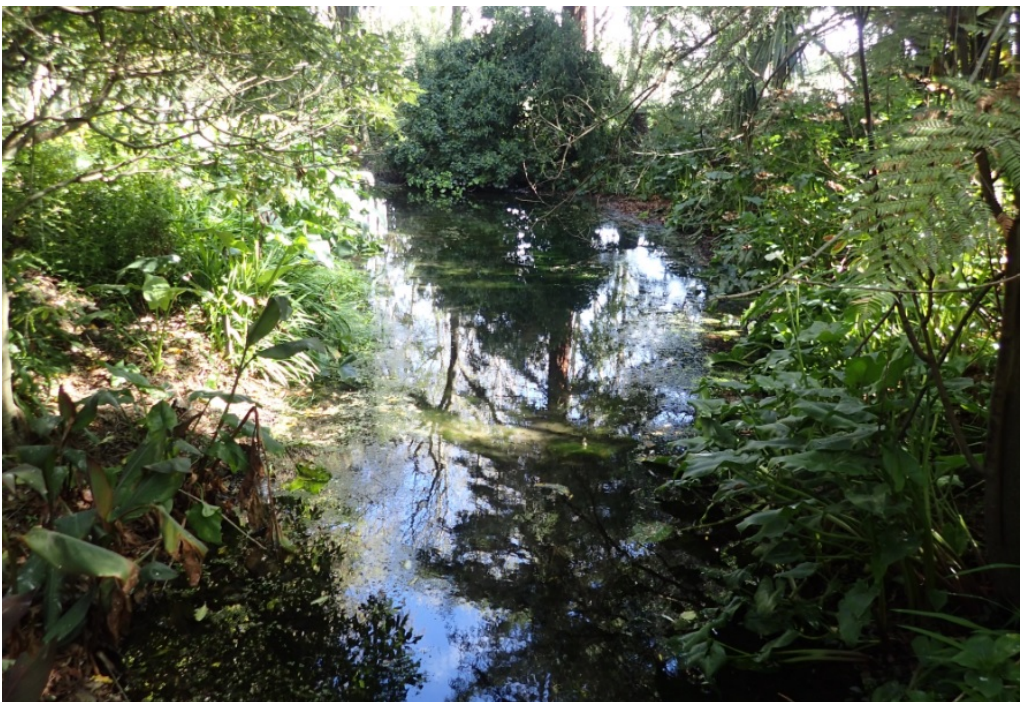
Figure 3: The first gauging site, which is also the location of the first significant surface flow of Caseys Creek.

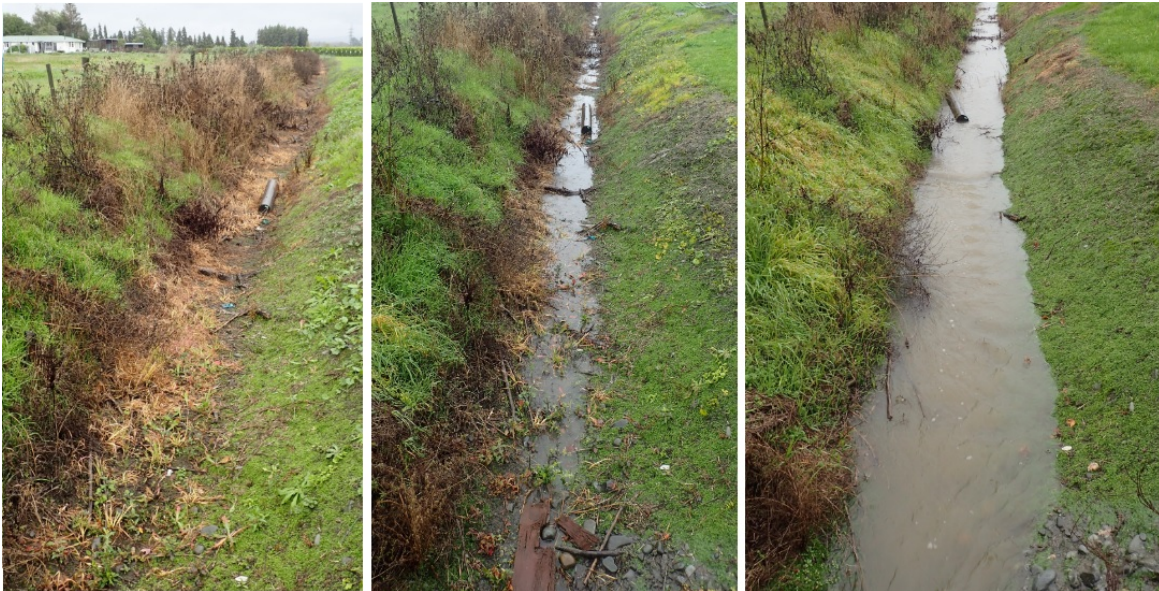
**Figure 5: The sampling site downstream of the De Lux property – dry (left), during base flow and light rainfall (middle), and heavy rainfall (right).**

Caseys Creek was also sampled immediately below the De Luxe property (Figure 5). Apart from the two sampling runs during heavy rainfall, flow was only observed during two of the base flow sampling runs, but not during the light rainfall runs. On all other sampling occasions the creek was dry at this point. When flowing water was observed during dry weather, the flow was very small (less than 0.5 L/s). This meant that any impact by wildfowl or other animals would have been significant due to the lack of dilution and the greater chance of bed disturbance. Therefore, the results from these samples need to be treated with caution.

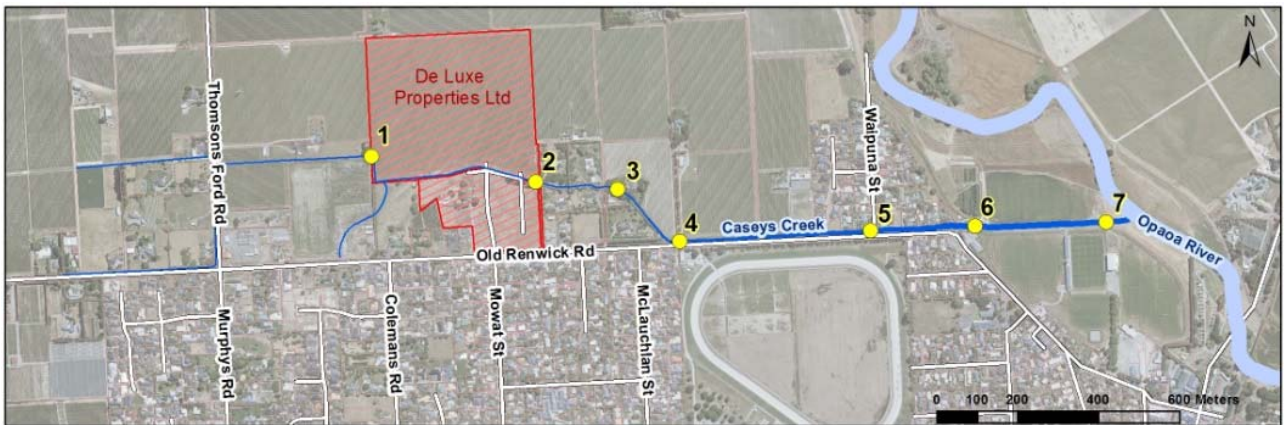
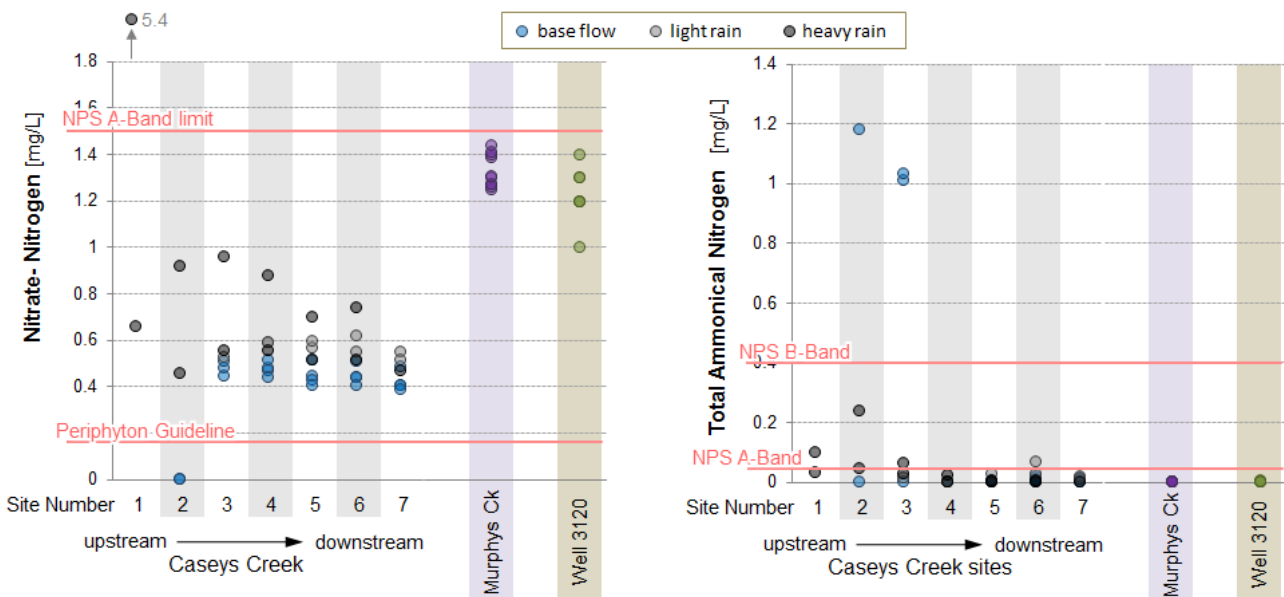
**Figure 7: Top: Map of the sampling sites (with Site Numbers) on Caseys Creek. Bottom: Nitrate-Nitrogen and Total Ammonical Nitrogen concentrations measured in Caseys Creek, Murphys Creek and Well 3120. For Caseys Creek the different sampling conditions are distinguished by colour.**

Nitrate-Nitrogen concentrations in Caseys Creek are generally above the Periphyton guideline, but below the A-Band limit of the NPS (Figure 7). During base flow conditions, concentrations are very similar at all sites, with a median value of 0.45 mg/L. The only exception is Site 2 (downstream of De Luxe). However, as mentioned, the flow was very low and the result is likely not representative of general water quality due to significant interaction with the stream bed.

Nitrate-Nitrogen concentrations in Caseys Creek are lower than those observed in Murphys Creek and Well 3120. It is likely that the groundwater emerging in Caseys Creek follows a slightly different flow path than that feeding into Murphys Creek and receives less nitrogen through leaching. The limited variation of the Nitrate concentrations in both streams, however, indicates that groundwater inflow is the main source of Nitrate during base flow conditions.

During rainfall events, Nitrate concentrations are higher than the base flow values. The difference is the result of inputs from overland flow and stormwater. The highest concentration was measured during heavy rainfall upstream of the De Luxe property. The water at this site is predominantly influenced by rural land uses upstream. Septic tanks are also a possible source, but microbial source tracking of the sample taken downstream of the De Luxe property during the same event showed that no human sewage was present.

Total Ammonical Nitrogen concentrations were below the NPS A-band limit in most samples. Exceptions during baseflow were samples taken at sites 2 and 3. It is unclear what caused the high Ammonical Nitrogen levels, but a possible origin is interactions with stream sediment at site 2 (see above). At site 3 the breakdown of abundant organic material from the dense vegetation surrounding the pond combined with low flows could also cause high Ammonical Nitrogen concentrations. Other sources are animal or human faecal matter, but *E. coli* concentrations at Site 3 were consistently low during base flow conditions, making this an unlikely source for these samples.

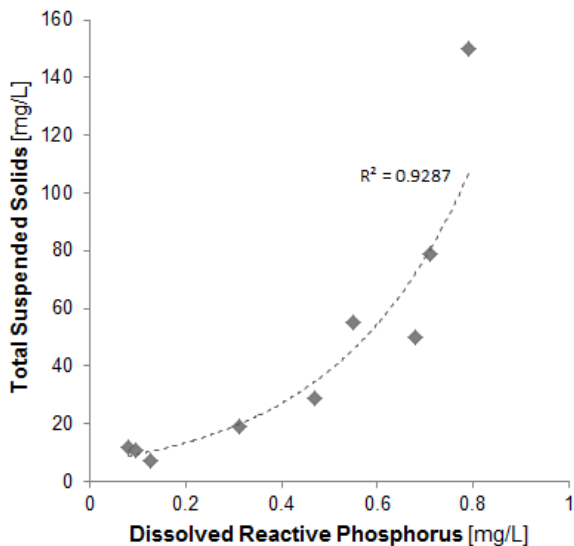
**Figure 10: Correlations between DRP concentrations and Total Suspended Solid concentrations measured in Caseys Creek.**

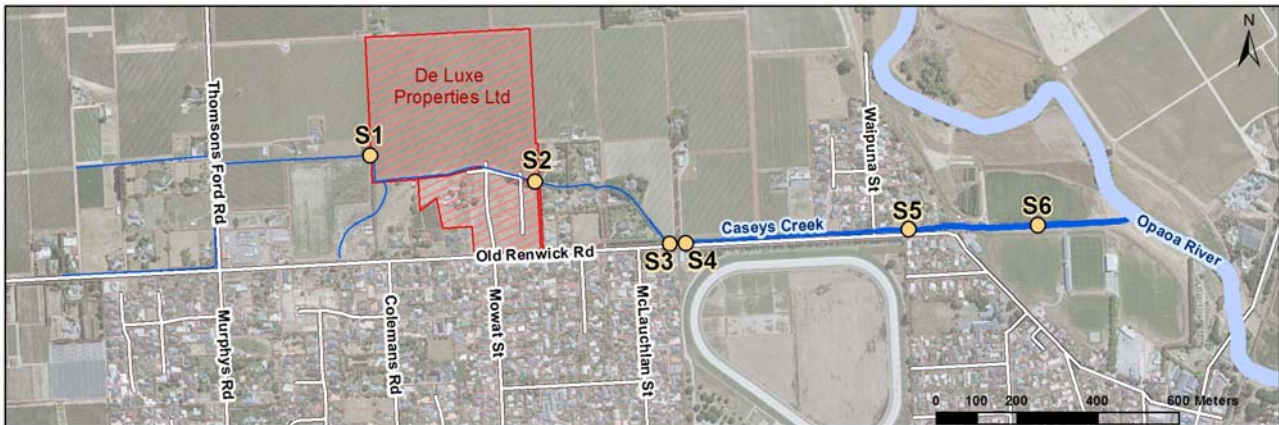
Stream sediment was sampled at four sites on 14 December 2016 and two additional sites upstream and downstream of the proposed stormwater discharge location on 8 June 2017. At each site five subsamples of fine sediment (clay, silt and fine sand) to a depth of 3cm were combined into a composite sample and sent to Hill Laboratories for analysis.

Table 1 shows a summary of the analysis results. The results are assessed against the Interim Sediment Quality Guidelines (ISQG) in the ANZECC 2000 Guideline document [1]. Although these guidelines are not 'pass/fail' values, they do provide indicators for the potential onset of biological effects (ISQG-low) and for concentrations that can cause significant biological effects (ISQG-high).

In the sediment from Caseys Creek all heavy metals were found in concentrations above the detection limits. However, the only contaminant of concern was Nickel, which was found in concentrations at or slightly above the ISQG-Low guideline value at all sites. The highest Nickel concentration was detected in the most downstream sample, but considering the natural variability and the limited sample effort<sup>3</sup> the differences between the Nickel concentrations at the sites cannot be considered statistically significant.

None of the sites had consistently higher heavy metal concentrations. The samples from each site had the maximum measured concentration for a different heavy metal. The only notable exception was the sampling site upstream of De Luxe (Site S1), which had the highest concentrations for three of the heavy metals. This is consistent with the results of the water quality sampling, which showed that the highest Zinc concentrations were observed in the upper reaches of Caseys Creek (see previous section)

The stream sediment samples were also analysed for Polycyclic Aromatic Hydrocarbons (PAHs). The highest concentrations were generally observed at Site S5, but values were well below the ISQG-Low levels for the individual analytes and the guideline level for Total PAHs.
