6.4. Turbidity and Sediment

6.5. Dissolved Oxygen, Water Temperature and pH

6.6. Ecology

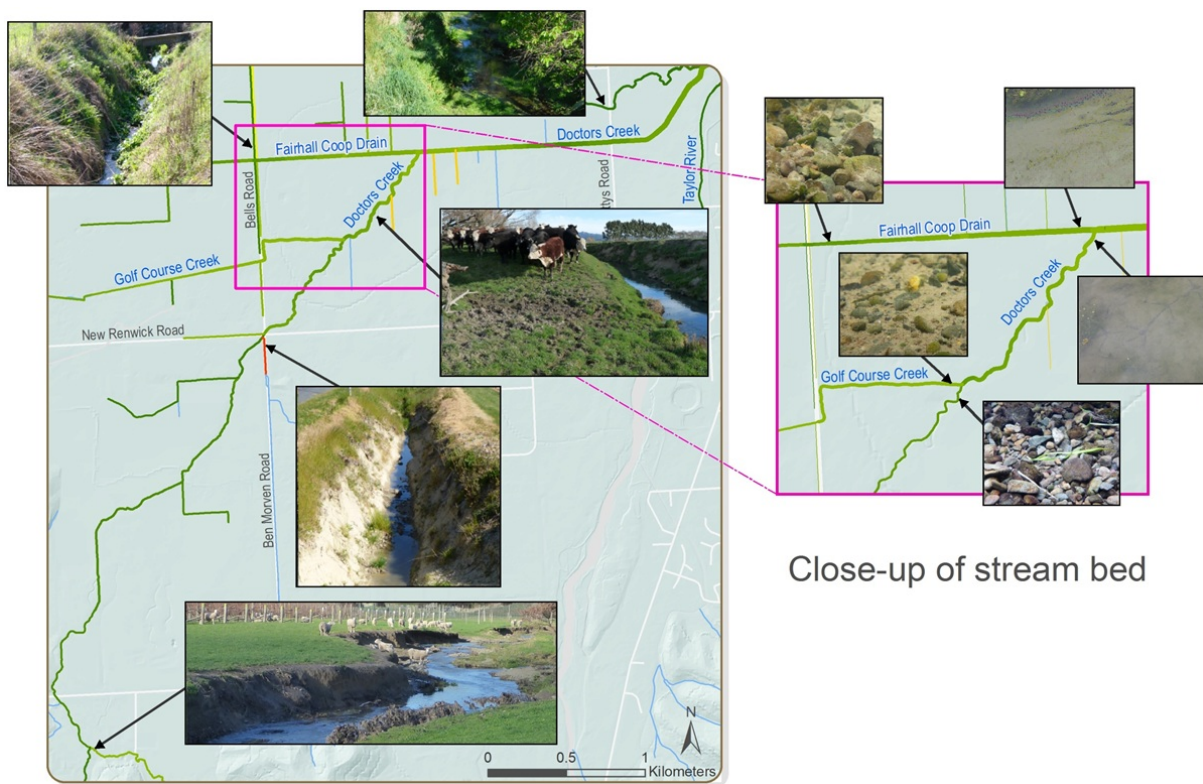
Figure 40: Examples of differences in bank vegetation and stability. The right side shows the variation in fine sediment cover for the area around the confluence between Fairhall Coop Drain and Doctors Creek compared to sites located upstream.

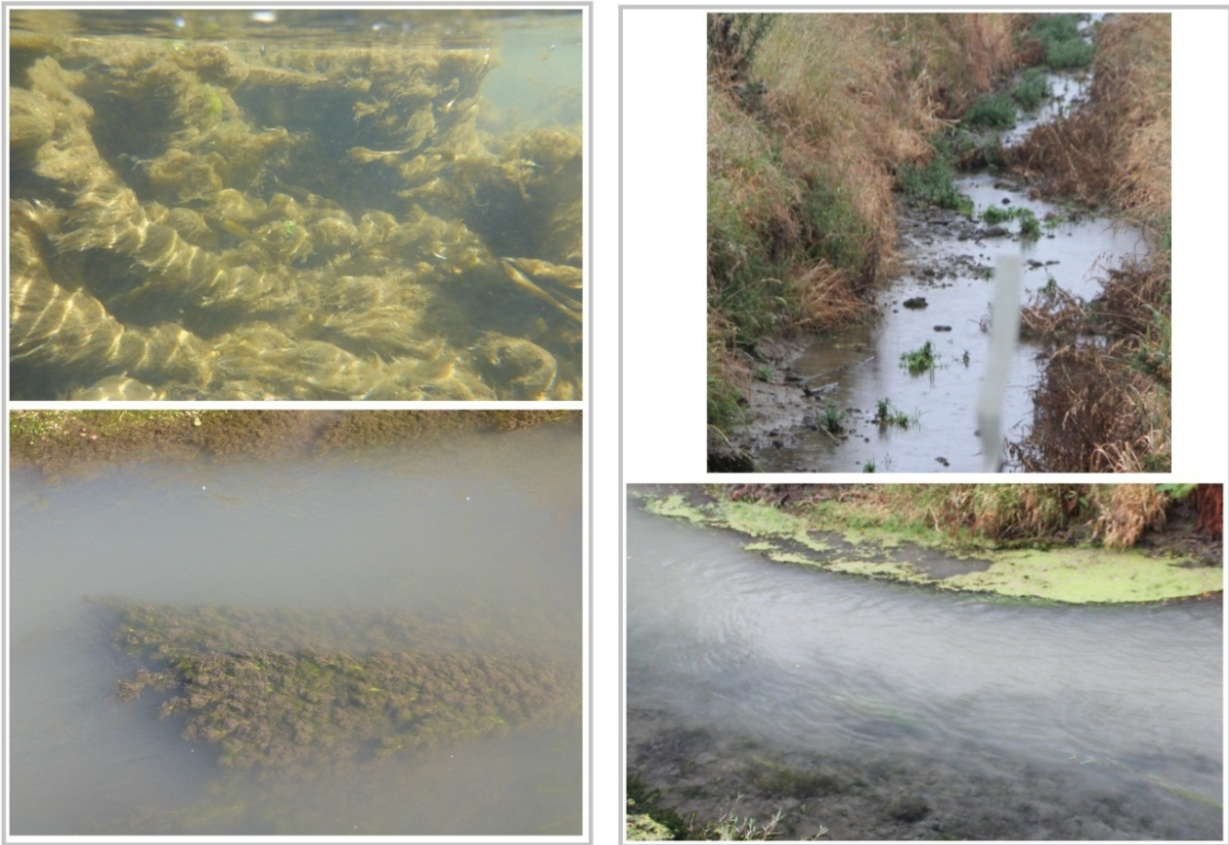
Figure 43: Two different causes for increased turbidity in the Fairhall Coop Drain; dense filamentous algae cover on the left and spraying of in-stream and bank vegetation on the right.

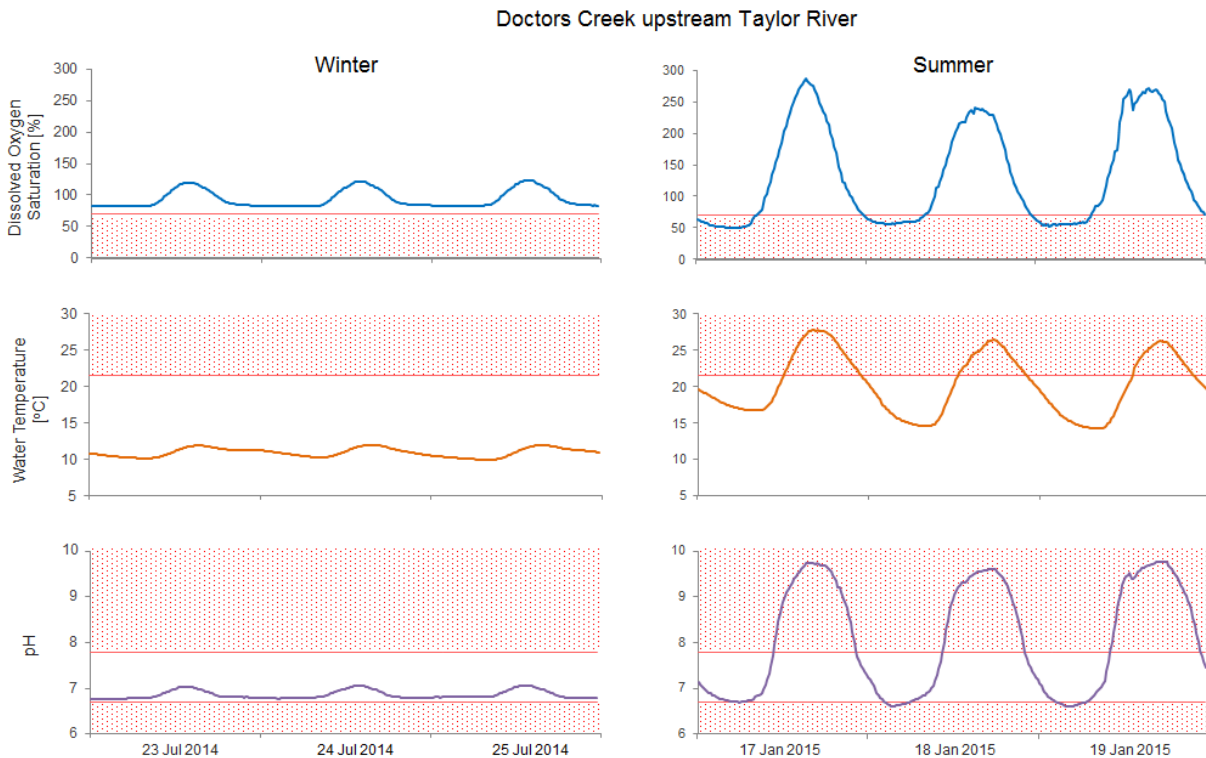
Figure 44: Continuous measurements of Dissolved Oxygen Saturation (blue), Water Temperature (orange) and pH (purple) in Doctors Creek upstream of the Taylor River over a period of three days, during the middle of winter (left) and summer (right). The range outside guideline values is shaded red.

Figure 44 shows the measurements of dissolved oxygen saturation, water temperature and pH taken at 15-min intervals in Doctors Creek just upstream of the confluence with the Taylor River over a period of three days. In winter none of the measurements exceed the guideline values and there is only a small variability over the course of a day. In summer, on the other hand, all three measurements exceed the guidelines on a regular basis. Extremely high dissolved oxygen saturation and pH values during the day

are a result of photosynthetic activity of excessive amounts of aquatic weeds and algae growing in the stream. Their growth is fuelled by high nutrient concentrations. The lack of larger vegetation along most of the banks of Doctors Creek and its tributaries also aid the growth of aquatic plants, as the lack of shade results in an abundance of sunlight reaching into the water column. At night, the same plants remove oxygen out of the water through respiration and the dissolved oxygen saturation decreases to values of 50%. Only physical input of oxygen as a result of turbulences and through the water surface prevent further reduction and result in the plateauing of the oxygen concentration during the night.

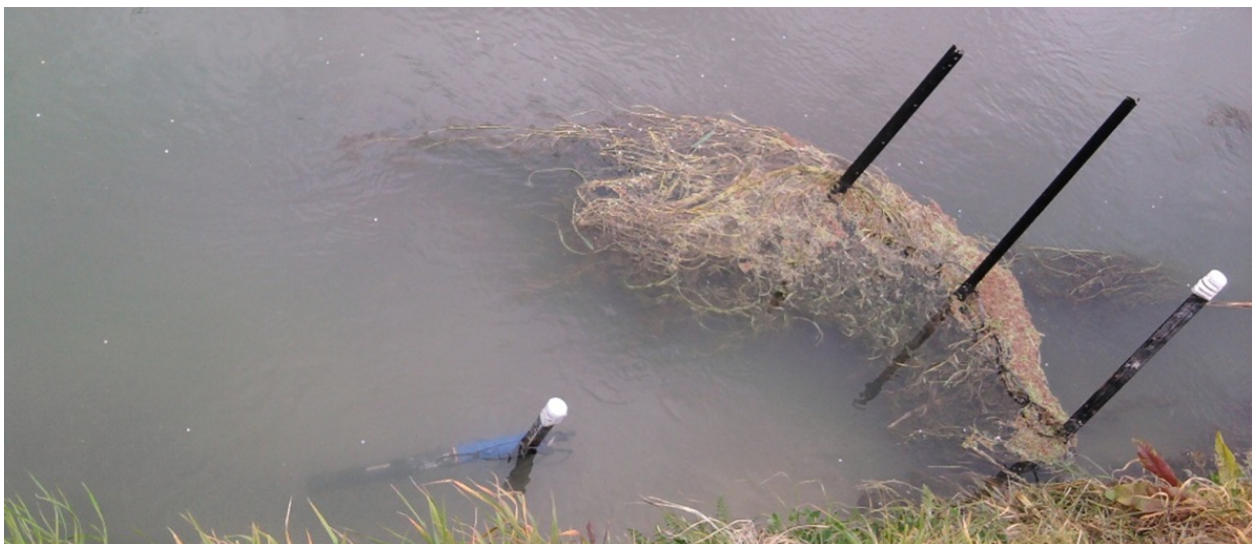
Figure 46: The 'Sonde' used for the continuous monitoring deployed in Fairhall Coop Drain. The screen to the right prevents floating aquatic weed to accumulate on the instrument.

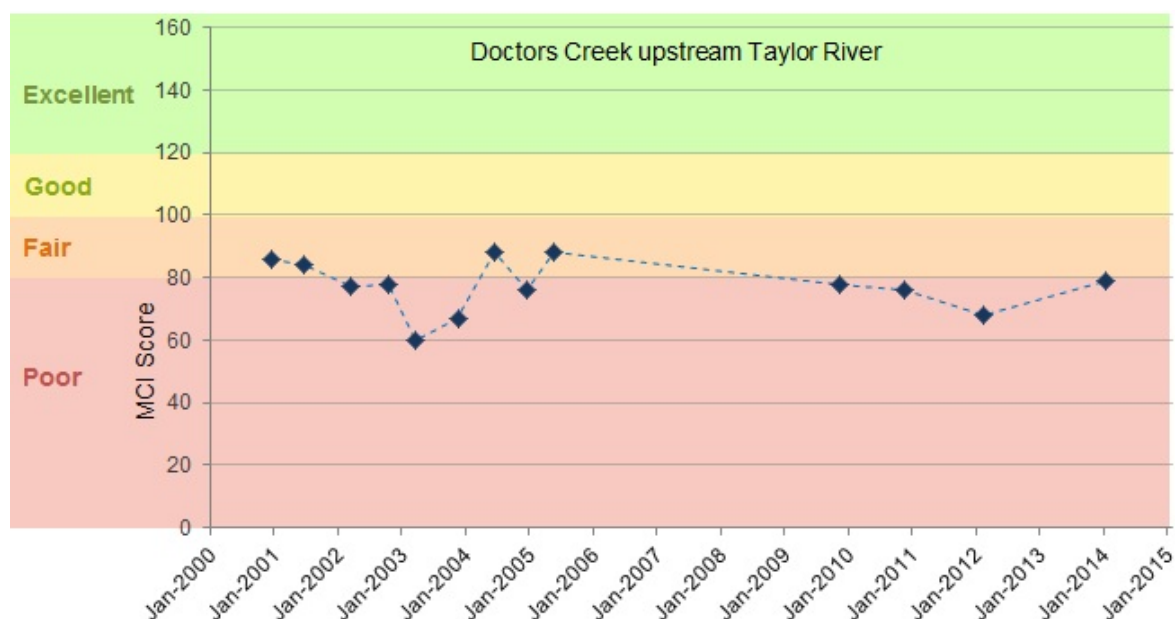
Figure 47: Macroinvertebrate Community Index (MCI) scores for Doctors Creek upstream of the confluence with the Taylor River.

The results of macroinvertebrate monitoring of Doctors Creek upstream of the Taylor River reflects the limited ecological value of this waterway. MCI scores are usually indicating poor or fair water quality and particularly in recent years MCI scores have been consistently in the poor category (Figure 47).

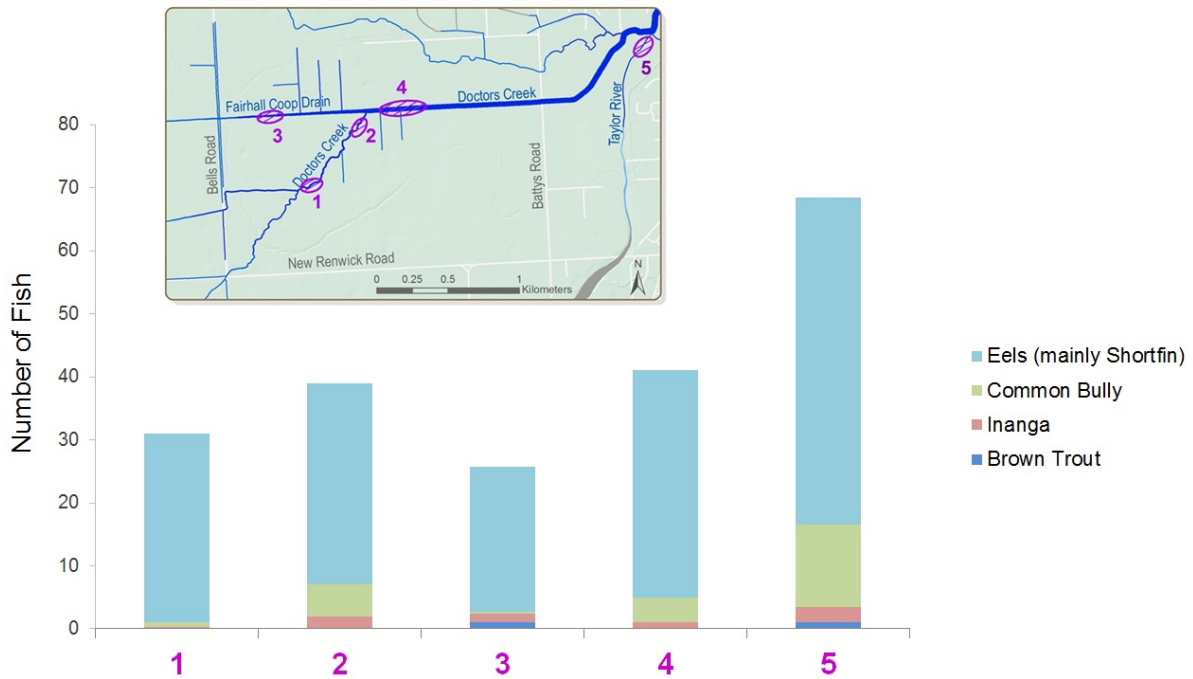
Figure 48: Average fish numbers found in several sites in the lower Doctors Creek catchment and in the Taylor River upstream of Doctors Creek [21, 42, 43].

Some sites have also been monitored for the abundance of fish (Figure 48). The fish fauna found as part of these surveys is limited to four or five species. Eels made up the majority of fish found at all of the sites. Shortfin Eels were most common, but Longfin Eels were also present, although in much lower
