# COASTAL

## COASTAL ENVIRONMENT

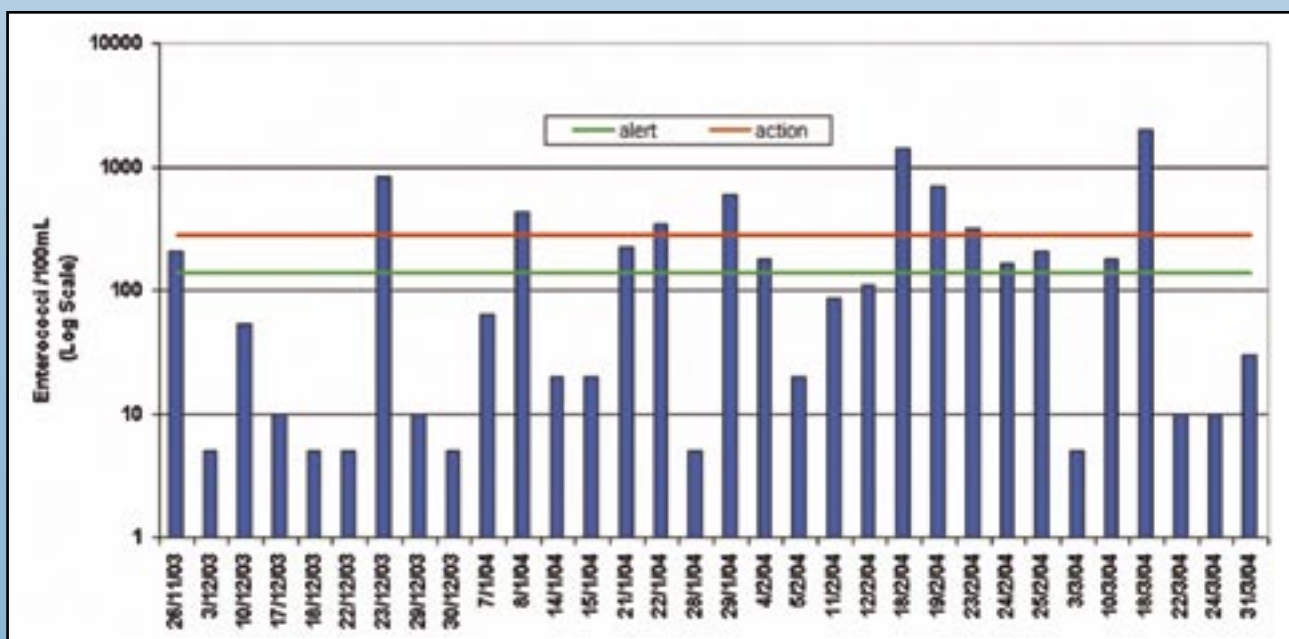
Figure 28: Monitoring Results for Picton Foreshore

Monitoring water quality at this site is very important, as there are frequent users of the beach for swimming, given its close proximity to the centre of Picton. Of the 32 monitoring occasions over the survey period, the alert guideline level was reached 14 times - see Figure 28. Of these, the survey results showed the action level being exceeded eight times. The non-compliance with the levels would most likely have related to the discharge of untreated sewage, usually during rain events or when overflows from the sewage pipes to storm water

pipes occurred. A number of these non-compliant results occurred in the days after the major flood event (reported in the Freshwater and Natural Hazard chapters). The pump station, which receives all of Picton's and Waikawa's sewage, failed when the floodwaters rose so quickly. Until repairs were made to the pumping station, sewage was temporarily pumped into Waitohi Stream, which then entered Picton Harbour. Bathing and shellfish gathering were banned for some time until bacteria levels dropped.

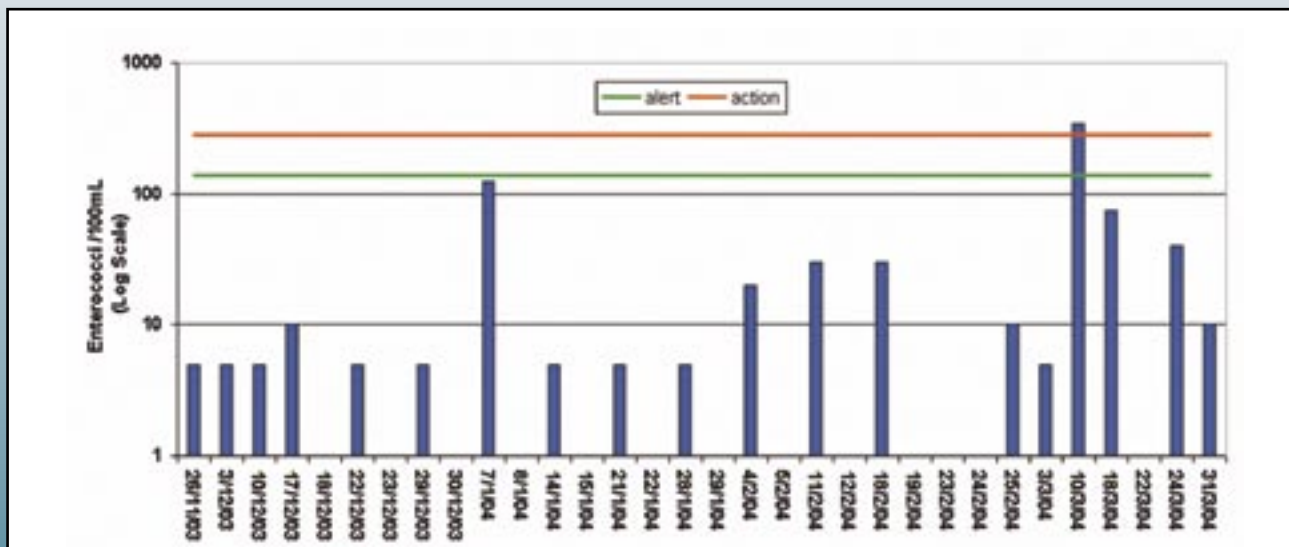
Figure 29: Monitoring Results for Ngakuta Bay

number of boats are also moored on swing moorings in the bay. The monitoring results for this site generally met the Ministry for the Environment guideline levels with the alert and action levels being exceeded only on one occasion - see Figure 29.

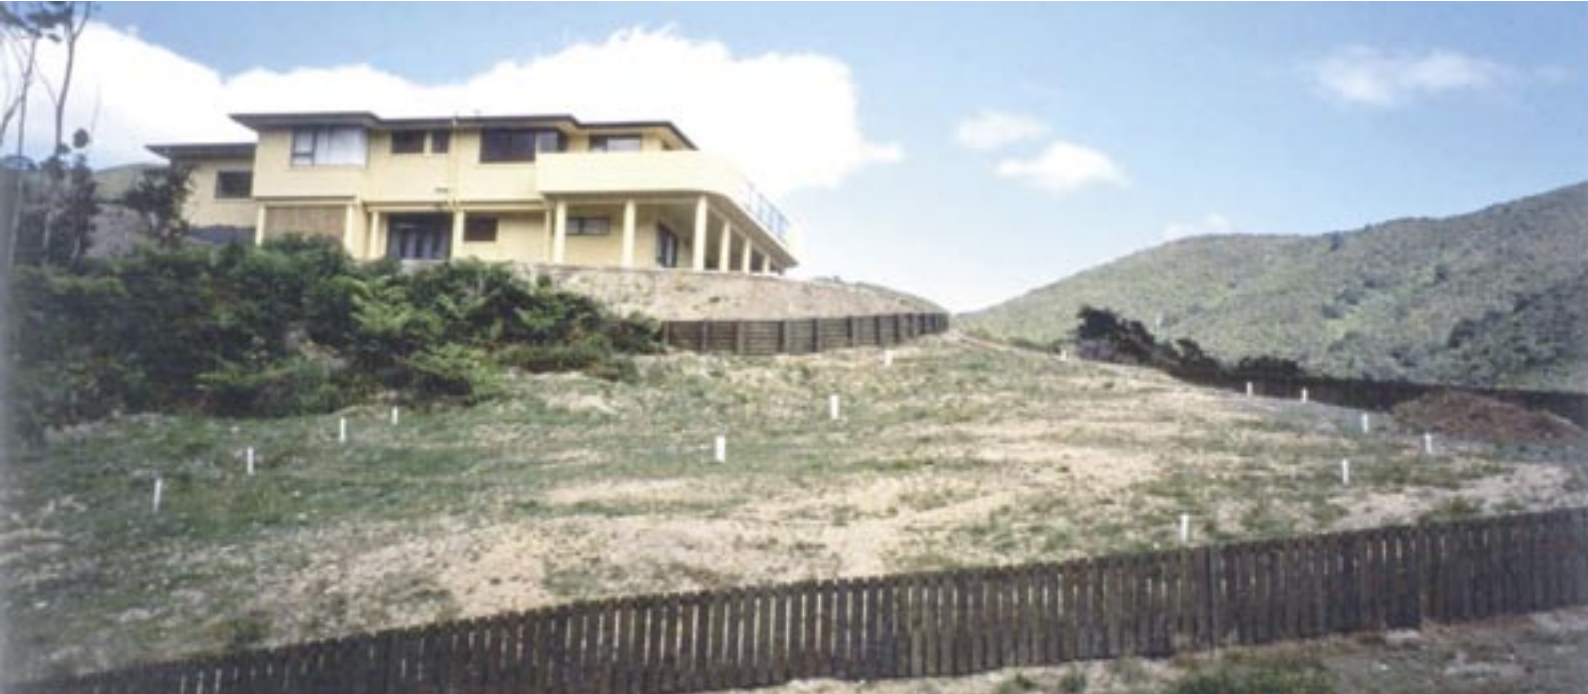
*Modern residential development in the Marlborough Sounds, with a large land treatment area in the foreground*

- current rules in the Plan are allowing on-site systems to be installed that do not necessarily suit site conditions;
  - the maintenance of existing on-site systems is seriously lacking and this contributes to poor performance; and
  - past subdivisions of land have created allotment sizes too small to allow the effective use of on-site wastewater management systems.
- there is enough land set aside for wastewater to be discharged into (land application areas); and
  - an assessment of the alternatives for servicing new lots is carried out, including an assessment of the best practicable option.

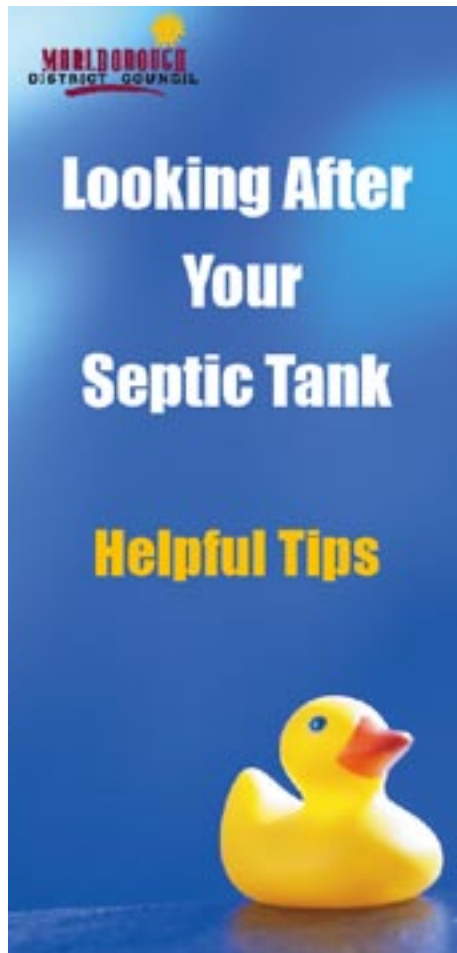
The do's and don'ts of looking after your septic tank (below)

using septic tanks. This is included with all building consent and land information memoranda issued by the Council in rural areas. The brochure describes how to have a healthy septic tank, and how to reduce the liquid load and solid load into the tank. It also describes how an on-site wastewater system works and what happens when a septic tank fails. The do's and don'ts from the brochure are set out below. (A copy of the full brochure is available from the Council's offices and is also able to be download from the website at [www.marlborough.govt.nz/documents/summarylist.cfm](http://www.marlborough.govt.nz/documents/summarylist.cfm))

The septic tank removes solids present in domestic wastewater, allowing the remaining liquid to pass through into the land application area. There are bacteria present in the wastewater that breakdown this solid material, turning it into a liquid sludge. Household cleaners, strong detergents and other chemicals can kill these "good" bacteria.

Solid material in wastewater settles on the bottom of the septic tank, where it forms a liquid sludge, while fats float to the top to form a crust. The more solids that enter the tank, the quicker the sludge and crust build up.

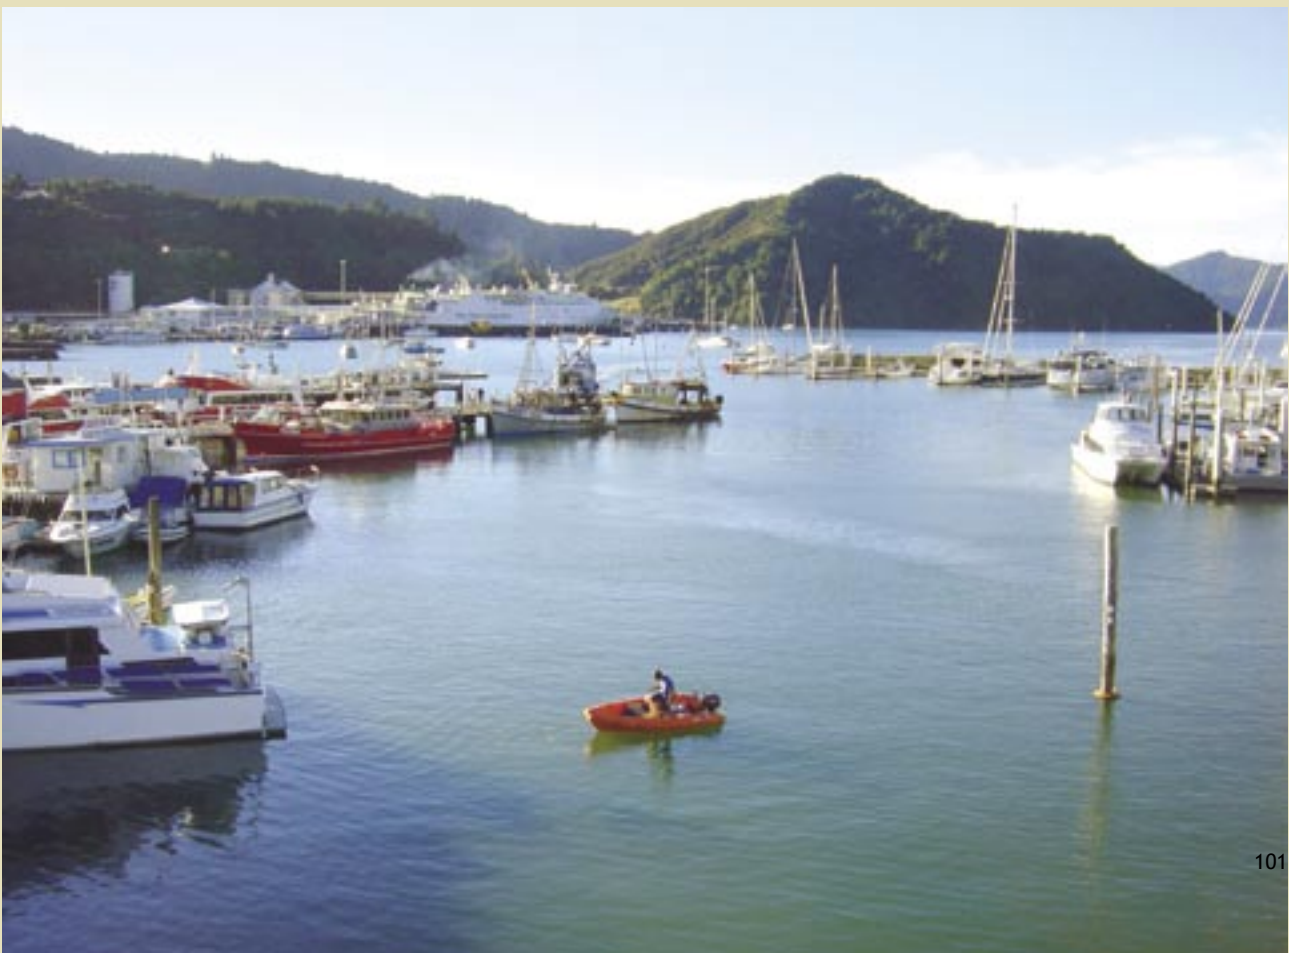
*Sampling sediments  
in Picton Harbour  
March 2004*

In March 2004 sediment samples were collected from Picton Harbour to establish levels of antifouling contaminants. Sediment samples were also collected from Whatamango Bay (April 2004) to establish background levels of antifouling contaminants outside of the harbour.

Results for sample analyses showed that trace metals were elevated in Picton Harbour sediments relative to the background levels in the Whatamango Bay sample. Levels of mercury, copper, lead and zinc were found to exceed the Australia New Zealand Environment and Conservation Council (ANZECC) guidelines with mercury being the trace metal of greatest concern.
