# Freshwater

## FRESHWATER

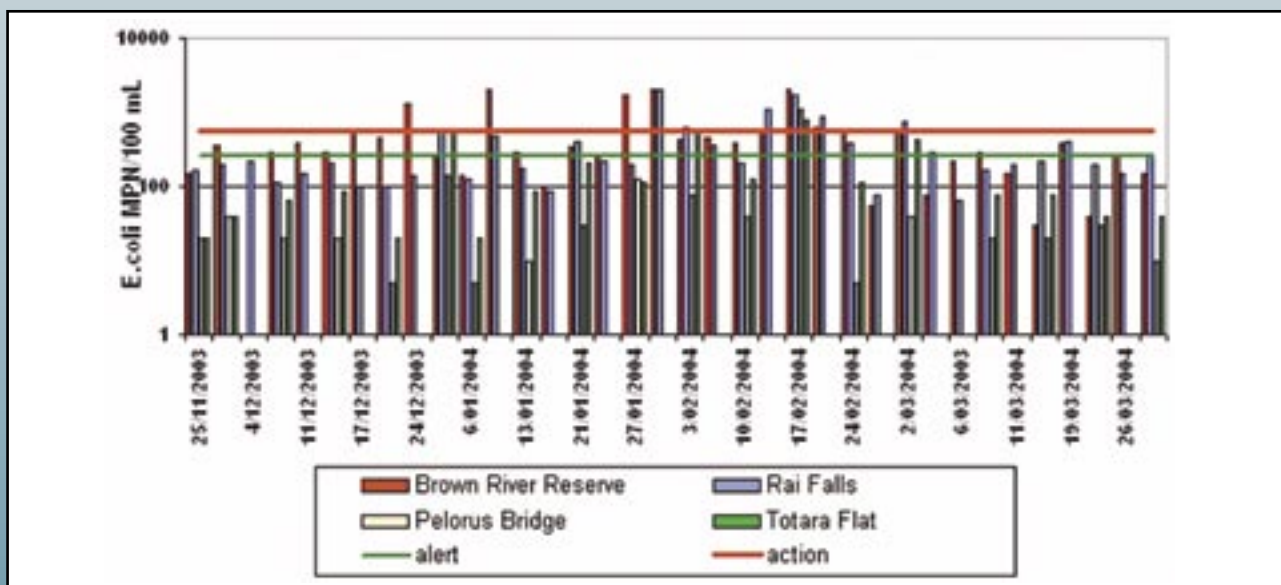
*Figure 5: Rai/Pelorus River results for November 2003 to March 2004*

The Council monitors five sites in this catchment. These sites are the Rai River at Carluke Bridge, at Brown River Reserve and at Rai Falls, and the Pelorus River at Pelorus Bridge and at Totara Flat. Figure 5 shows the results for the summer monitoring period for four of these sites. The Carluke site has not been included in the results as monitoring has only just commenced at this site.

recreational sites. The monitoring shows that water quality at these two sites is not very good, with the action guidelines being exceeded relatively frequently. The Council needs to do frequent monitoring and alert the public if the water quality might be a risk to public health.

In contrast, the two sites on the Pelorus River, Totara Flat and Pelorus Bridge, more consistently meet the freshwater guidelines.

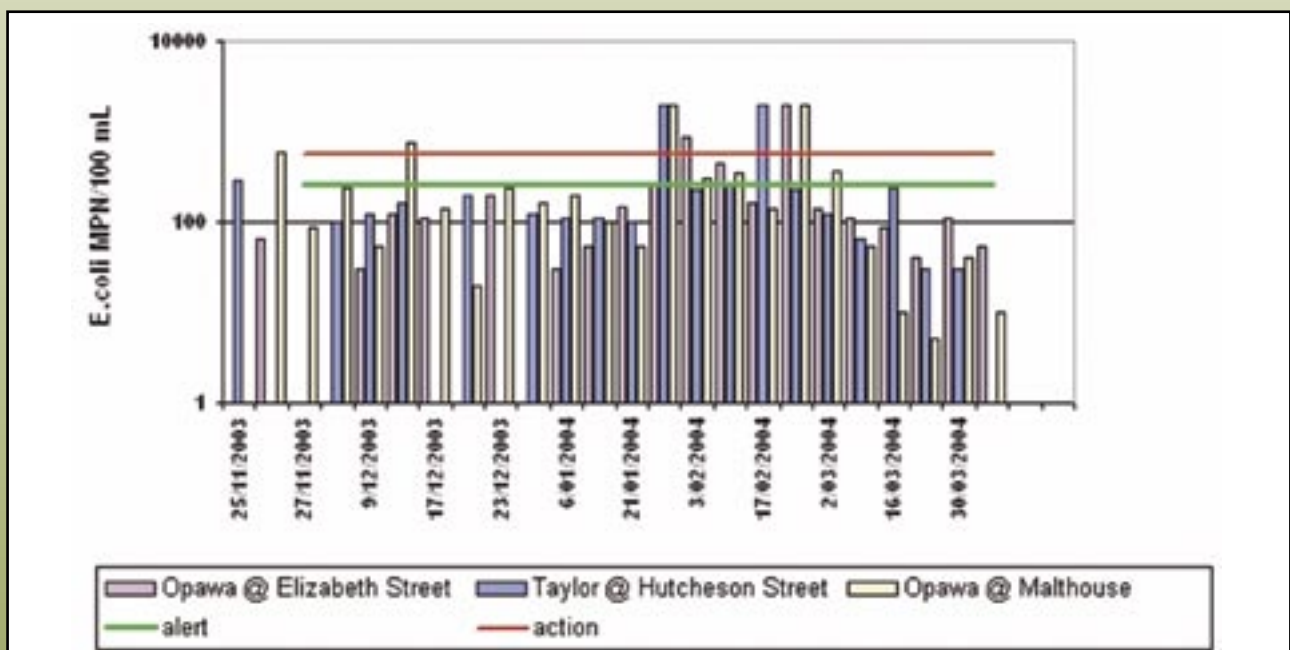
Figure 7: Taylor and Opawa Rivers results for November 2003 to March 2004

The monitoring results for three sites on the Taylor and Opawa Rivers are shown in Figure 7. These sites are the Taylor River at Hutcheson Street, and the Opawa River at Elizabeth Street and at Malthouse Road.

All three sites have exceeded the guideline levels and have been unsuitable for recreational use.

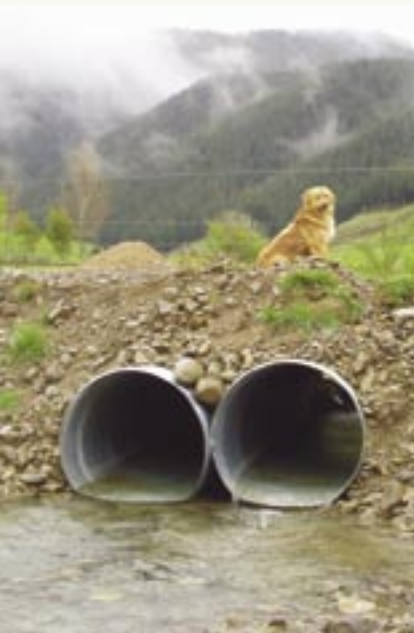
*Culverts need to be installed correctly to allow fish passage*

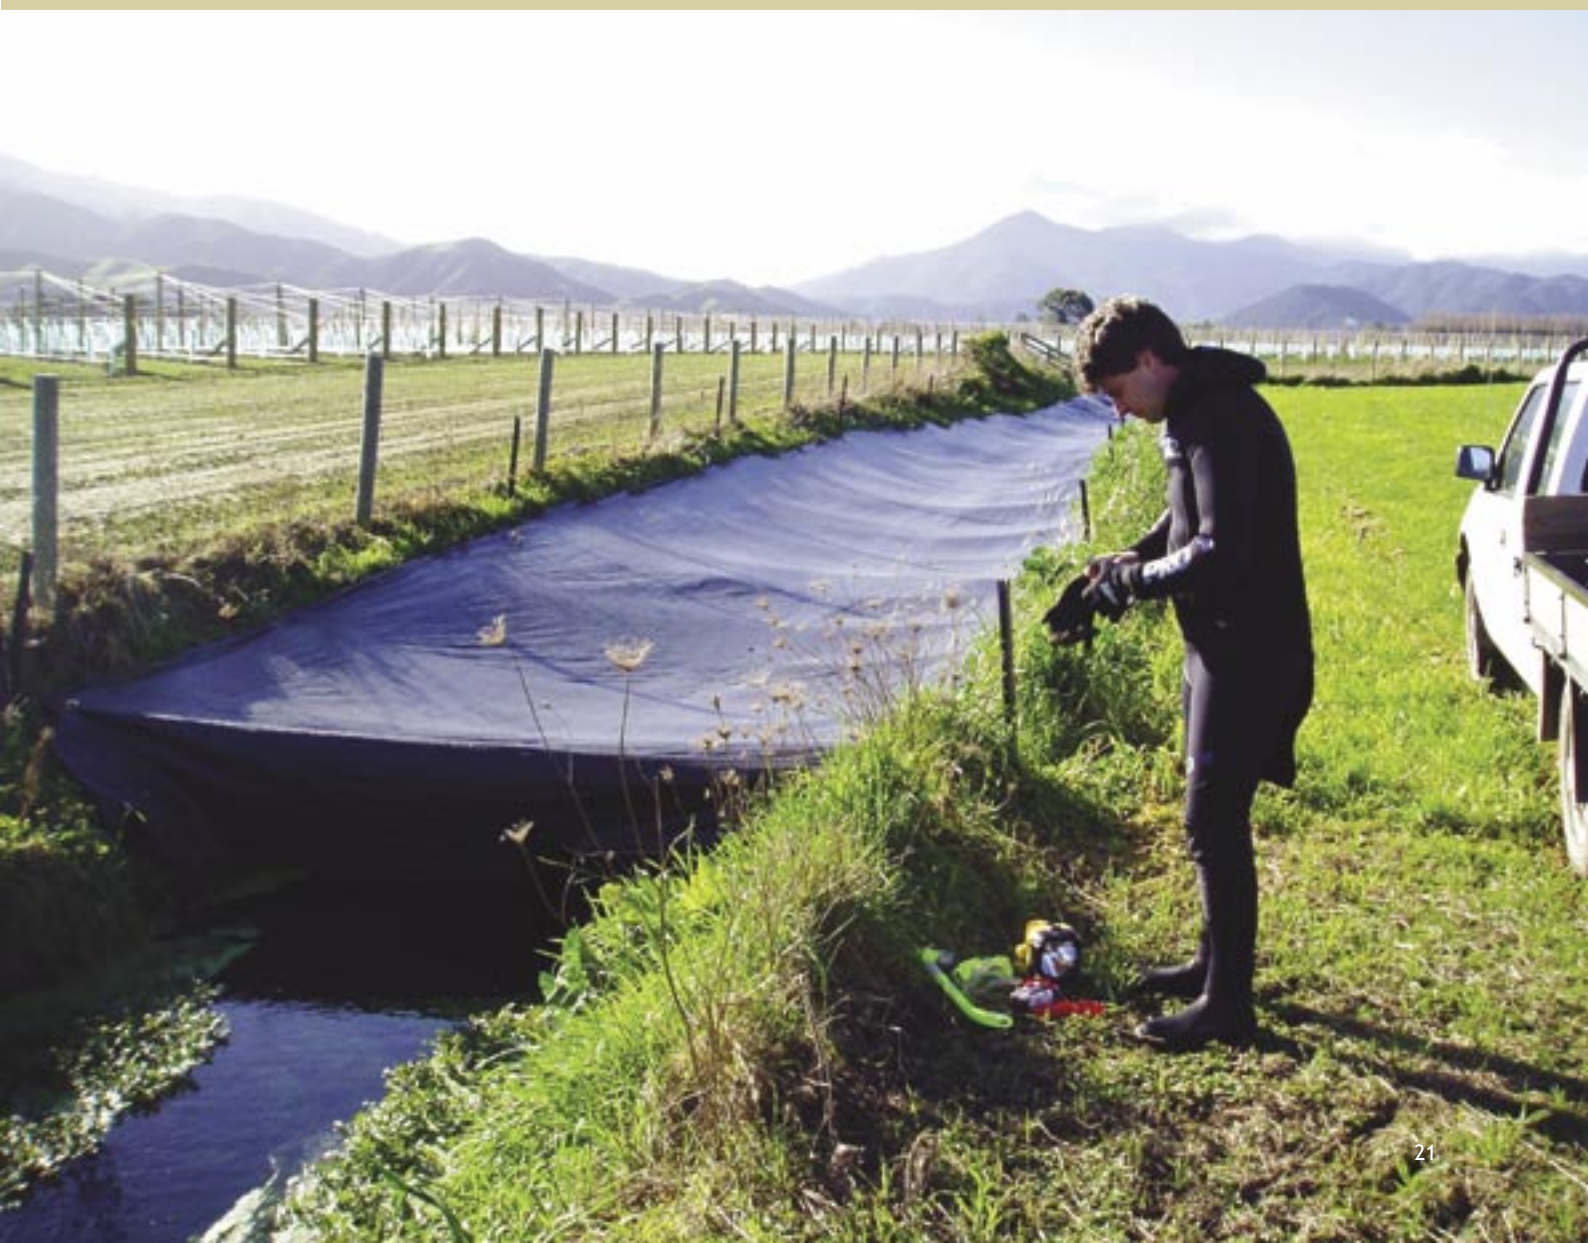
*Phase 2 of shading  
experiment on Roses  
Creek*

Phase two of the trial has been set up using one layer of weed mat for a shorter period of 3 months. Initial results with this faster, and more cost effective method, are looking positive.

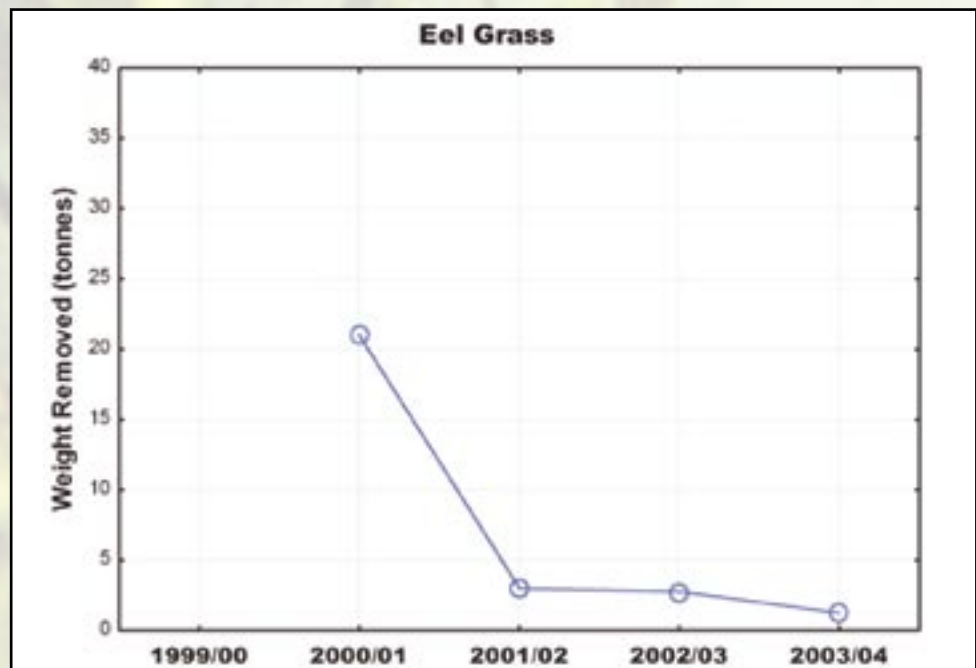
*Figure 8 - Eel grass removal from Opawa Loop*

In Marlborough, there are six sites in the Opawa River loop near Blenheim, which are known to have eel grass. There is also a small infestation in Waterlea Creek. In 2000/2001 a total of 21 tonnes of eel grass was removed from waterways. This has reduced significantly, with only about 1.25 tonnes being removed over the past year from the Opawa Loop - see Figure 8, which shows the amount of eel grass in tonnes, that has been removed over the past 4 years from Marlborough's waterways.
