# The Microbiological Quality of Marlborough Coastal Bathing Beaches 2005-2006

May 2006

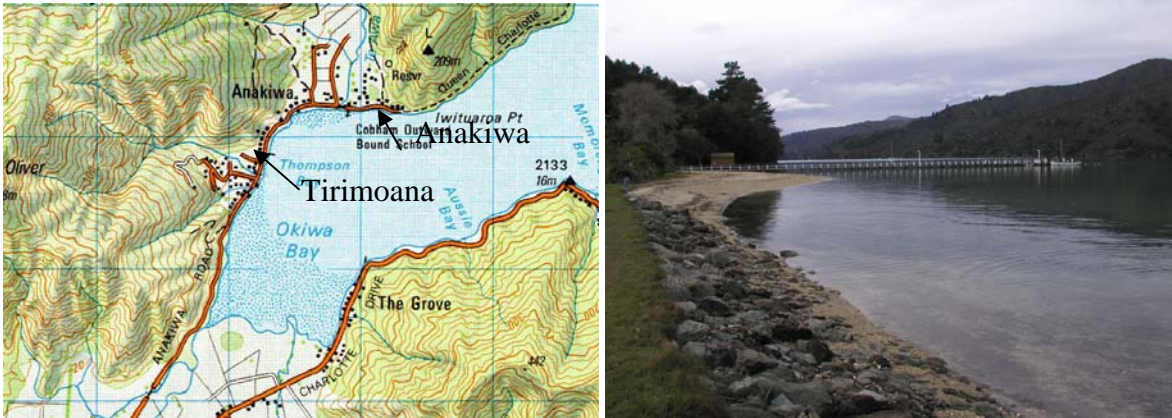
- **Anakiwa and Tirimoana**

Anakiwa is an enclosed bay at the western end of the Queen Charlotte Sound. It has an annual average rainfall of 1500mm and is used all seasons for swimming, water sports and boating. The beach is sand and stones and is surrounded by housing and bush clad hills.

The Outward Bound School has a sophisticated sewage treatment system with tertiary treatment and discharge to an inland man-made wetland. Domestic sewage disposal systems are contained on site. Although discharges to the sea have occurred from some domestic sources, there have been significant upgrades in the past two years.

Tirimoana is a closely settled bay adjacent to Anakiwa (70-80 houses) with onsite sewage treatment and disposal systems. There have been recorded incidents of discharge from some sites to small streams to the bay. Dense estuarine mud at the head of Okiwa Bay has a strong odour when the tide is low. Several surveys including sediment sampling indicate that there is no contamination from sewage in the sediments. There is swimming from the jetty, and boating and kayaking in the bay.

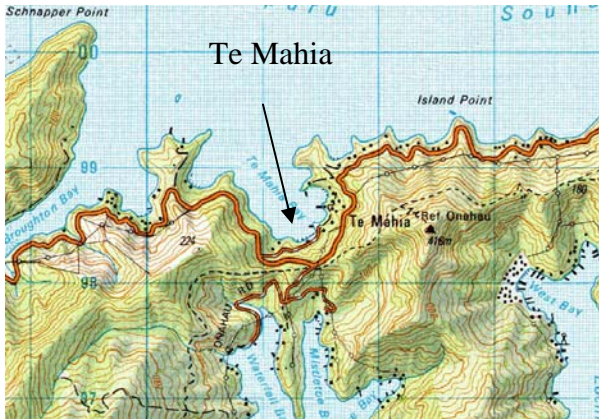
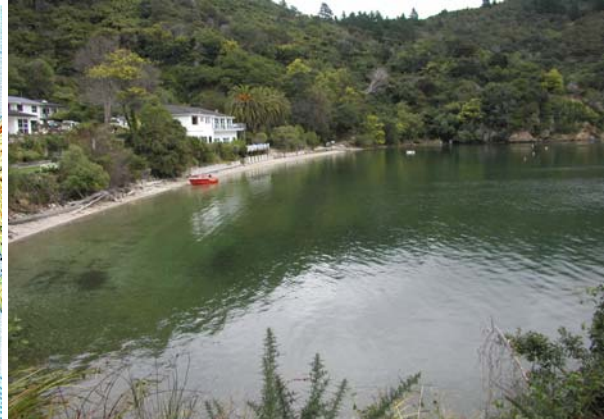
- **Te Mahia**

Te Mahia is an enclosed bay in the Kenepuru Sound. There is an annual average rainfall of 2000mm per year. The beach is pebbly and there is a surrounding shoreline of steep bush-clad hills. Swimming and boating are popular.

There is onsite sewage treatment, with septic tanks discharging inland in the bush. Grey water is discharged directly to the sea. Monitoring since 1996 has shown no impact on the coastal water from any discharge to land or directly from the grey water system.

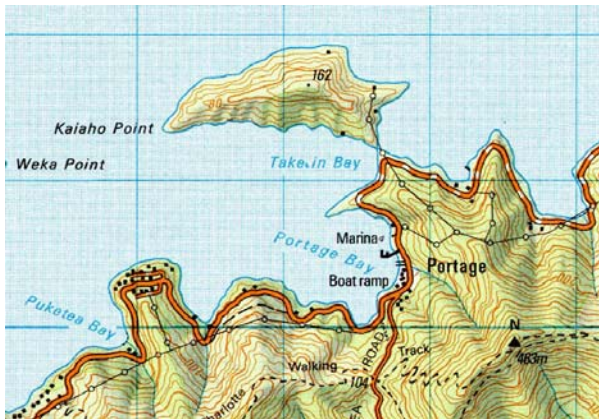
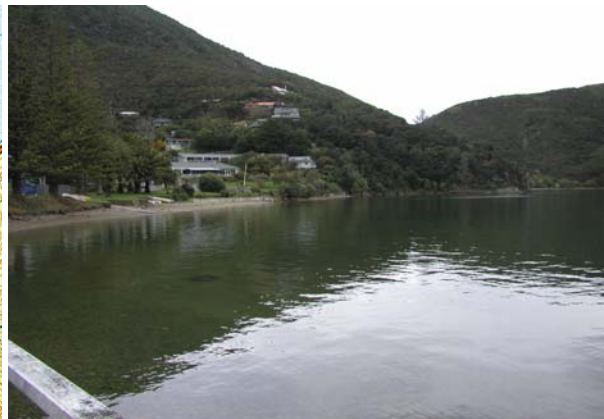
- **Portage**

Portage Bay is an enclosed bay of the Kenepuru Sound. There is an annual average rainfall of 2000mm per year. There is a large hotel complex and some 12-15 houses. A sewage treatment system servicing the hotel, shop and some houses, discharges to the bay at approx 0.5K from the inner bay shoreline. The beach is sand and stones, and steep bush clad hills surround the bay.

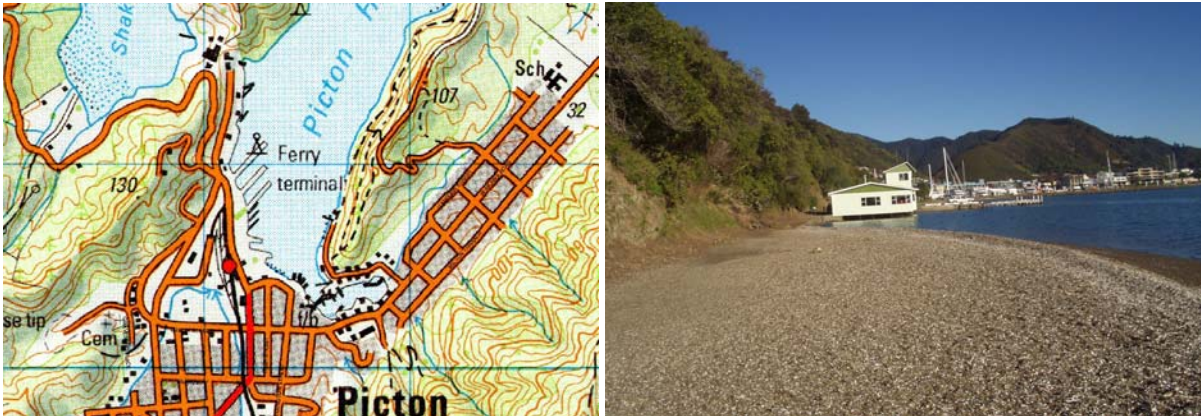
- **Shelley Beach**

Shelley Beach is located in Picton Harbour on the eastern side. There is an annual average rainfall of 1500mm per year. The beach is sand and stones and is surrounded by steep bush-clad hills. The Queen Charlotte Yacht Club is situated at one end of the beach. The water quality of Picton Harbour is at times not suitable for recreational use, and this includes the Shelley Beach site. Storm water discharges and occasional sewage overflows affect water quality in the harbour at most of the recreational sites, especially after heavy rain events.

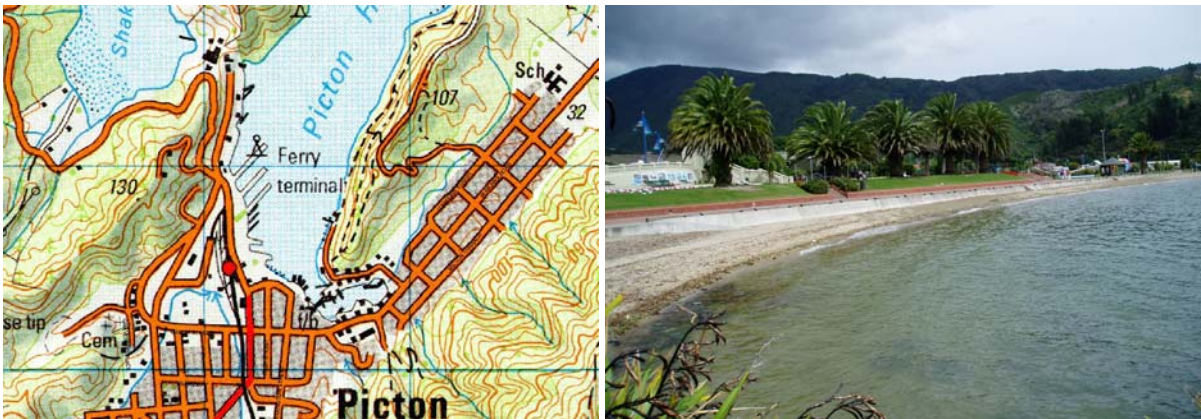
- **Picton Foreshore**

The Picton Foreshore beach is located at the head of Picton Harbour. The annual average rainfall is 1500mm. The shore is small stones with imported sand, and the area has been developed and landscaped as a playground with grass, palm trees and concrete and paving structures. A children's paddling pool discharges to the beach. The sea water quality is affected by discharges from stormwater outlets from the urban area, and from streams from the upper, bush-clad, catchment. The site is also adjacent to the Picton Marina and to the Picton Wharf. At times water quality is not suitable for recreational use. This relates to heavy rainfall events, and also sewage overflows to the stormwater system or directly to streams that discharge to the sea.

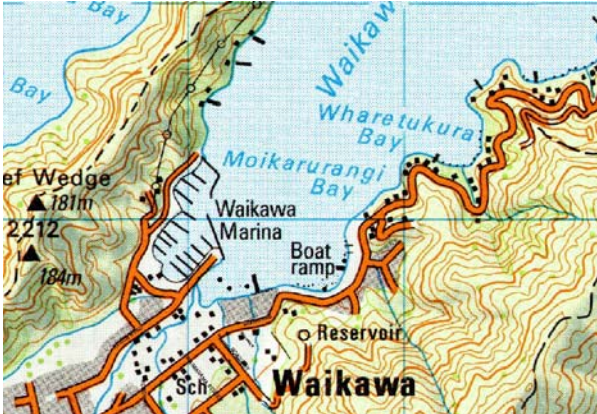
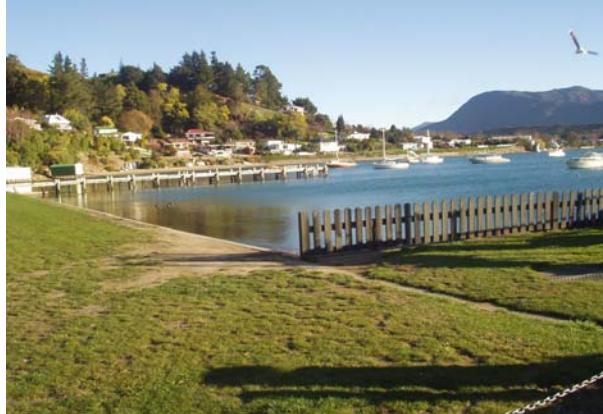
- **Waikawa Bay**

Waikawa Bay is an enclosed bay in Queen Charlotte Sound. The annual average rainfall is 1500mm. The bay is used for swimming, and boats are moored in the bay and adjacent boat marina. The beach is sand and stones, with a landscaped area of grass and walls. The beach is surrounded with houses and bush-clad hills. There are storm water discharges to the bay from the urban area and the upper catchment.

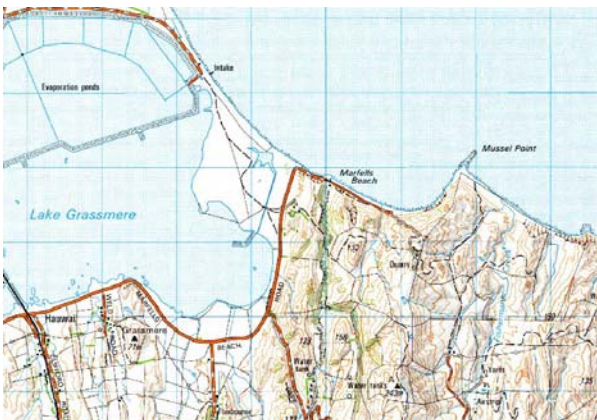
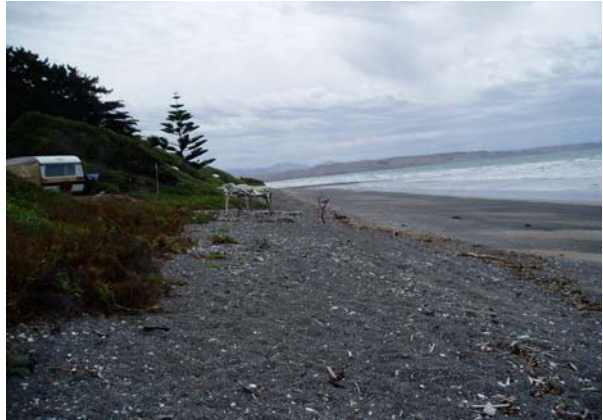
- **Marfells Beach**

Marfells Beach is approximately 45K south of Blenheim, on the Pacific (east) coast. The beach is sand and stones with dunes and small hills rising to pasture flats. Adjacent to the beach is a narrow stretch of road and grassed areas with camping sites for tents and caravans. There is a DoC toilet and cold water ablation block. The beach and camping sites are used throughout the year, and intensively in the summer time. Fishing, boating and swimming are popular activities.

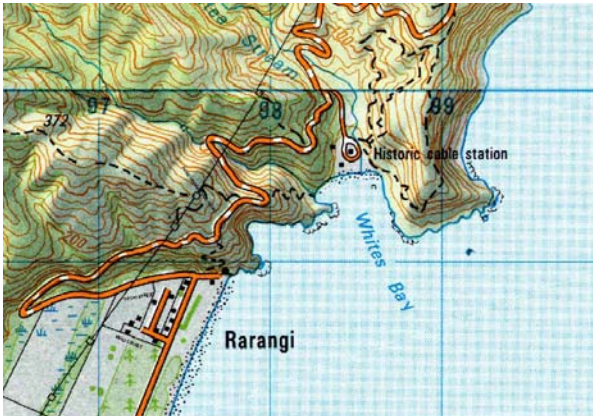
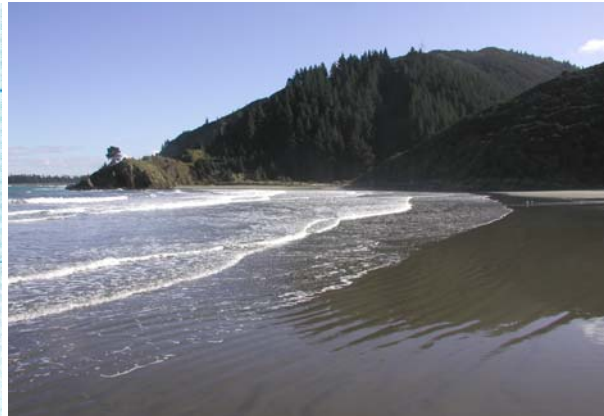
- **Whites Bay**

Whites Bay is situated on the east coast at the southern entrance to Cook Strait, about 25K north of Blenheim. It is an enclosed bay with a sandy beach and dunes with rocky headlands. The surrounding area is flat with grassed areas and bush where there is a camping site, and has surrounding steep bush-clad hills. There is a DoC information site with toilets and an ablution block. The site is a popular summer swimming site, and there is some surfing and fishing all year.

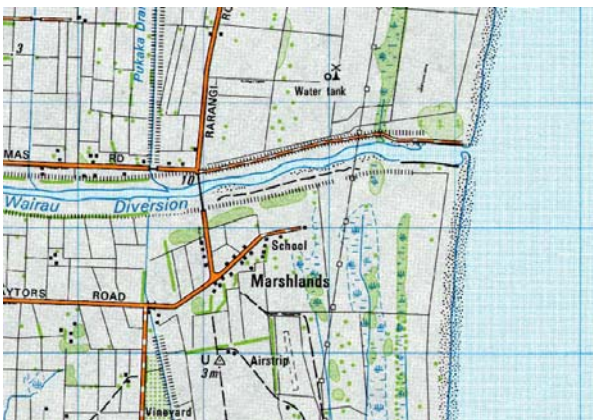
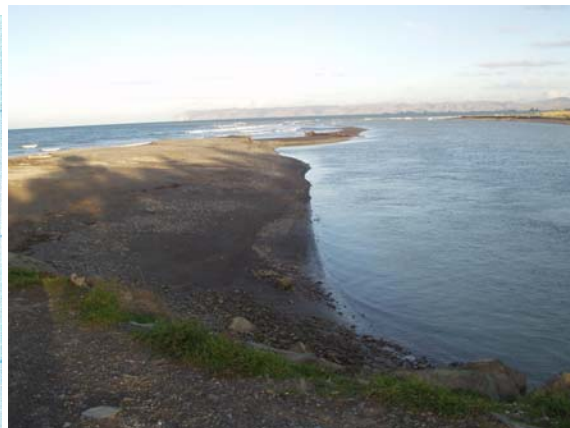
- **Wairau Diversion**

The Wairau Diversion is a man-made channel, diverting part of the Wairau River at Tuamarina through pasture and vineyards to the east coast. The average annual rainfall is 760mm. There is a small shingle bar at the mouth of the Diversion. Both the open coast and the partly enclosed mouth of the Diversion are used for fishing. Surf casting to the open sea, and whitebaiting and fishing for flounder, etc, are very popular. Monitoring of the water quality is done within the tidal area at the mouth of the Diversion where there is swimming. There is some impact on the water quality in the Diversion from farming (dairying and piggeries) at times, but this is generally farm runoff rather than direct discharges. There is no camping permitted at this site, and there are no facilities, apart from a toilet block, but it is not uncommon for campervans and vehicles to be at the site for long periods of time.

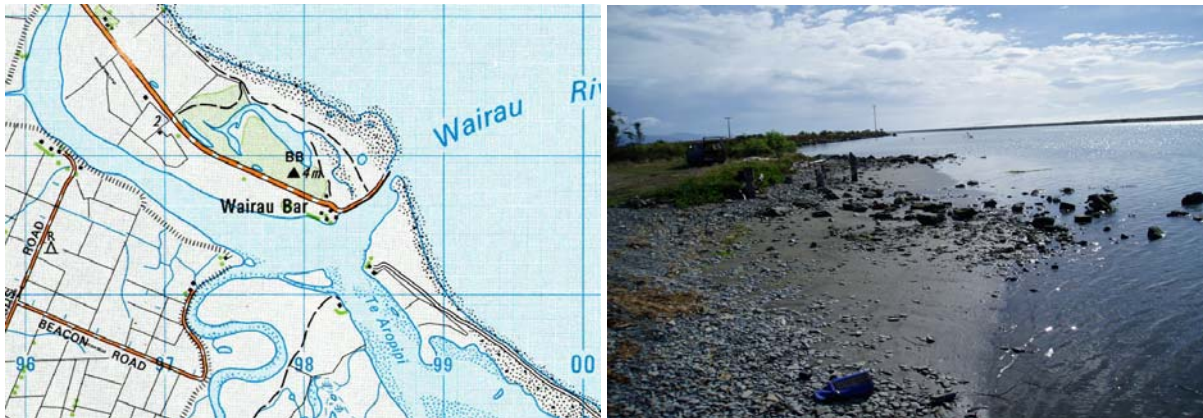
- **Wairau Bar**

The Wairau Bar is located at the mouth of the Wairau River some 500 metres from where the Boulder Bank, enclosing the Wairau Lagoons, extends in a northerly direction to the lagoons and estuarine area. This site is at the confluence of the Wairau and Opawa Rivers and the exit channel from the Lagoons (Te Aropipi). The site is popular with whitebaiters and fishers (mostly set nets for flounder within the bar, and surf casting outside of the bar). There is also recreational boating, kayaking, wind surfing and swimming within the enclosed area. Shellfish (cockles and pipipi) are abundant. The Lagoons are also populated with large numbers of birds. There is a DoC toilet block, but no other camping facilities. The beach is mostly stones with a small area of sand. Use of the area is restricted (shellfish cannot be taken for consumption) because effluent is discharged from the Blenheim oxidation pond to the Opawa River approximately 3K upstream of the estuary. However, monitoring shows that the water quality is at most times suitable for contact recreation.

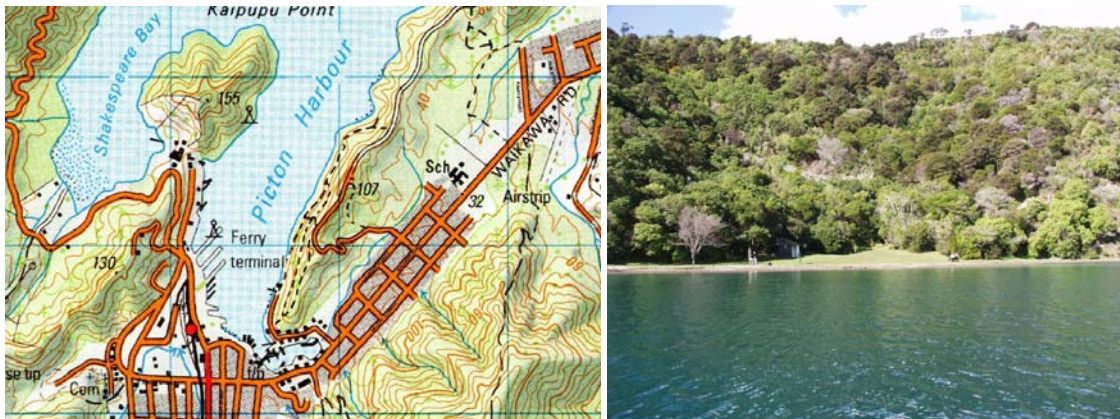
- **Bobs Bay**

Bobs Bay is situated in the Queen Charlotte Sound and is accessible only on foot or by boat. It is approximately a 20 minute walk from Picton. It is an open bay with a sand and stone beach and surrounding bush-clad hills. Other than tidal influences and impacts from passing ferries, there is no direct source of faecal input. There is a DoC toilet block with septic tank. Monitoring shows that the water quality is generally suitable for contact recreation.

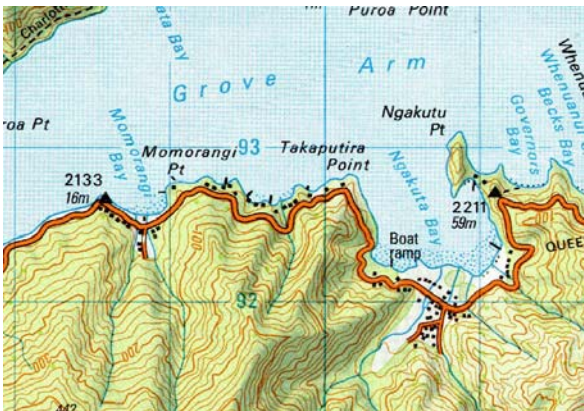
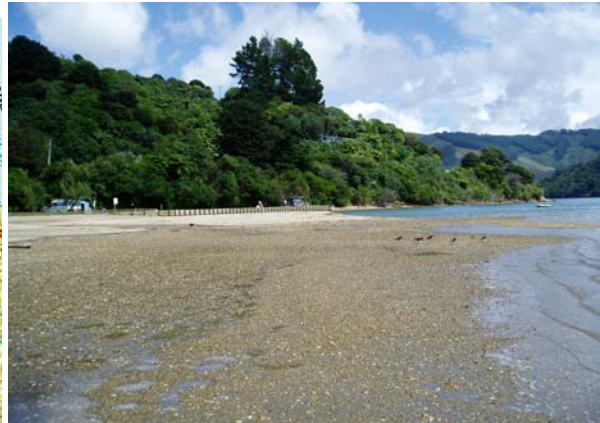
- Momorangi

Momorangi is an enclosed bay at the western end of the Queen Charlotte Sound diagonally opposite Outward Bound . It has an annual average rainfall of 1500mm and is used all seasons for swimming, water sports and boating. The beach is sand and stones and is surrounded by some housing, a camping ground and shop, and bush-clad hills. There are cockle and pipi beds, and mussels at the rocky headlands. The motor camp sewage treatment system discharges to sea (mid bay) approximately 300 metres off shore. At times high numbers of bacteria are discharged from the system. Taking shellfish is not recommended, and monitoring shows that at times the water quality is not suitable for contact recreation. Proposed upgrading of the treatment system with discharge to land should result in improved water quality and a reduced health risk associated with recreational use.

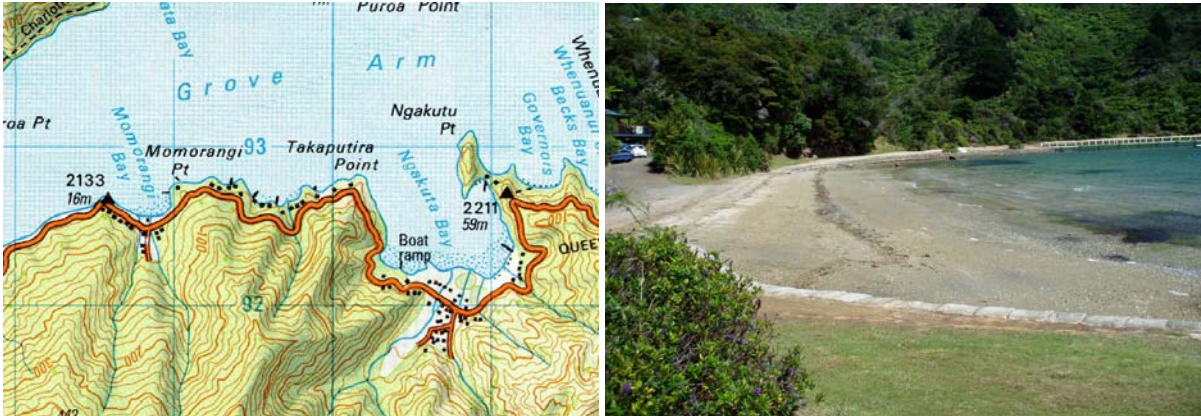
- **Ngakuta Bay**

Ngakuta Bay is an enclosed bay located in the inner Queen Charlotte Sound. The beach is sandy with input from several small streams resulting in estuarine conditions in the eastern part of the bay. Public use is mostly in the western part where there is a carpark and public toilets. There is a jetty and the bay has numerous boat moorings. There are approximately 70-80 houses and holiday homes in the bay, and the bay is surrounded by bush-clad hills. There are drains from several sections to the bay discharging storm water and at times these are contaminated with septic tank overflows. There are extensive cockle beds in the east bay, cockle and pippi beds in the west bay and mussels on the rocky points. Water quality is generally suitable for contact recreation, but the shellfish are compromised during peak visitor times. Monitoring has shown that shellfish should not be taken during the summer period.

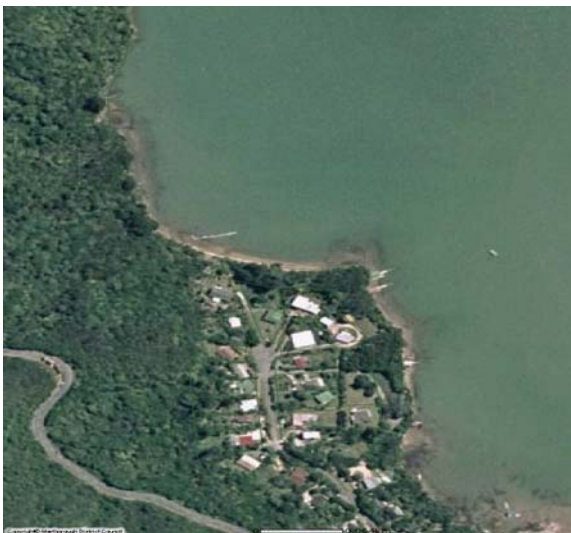
- **Moenui**

Moenui is a small settlement of some 45 houses in the Mahakipawa Arm of the Pelorus Sound. Access to the coast is through private property. The beach is stony and surrounded by housing and bush. Water quality has been monitored for just two years and is suitable for contact recreation.
