**MARLBOROUGH
DISTRICT COUNCIL**

Recreational Water Quality Report 2017-2018

**Technical Report No: 18-005
May 2018**

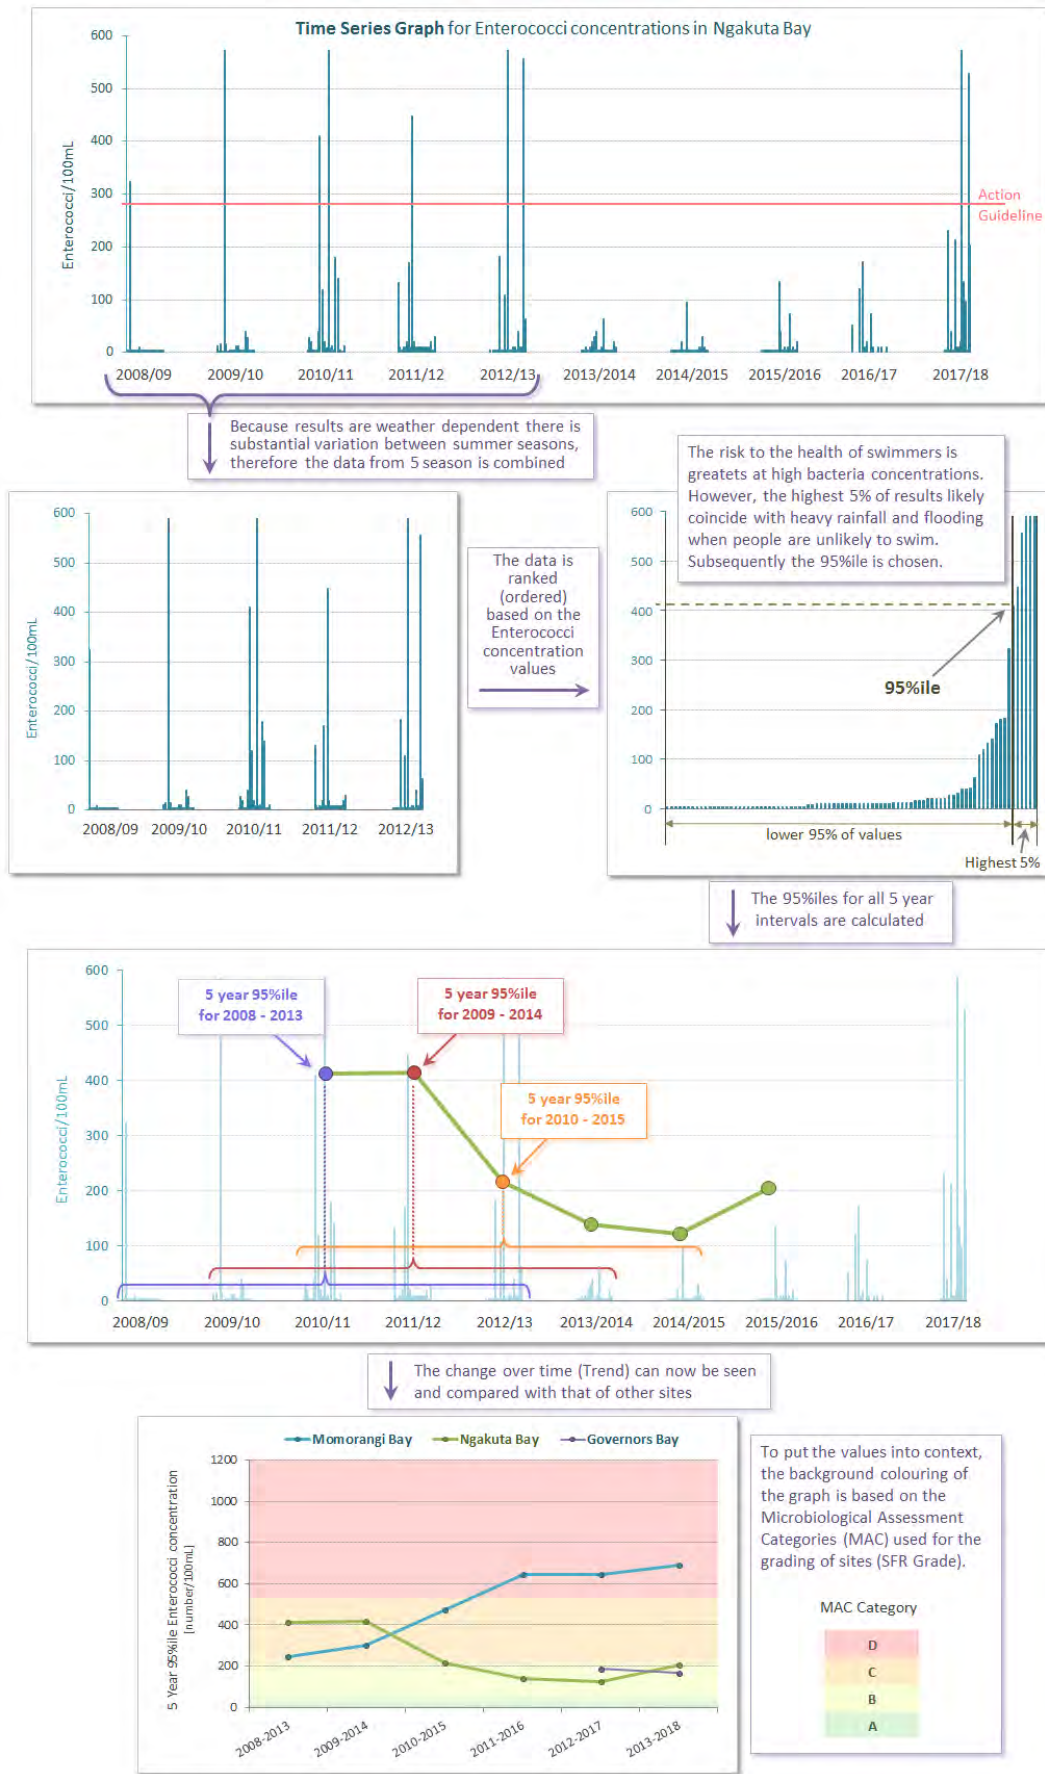
Figure 1: Creation of 5-Year-95%ile Graphs, used to display long-term trends.

The following chapters present the monitoring results for the 2017/2018 summer season as well as changes of faecal bacteria concentrations over time (long-term trends). Where appropriate, sites are grouped into sets of two or three sites. For each group the concentration of faecal indicator bacteria in the samples taken from each site is shown graphically, together with rainfall and/or flow data recorded at nearby sites. This allows the results to be viewed in the context of rainfall and flood events, which are the main causes for increased concentrations of faecal bacteria concentrations at most sites (see Section 4). A map shows the location of the sampling sites as well as the rainfall and/or flow recorder. For sites with longer monitoring records, the changes over time are shown using the 5-year-95%ile (MAC) values (Figure 1), which are also used for the calculation of the SFR Grades (see Section 3.2).

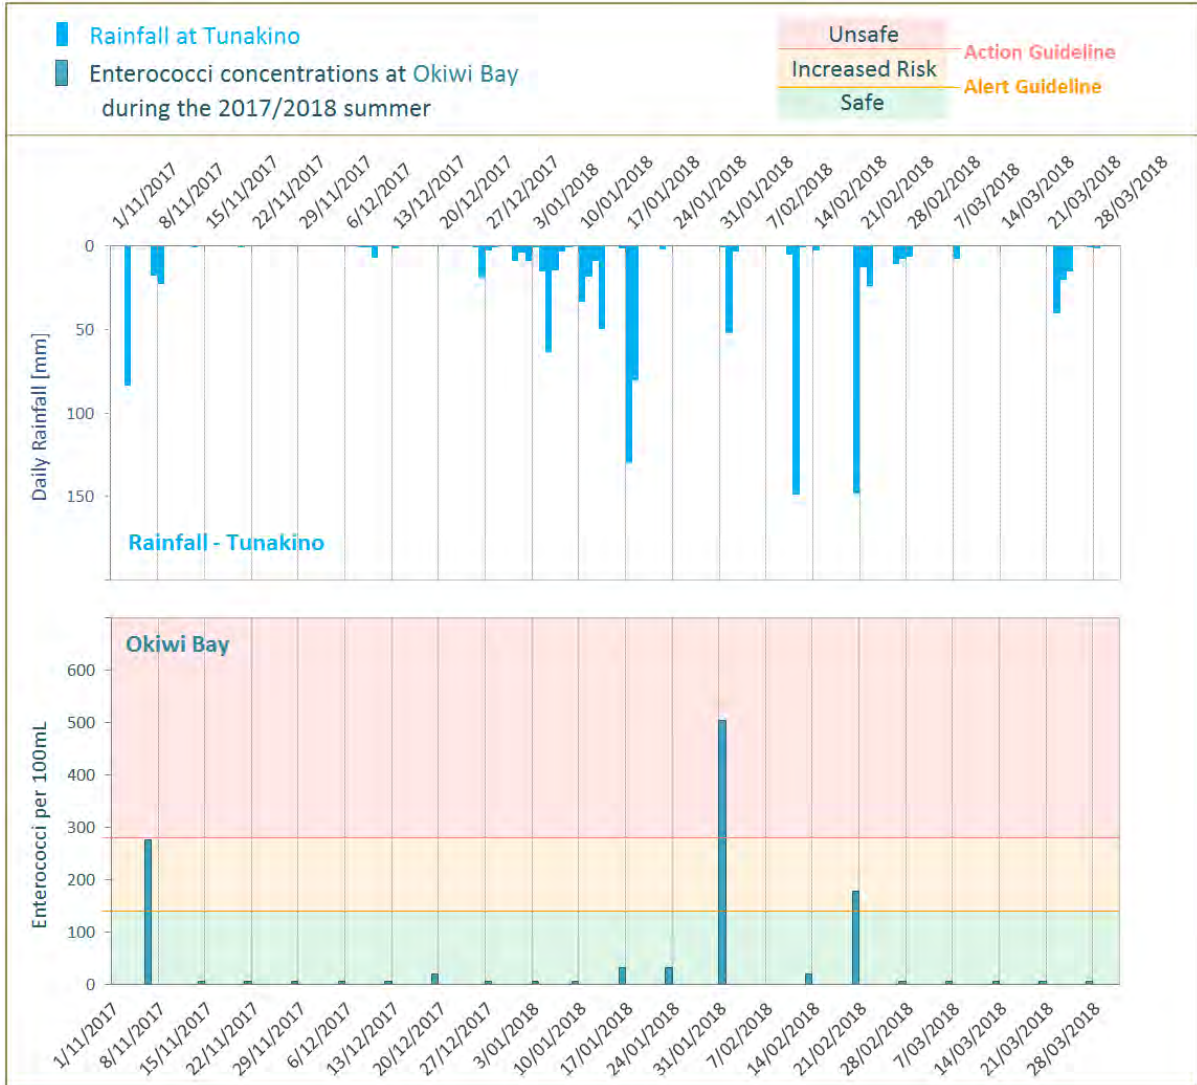
Figure 3: Enterococci concentrations at Okiwi Bay for the 2017/18 summer season.

The only sample with unsafe bacteria concentrations was taken on 31 January 2018 (Figure 3). None of the other sites sampled on that day exceeded guideline levels and only a very small amount of rainfall was recorded at the Tunakino rainfall recorder, located less than five kilometres South of Okiwi Bay (Figure 2). It is possible that a localised rainfall event did not reach the Tunakino recorder, but this is rather unlikely considering the scale of the effect on the water quality at Okiwi Bay. The two samples with Enterococci concentrations that exceeded the Alert guideline only, coincided with elevated *E. coli* concentrations in the neighbouring Pelorus catchment. It can therefore be assumed that a significant amount of rainfall is required to cause unsafe bacteria levels at Okiwi Bay as a result of rainfall run-off. Therefore, rainfall run-off might not have caused the high Enterococci concentrations in the January sample. Unfortunately, due to the remoteness of the site, council was unable to take additional samples following the event.

Apart from the three guideline exceedances discussed, samples taken from Okiwi Bay had very low bacteria concentrations, indicating that recreational water quality at this beach is very good most of the time.

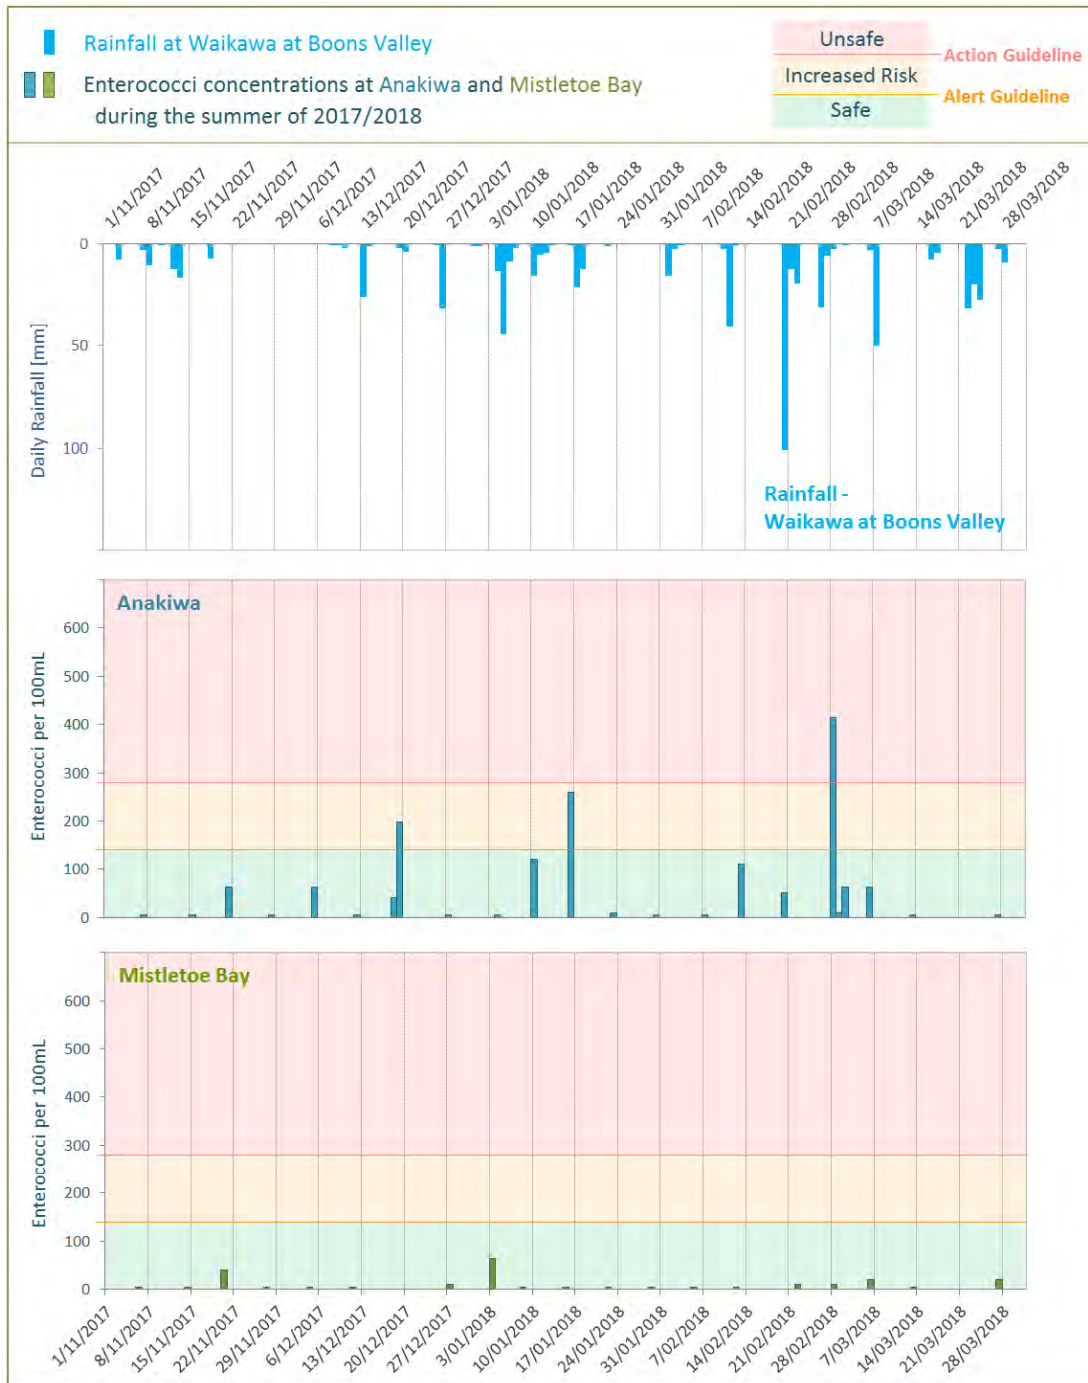
Figure 5: Enterococci concentrations at Anakiwa and Mistletoe Bay for the 2017/18 summer season.

This summer, *Enterococci* concentrations in Anakiwa were generally higher than those observed in Mistletoe Bay. This is not surprising considering the significantly greater number of houses in the Anakiwa area. High *Enterococci* concentrations in Anakiwa all coincided with rainfall recorded at the Boons Valley rainfall recorder. Additional sampling carried out following the only exceedance of the Action Guideline in February 2018, showed that bacteria concentrations had returned to safe levels within a day of the event (Figure 5).

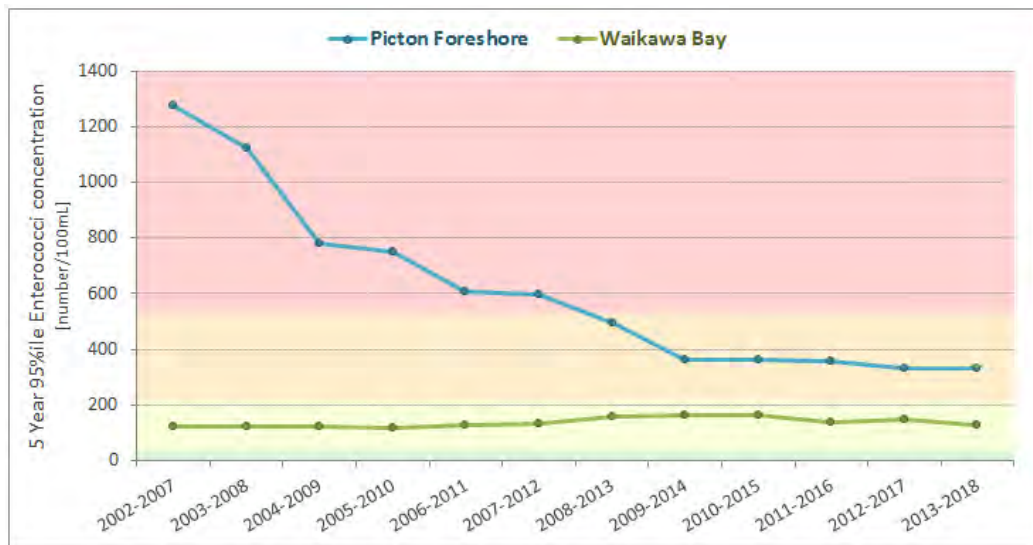
Figure 13: The 5-year 95%ile Enterococci concentrations for Picton Foreshore and Waikawa Bay.

The long term trend shows the significant improvement of the recreational water quality at the Picton Foreshore that was achieved so far (Figure 13). In recent years Enterococci concentrations continued to decrease, albeit at a reduced rate. In comparison, bacteria concentrations in Waikawa Bay have changed very little over the more than 10 years the site has been monitored.

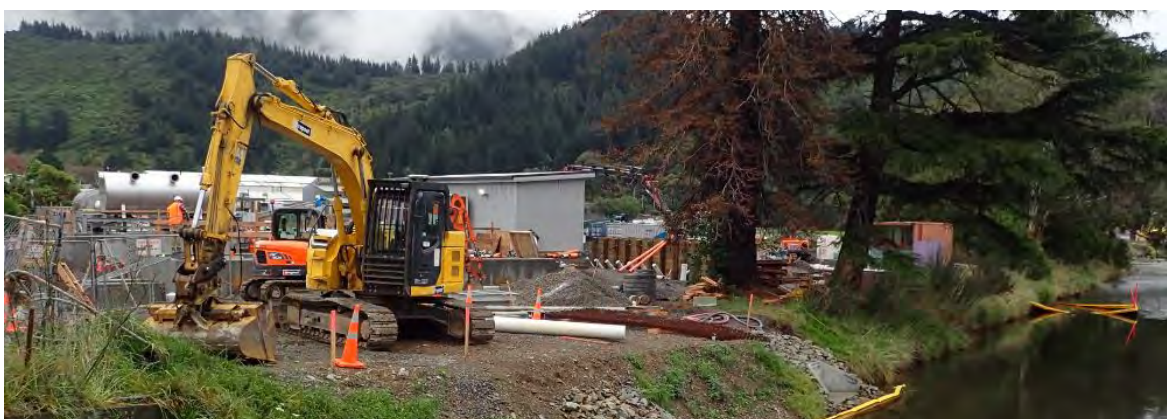
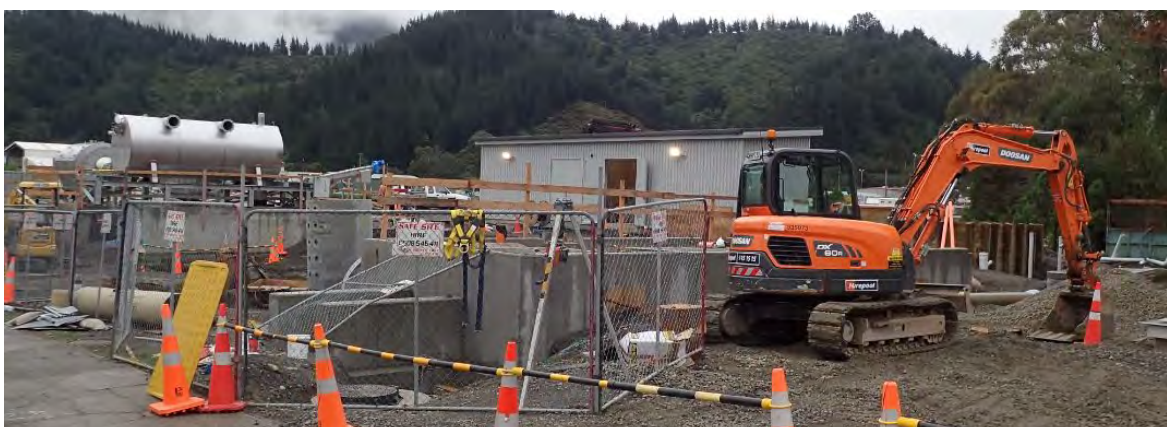
Figure 14: Upgrade of the sewerage network near the Waitohi River which flows into Picton Harbour.

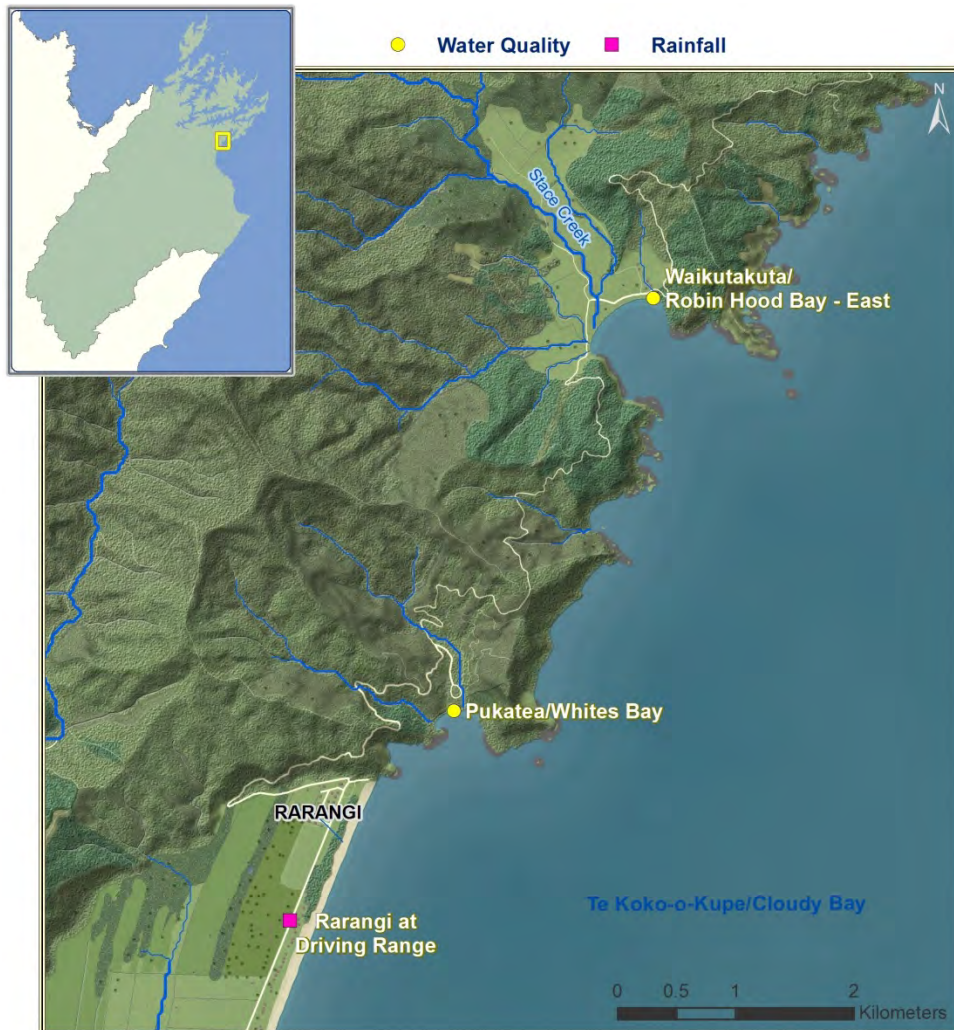
Figure 15: Locations of the Pukatea/Whites Bay and the Waikutakuta/Robin Hood Bay East sampling sites, as well as the Rarangi rainfall recorder.

Pukatea/Whites Bay and Waikutakuta/Robin Hood Bay are located on the upper East Coast of the region. Pukatea/Whites Bay is one of the most popular beaches in Marlborough. A Department of Conservation campground is the only human influence in the bay and consequently water quality is generally very good. Waikutakuta/Robin Hood Bay, located only a few kilometres north of Pukatea/Whites Bay also offers a campground, but has a much larger catchment. Several streams flow into the bay. The largest, Stacy Creek, drains 90ha of pasture, which has a potential to affect the water quality in the bay. Waikutakuta/Robin Hood Bay is sampled at the swimming beach on the North-East side of the bay, which is also used to launch boats.

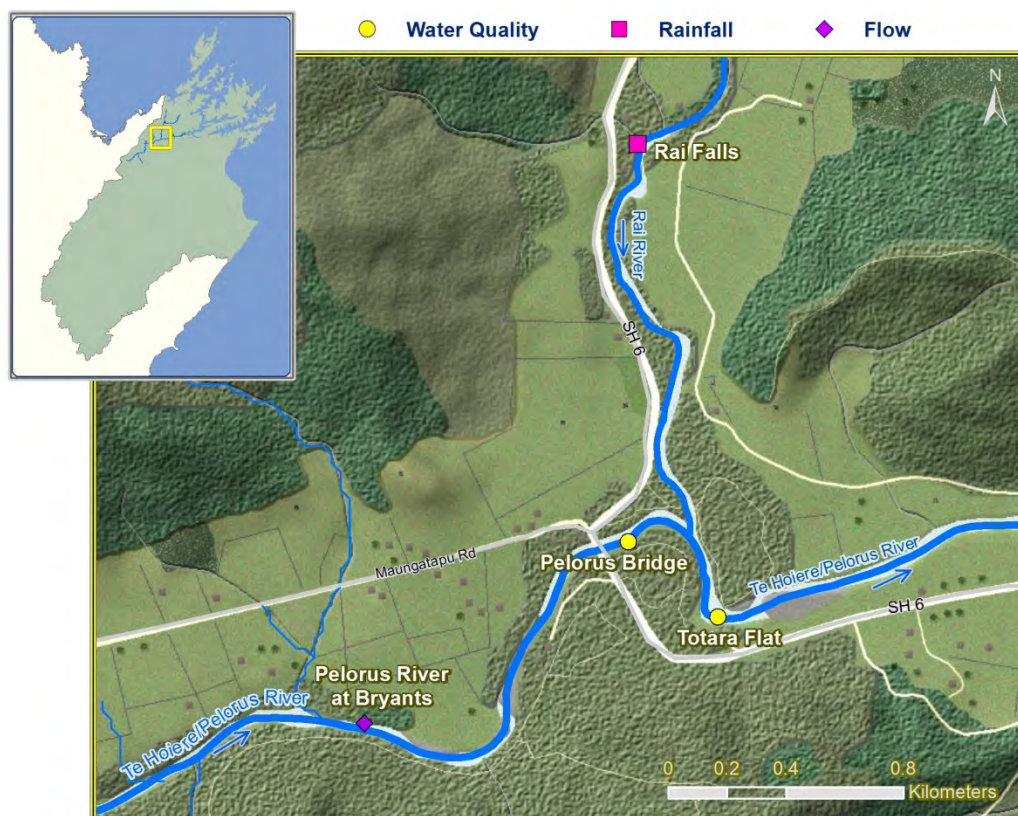
Figure 19: Locations of the Te Hoiere/Pelorus River sampling sites as well as nearby rainfall and flow recorders.

The Te Hoiere/Pelorus River has two popular swimming sites that are sampled as part of the Recreational Water Quality program, Pelorus Bridge and Totara Flat. Pelorus Bridge is the most popular river site in the region for both, local residents and visitors. The large proportion of native vegetation upstream also means that it has the best water quality of all river sites monitored.

The Rai River drains one of the main dairy catchments of the region. It flows into the Te Hoiere/Pelorus River between the two sampling sites, approximately 300m upstream of Totara Flat. Subsequently, water quality at Totara Flat is strongly influenced by the water quality of the Rai River.

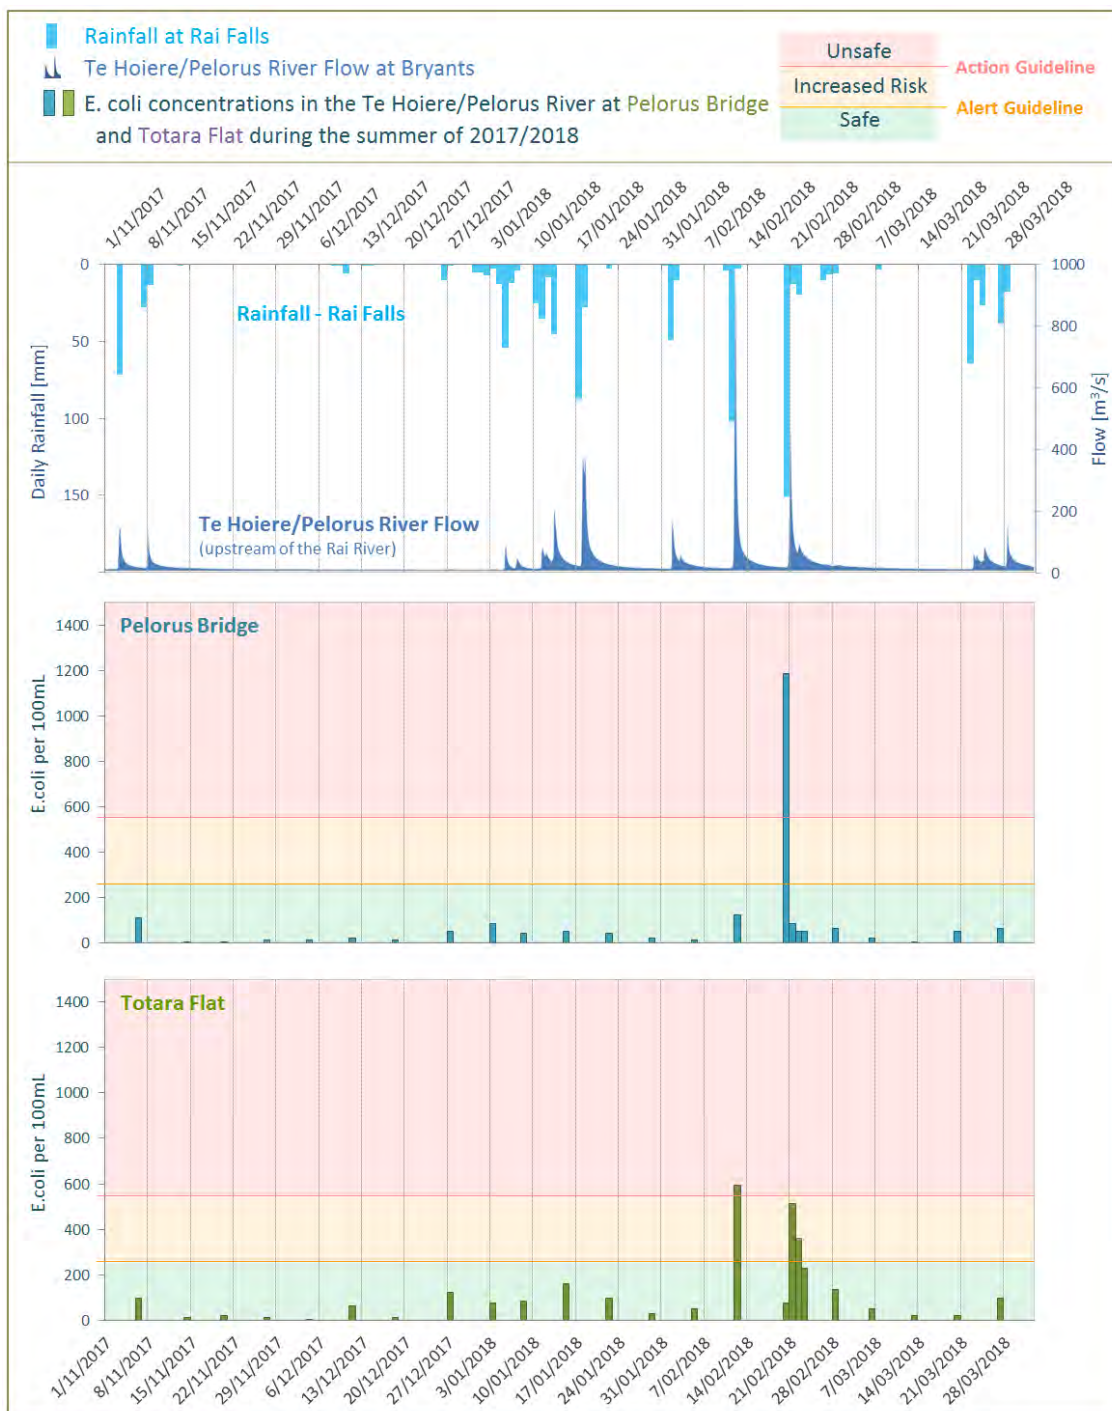
Figure 20: E. coli concentrations in the Te Hoiere/Pelorus River during the 2017/18 summer period.

An earlier rainfall event on 11 February resulted in an exceedance of the Action Guideline at Totara Flat on the following day, while E. coli concentrations at the Pelorus Bridge were comparatively low. This was yet another example of the faster recovery of water quality at the Pelorus Bridge compared to Totara Flat.

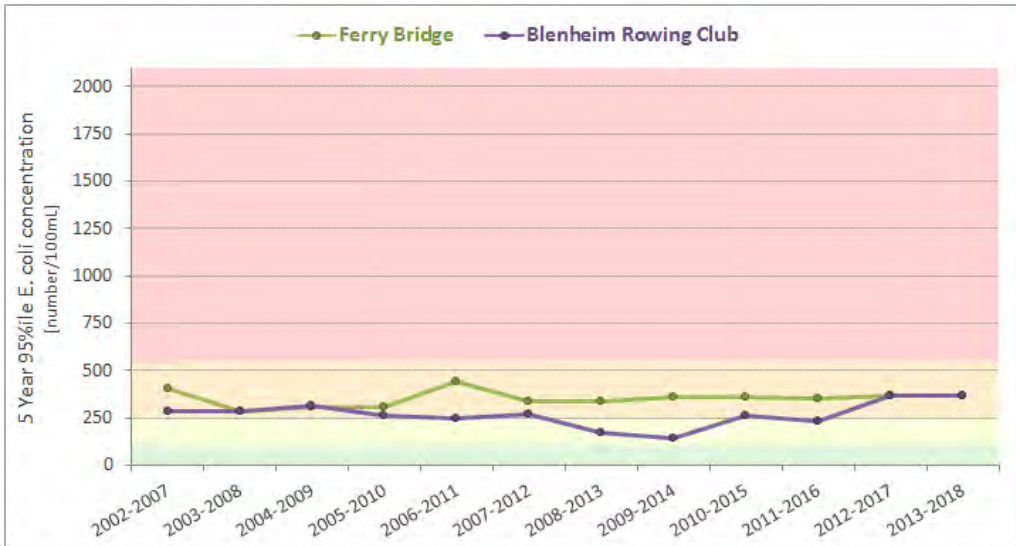
Figure 28: The 5-year 95%ile E.coli concentrations in the Wairau River at Ferry Bridge and the Blenheim Rowing Club.

For a number of years, recreational water quality at Blenheim Rowing Club was improving and has been noticeably better compared to the Ferry Bridge. However, recently E. coli concentrations appear to be increasing again, resulting in similar levels at both sites (Figure 28). It is unclear what exactly is causing the increase in E. coli concentrations, but the change started in the season following the 2013 Seddon earthquake, which caused significant infrastructure damage in Blenheim. Unfortunately, E. coli concentrations are often not high enough to allow genetic source tracking in order to determine if small amounts of sewage from damaged septic tank systems are leaking into the river. However, other source such as wildfowl and farm animals are also possible contributors. The Wairau at Blenheim Rowing was graded 'Good' for a number of years, but had to be downgraded to 'Fair'; the same SFR Grade as Ferry Bridge.

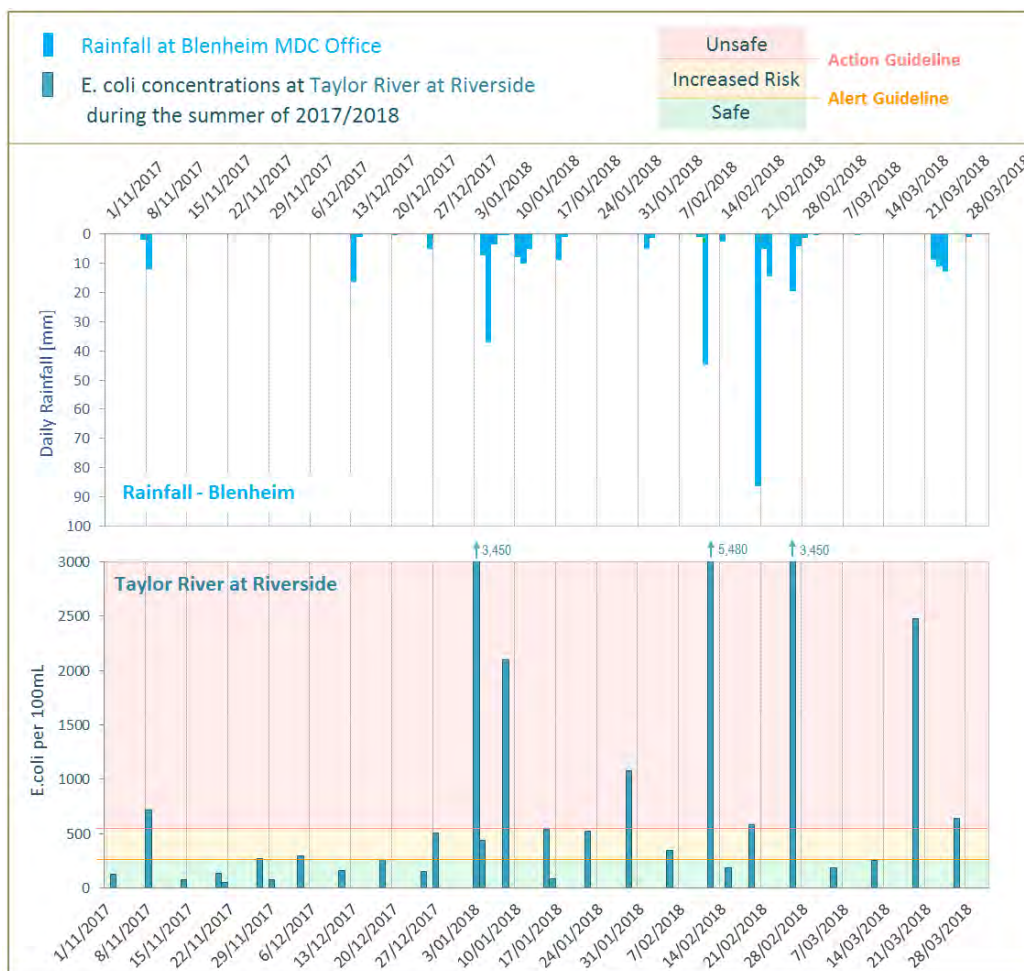
Figure 30: E. coli concentrations in the Taylor River at Riverside during the 2017/18 summer season.

Recent sampling of stormwater outflows into the Taylor River had shown that very high E. coli concentrations were being discharged into the river, particularly from pipes near the Riverside sampling site. Use of genetic marker analysis revealed that human sewage was one of the sources of faecal contamination. Investigation of the stormwater infrastructure showed that recent earthquakes had caused significant damage to both sewerage and stormwater pipes resulting in cross-contamination of stormwater with sewage. As a precautionary measure, warning signs were placed at the Riverside sampling site throughout the summer season. Nevertheless, sampling of the site as part of the Recreational Water Quality Program continued. The results of this sampling showed that E. coli concentrations reached very high levels on several occasions this season. Although the highest bacteria concentrations were observed as a result of rainfall events, a number of guideline exceedances also occurred during dry weather periods. This justifies the permanent placement of warning signs.

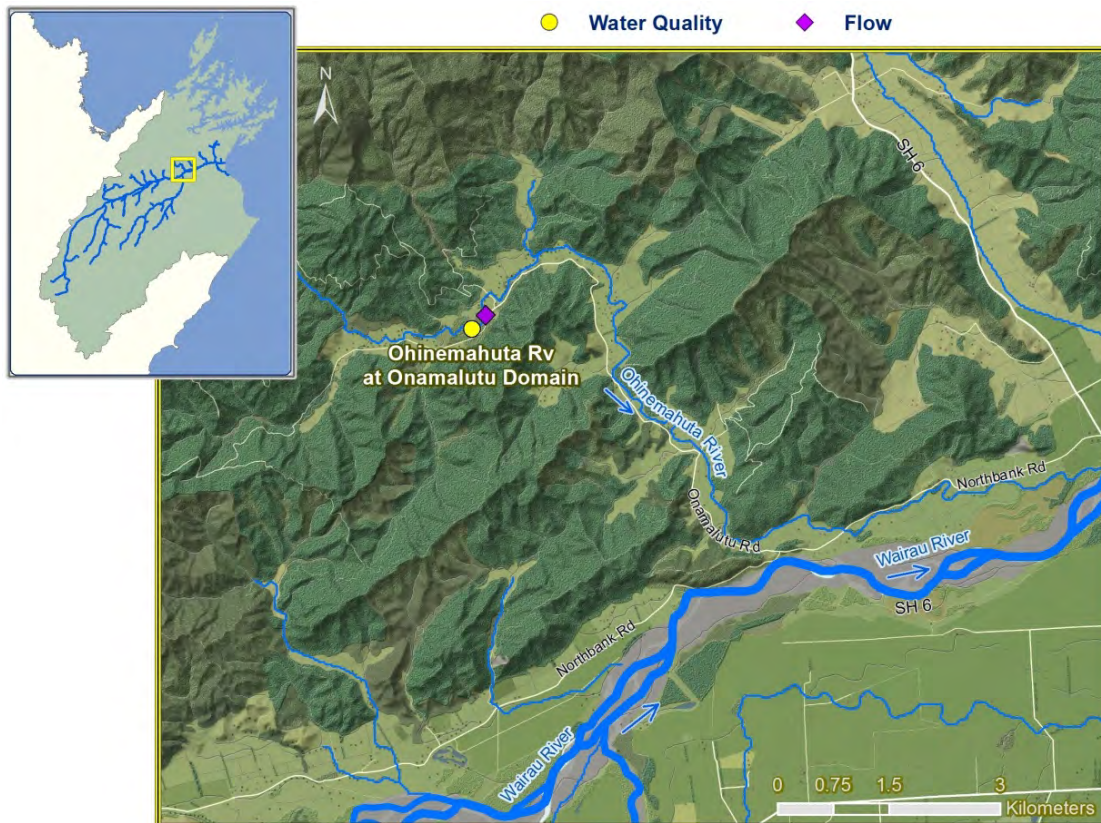
Figure 32: Location of the Ohinemahuta River water quality and flow sites.

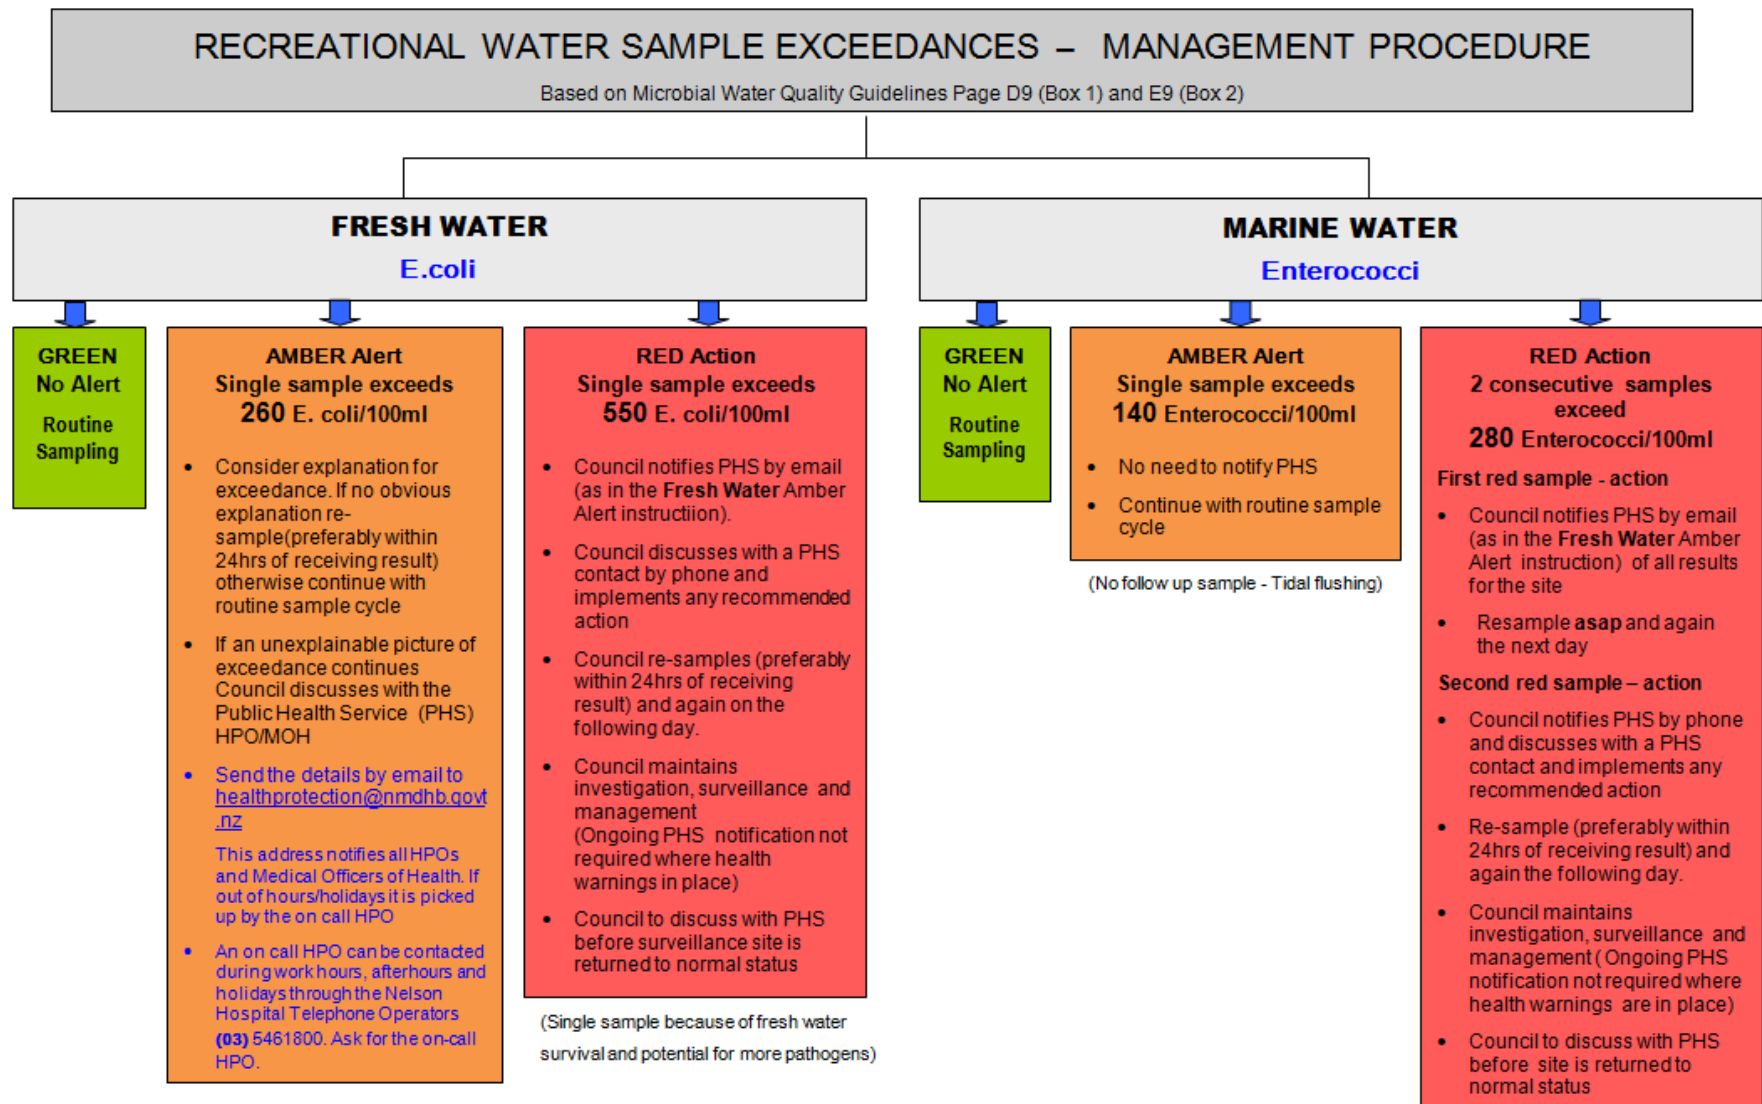
8.2. Appendix 3: Management procedure for exceedances of bathing water guidelines

If indicator bacteria concentrations are above the Alert or Action Guideline possible causes are considered and the District Health Board is informed. A joint decision is made on how to proceed. Usually, warning signs are erected at sites with unsafe levels of indicator bacteria. The sites are then sampled more frequently until indicator bacteria concentrations have returned to safe levels and warning signs can be removed. A flowchart outlining the process is shown in Appendix 3.
