Dissolved oxygen responses to weed control works in watercourses on the Wairau Plains

Prepared for Marlborough District Council

January 2018

NIWA CLIENT REPORT No: 2017231HN
Report date: January 2018
NIWA Project: MDC15203

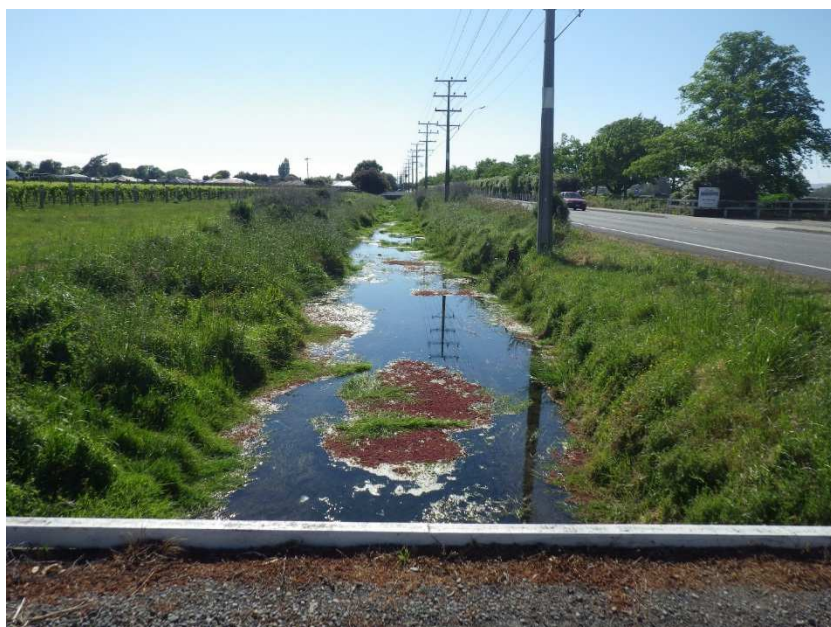
This moderate sized watercourse averaged 5.52 m width (all assessments) and a maximum depth of 0.57 m. It was flanked by batters covered by pasture grasses (Figure 1) that were mown in some areas. Spring inflows were noted within the Untreated reach.

Figure 1: Caseys Creek viewed from the road and looking upstream.

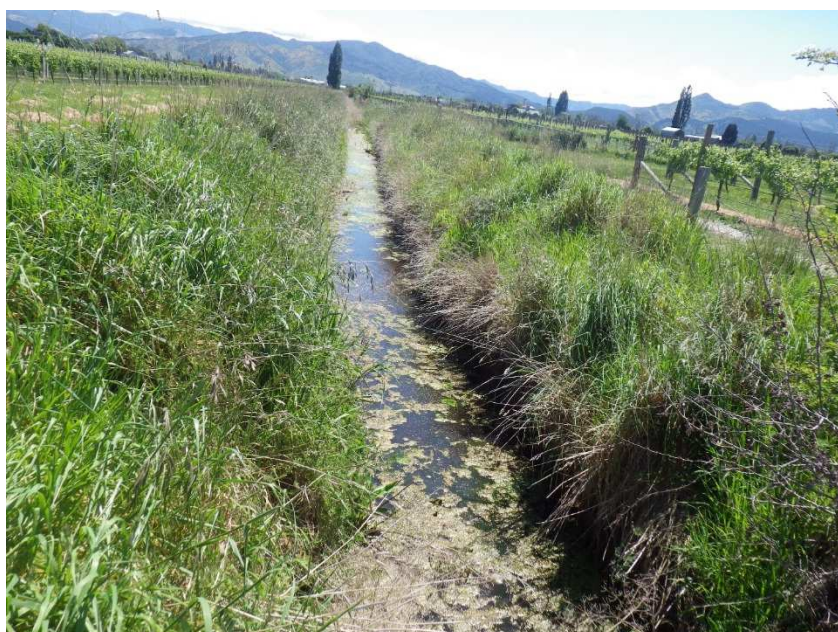
Figure 4: Drain C showing the narrow, shallow channel and grassy batter.

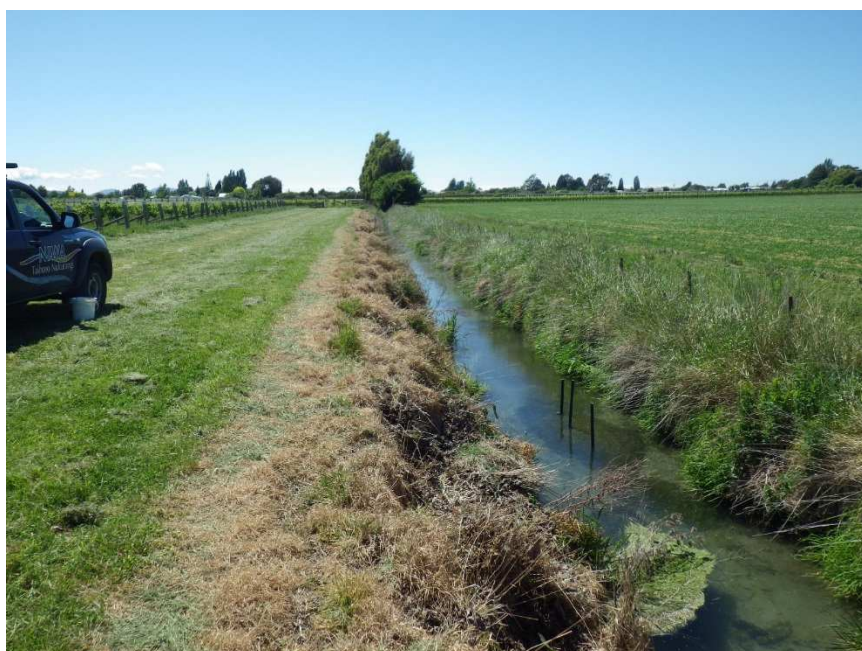
Figure 7: Kellys Drain showing the narrow, deep channel and grassy batter that has been controlled on the left bank.

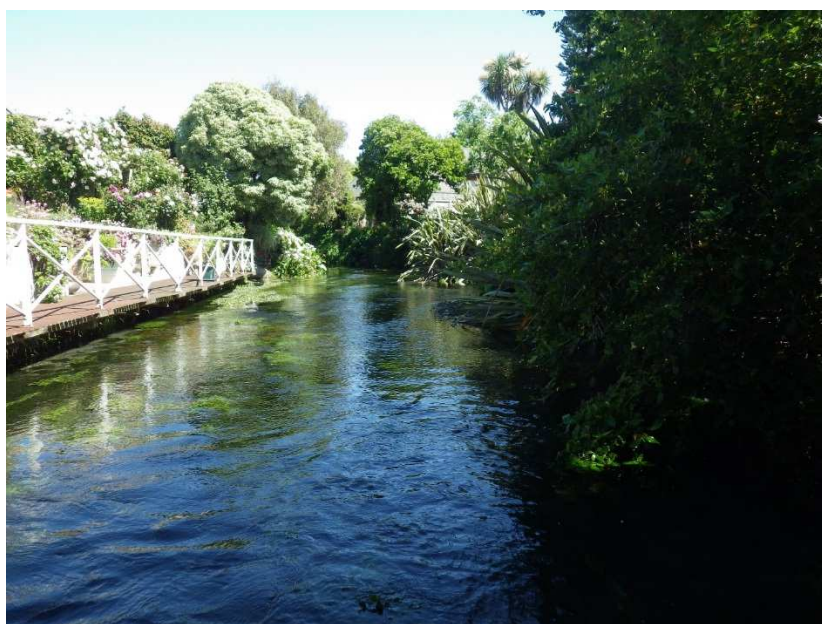
Figure 10: Murphys Creek showing access ways and creek-side structures typical of the watercourse.

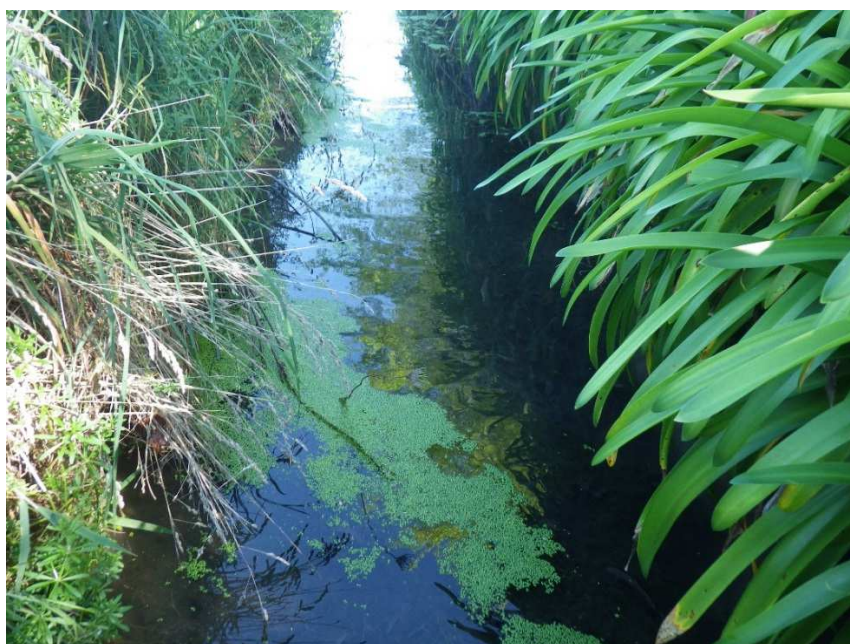
Figure 16: The narrow incised channel of Drain Q.

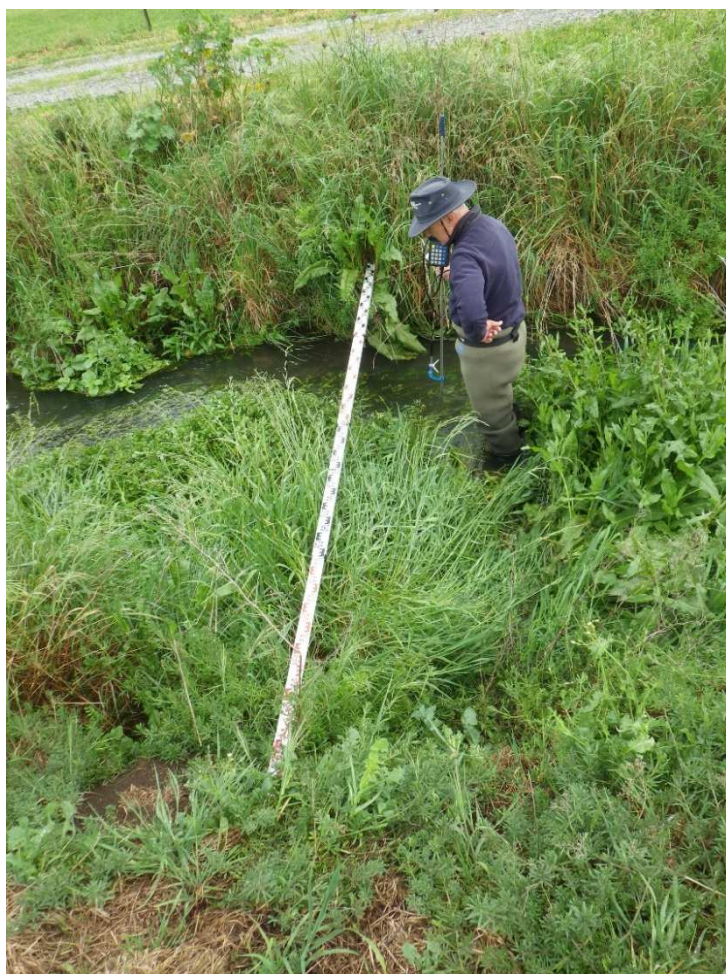
The average width of Fairhall Co-op drain was 2.9 m and depth was 0.47 m. Both batter banks had high covers of tall grass (average 0.6 m). In-channel vegetation comprised water speedwell (*Veronica anagallis-aquatica*), monkey musk (*Erythranthe guttata*), water buttercup (*Ranunculus trichophyllus*), watercress, duckweed and grass from the batter. Bank vegetation of the Treated reach was observed to be dying by 14 days after treatment (10th November 2016).

Figure 19: Abundant instream vegetation at Fairhall Co-op.

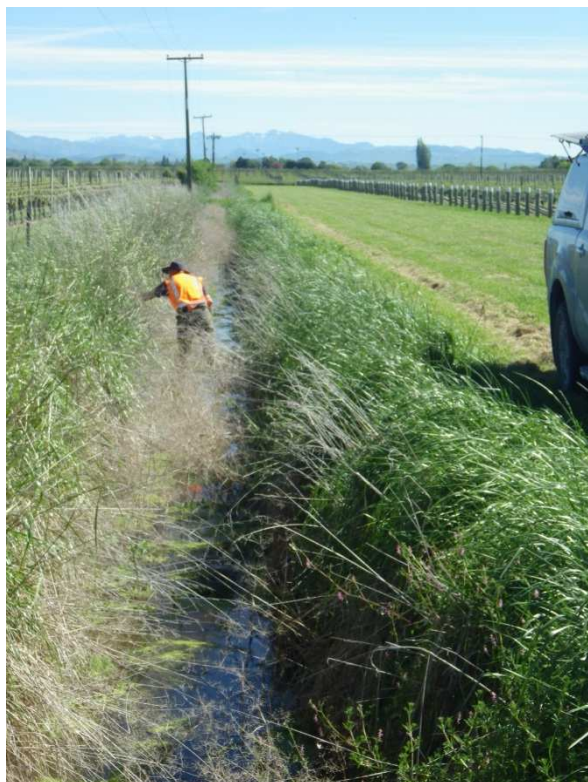
On average this small watercourse was 1.5 m wide and 0.21 m deep. The lower batter comprised dead grasses. Dominant in-channel vegetation comprised duckweed, azolla, watercress, water plantain, *Nitella* sp. aff. *cristata* and grasses from the batter. Herbicide symptoms were evident in bankside vegetation by 14 days after treatment (10th November 2016).

Figure 22: Drainage channel at Woolley & Jones.

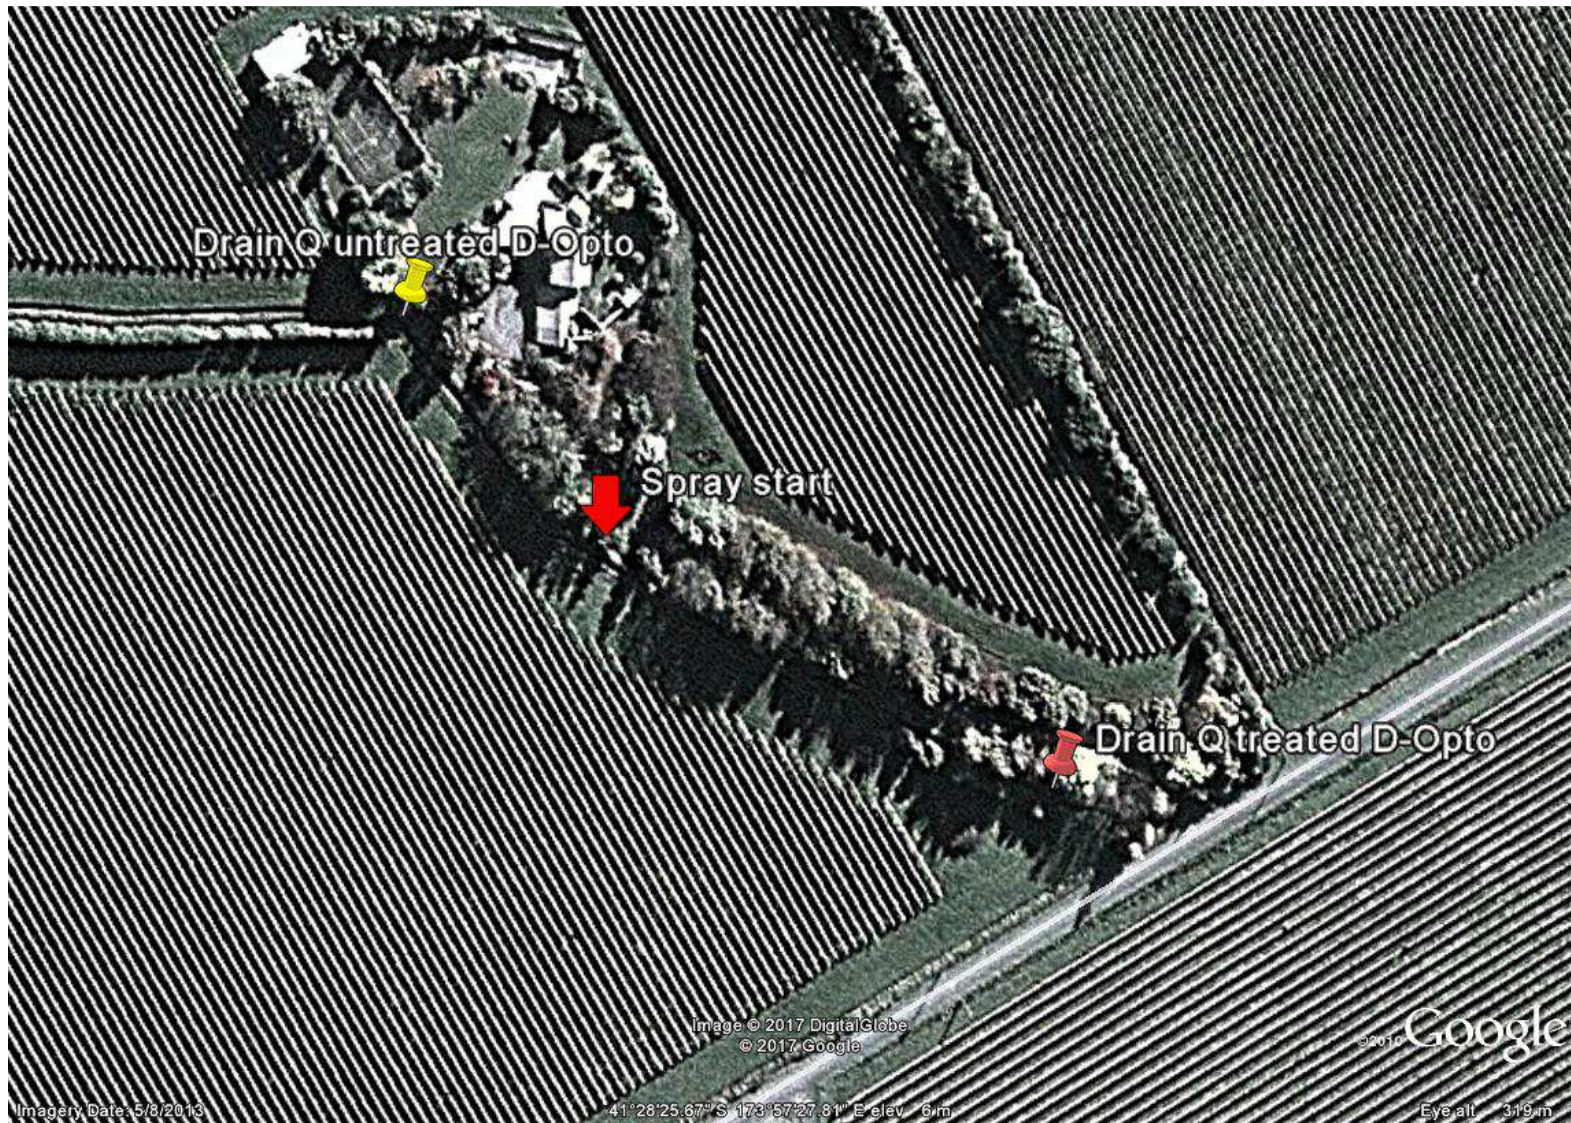
Figure A6: Drain Q showing the start point for herbicide application and locations of the D-Opto loggers measuring DO and water temperature in the untreated reach (yellow marker) and treated reach (red marker).
