# Marlborough Region Town Centre Health Checks 2016

- Part One: Blenheim Town Centre
- Part Two: Picton Town Centre

January 2016

**MARLBOROUGH  
DISTRICT COUNCIL**

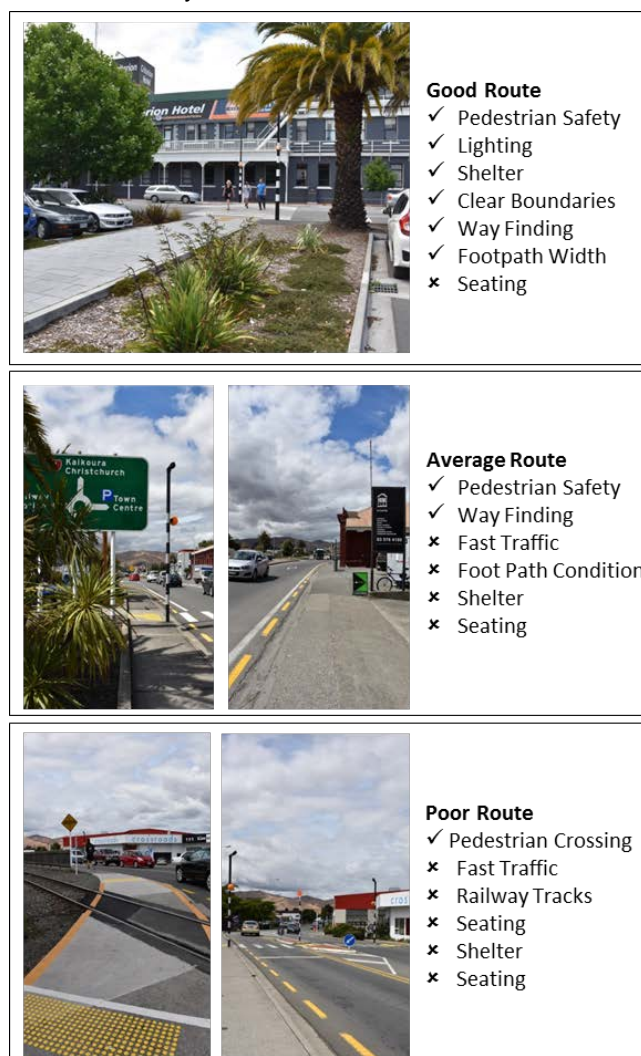
Figure 4: Pedestrian route quality examples from the Blenheim Town Centre.

The routes in the northern end of the town tends to perform better in terms of available lighting, useful directional signage, good quality of surrounding environment, and a good level of pedestrian safety with accessible pedestrian crossings. These routes are however let down by a lack of shelter, and in places a lack of seating. In the northern part of town, an exception to the general high standard is the link that pedestrians use between the iSite and the town centre, including the intersection of Alfred and Sinclair Streets, and the path over the bridge on Alfred Street. This

pedestrian route is let down by a poor state of the environment, and limited wayfinding signage that directs people away from fast moving traffic.

Walking routes in the south and east rated less than those in the north, predominately due to the condition of footpaths, poor surrounding environment, lack of directional signage, and the level of pedestrian safety. These routes are typically from accommodation outside the town centre, or cross high volume traffic areas. For example, the links connecting New World and the accommodation along Main Street with the town centre are of poor quality. Such routes feel disconnected from the town due to the lack of pedestrian safety caused by the high traffic flow intersection and train tracks. The state of the surrounding environment degrades this walking route too, with a lack a wayfinding signage a problem.

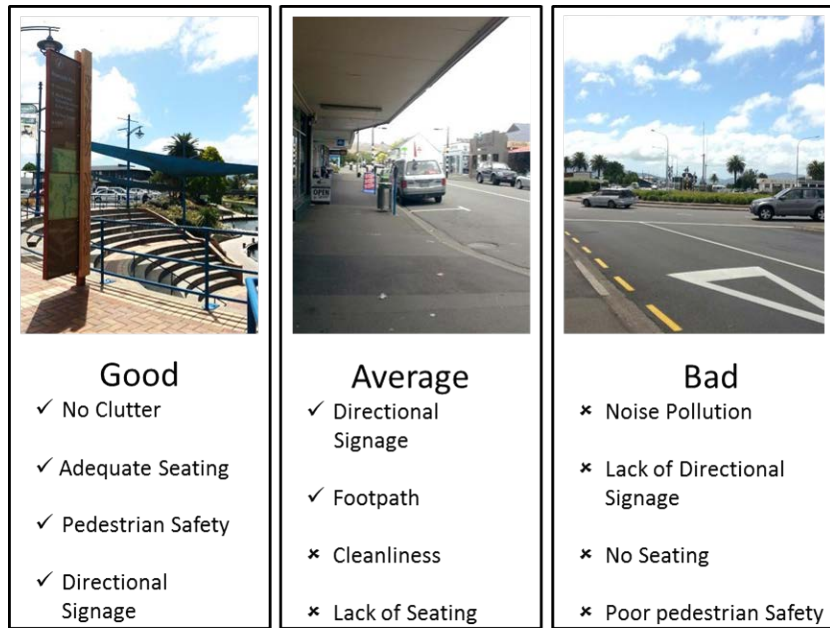
Figure 6 State of the environment examples from the Blenheim Town Centre.

Individual assessment of the fifteen sites revealed that eight sites were classed as good, six as average, and one as bad. Examples of what these different sites look like shown in Figure 6.

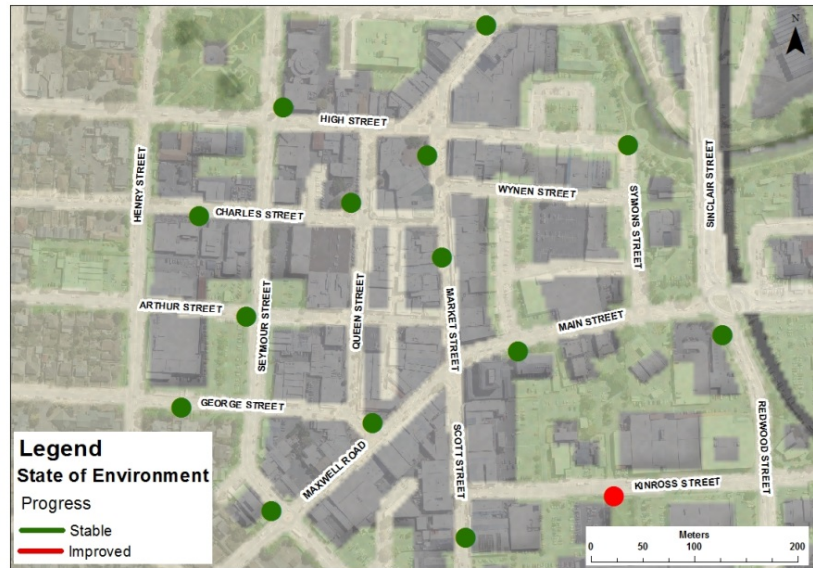
Figure 7: Change in the state of environment in Blenheim's Town Centre since 2014.

As can be seen in Figure 7, the site on Kinross Street has improved enough since the 2014 study to be re-classified from an average site to a good site, while all other sites remained constant. This is principally as a result of the construction of a pocket park. Although this is the only site to have improved significantly enough to warrant a change in class, other sites have experienced some improvement. Minor improvements are result of less clutter on streets, and less visual pollution. Also noticeable the general growth of vegetation on streets and in pocket parks which contributes to an improved state of environment. Overall, as concluded in 2011 and 2014

the civic areas of the town centre such as the Forum, library, and pocket parks are of good environmental standard.

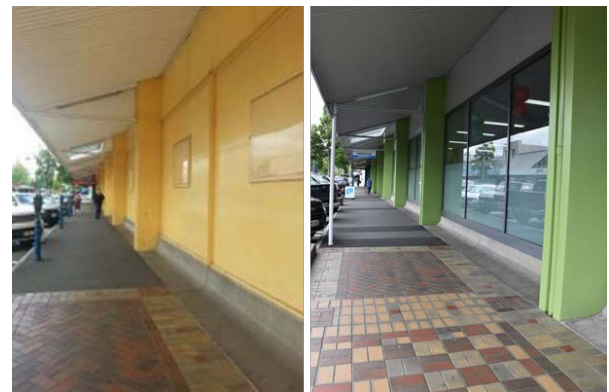
Change has also occurred in areas that were previously identified as needing improvement. For example, the blank walls along Queen Street have been replaced with large frosted windows. Although these are frosted, this has improved the vitality of this street edge (Figure 10). Areas identified as improved in Figure 8 have been re-classified based on a general better feel, modifications that increase the interaction pedestrians have with buildings, or the freeing up of window space and removal of large posters that allow pedestrians to see into shops.

Figure 10: Redevelopment of walls along Queen Street. Left: 2014 blank wall. Right: New frosted windows in 2016.

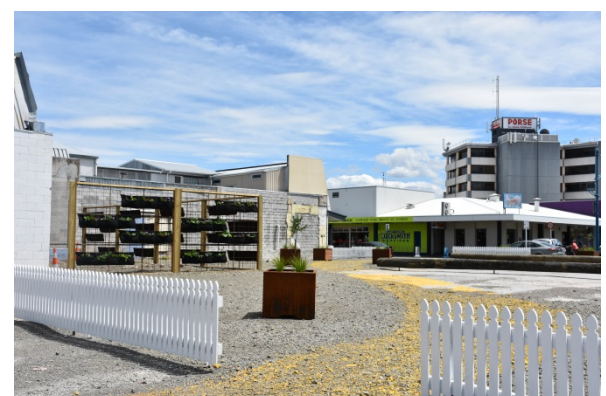
It is positive that improvement has occurred, however some street edges have deteriorated since 2014. Where this has occurred, building demolition or construction is generally responsible, with building vacancy an ongoing issue leading to weak street edge vitality. Although the demolition/construction that is occurring in the town centre has caused areas of weak vitality, over time the vitality of these areas may improve as redevelopment occurs. In some areas, council has endeavoured to improve areas of weak vitality caused by demolition until permanent redevelopment occurs (Figure 11).

Figure 11: Pocket park that has been created on demolished building site on High Street.

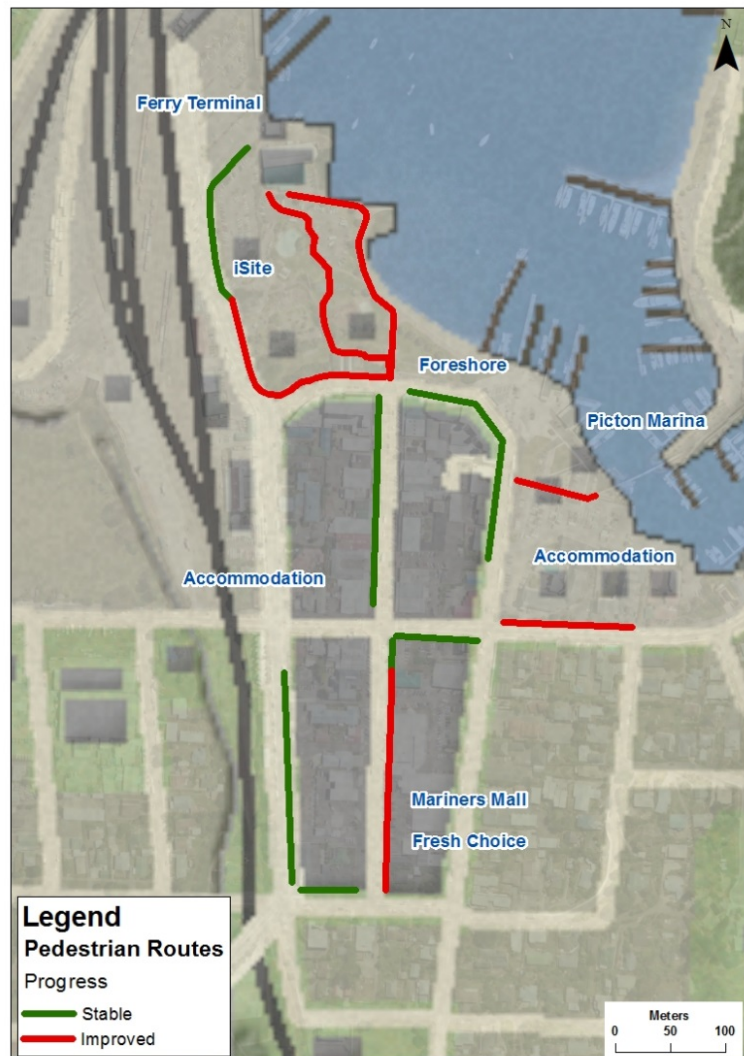
Figure 18: Pedestrian route change over time between 2014 and 2016, showing points of attraction.

Other routes that have improved (Figure 18) have done so primarily due to a general increase in quality of the environment or street edge, improving pedestrian experience. The routes that direct people through the foreshore towards high street have also improved due to general maintenance improvements, installation of new lighting, and pop up food outlets. The most significant improvement has occurred along High Street outside Mariners Mall, where the footpath and surrounding environment has been redeveloped. The upgrading of the footpath and replanting of new gardens, along with new seating improve this pedestrian route. Efforts have been made also to improve the safety of pedestrians from the car park by developing kerbing that act as planter boxes, but also make a clear distinction between the footpath and the road.

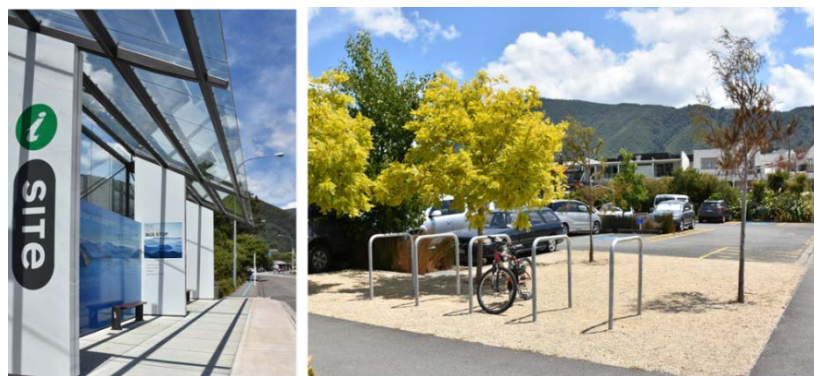
Figure 19: Left: Bus stop on Auckland Street. Right: Bike racks in the redeveloped area on London Quay.

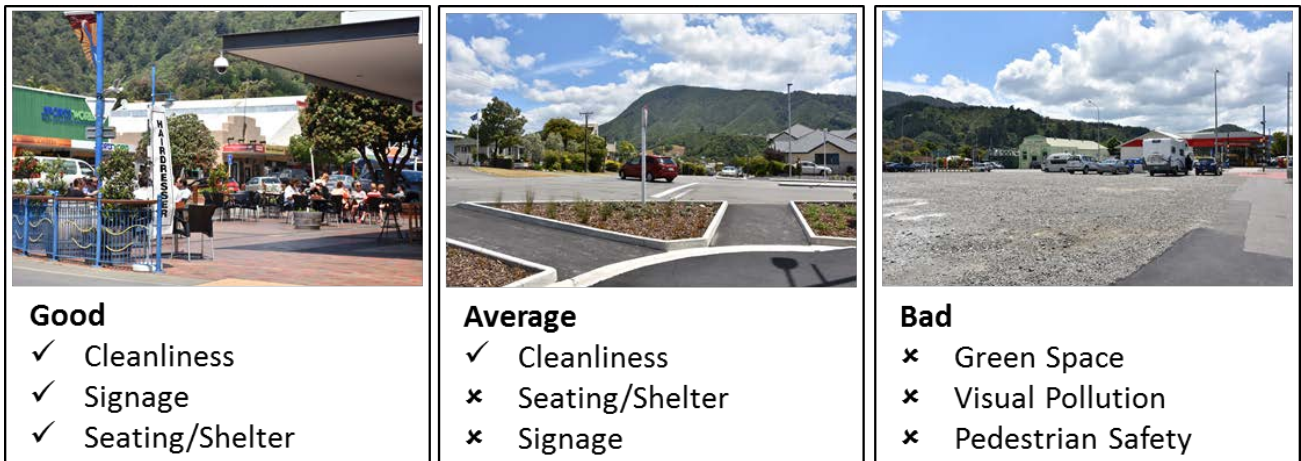
Figure 20: Examples of different state of environment categories from Picton Town Centre.

The 2016 state of the environment check highlighted a number of areas that rated averagely, and did not meet the same standards as those that stood out as having a good state of environment. This indicates that work could be done in the town centre to establish more consistent environmental conditions. Areas closest the foreshore tended to perform better than areas on the periphery of the town centre.

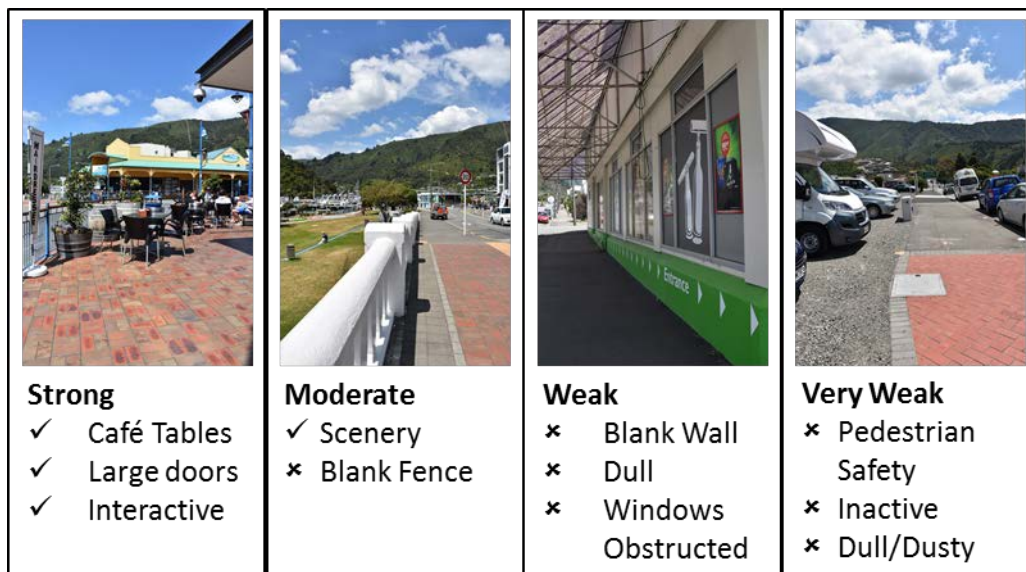
Figure 22: Examples of different street edge vitality categories from Picton’s Town Centre

The majority of Picton’s Town Centre is performing well in terms of the street edge vitality and the interaction pedestrians have is positive. Edges in the primary shopping area, e.g. High Street, where there are high levels of pedestrian movement are of strong or moderate vitality. This strong and moderate vitality radiates less through outer streets, as vitality declines where weak and some very weak edges are associated with residential property, accommodation, car parks, larger buildings, and secluded restaurants and pubs. Examples of these categories are shown in Figure 22.

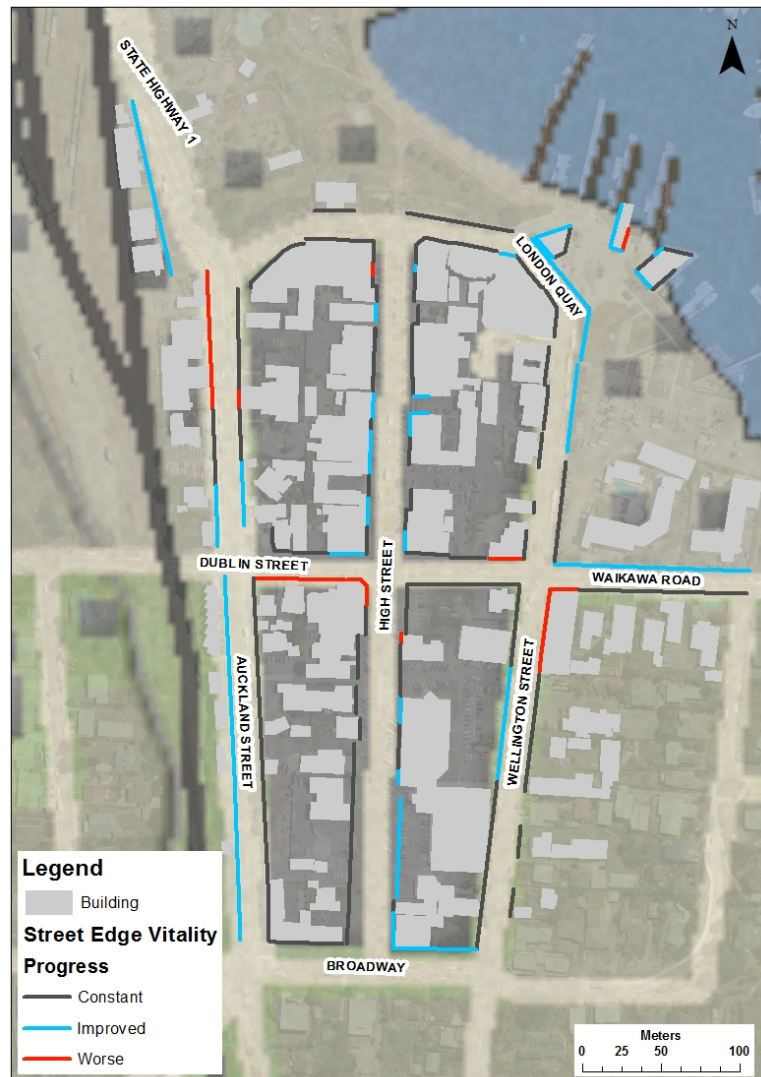
Figure 23: Street edge vitality change over time between 2014 and 2016.

A comparison of vitality between 2014 and 2016 identifies some areas that have improved and other areas that have degraded and are worse (Figure 23).

Street edge vitality that has degraded is the result of demolition, blank wall, new vacant shops, or a general degradation of the area. Most concerning is the poor street edge vitality caused by demolished buildings on the corner of Dublin and High Street. This area will eventually improve as a result of the construction of the new Picton Library.
