*Attachment 4.4 –
Technical Report [v5 2021]*

East Coast Beach Vehicle Bylaw

Technical Report
July 2021

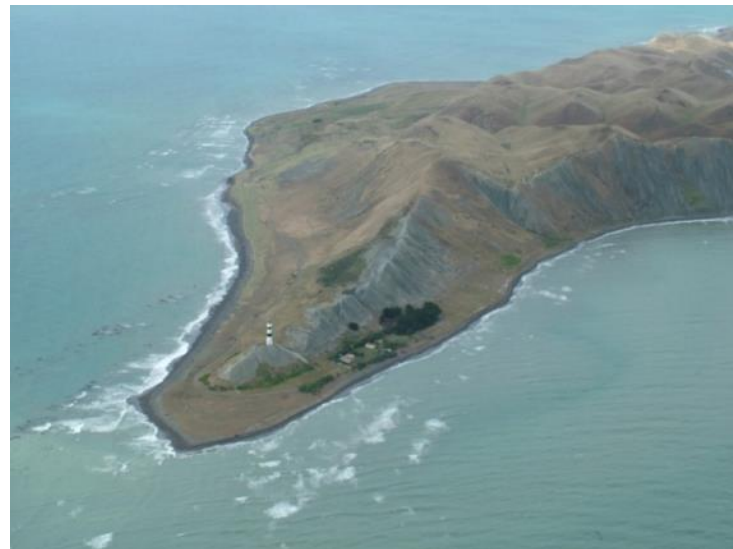
Figure 1: Cape Campbell/Te Karaka before the earthquake.

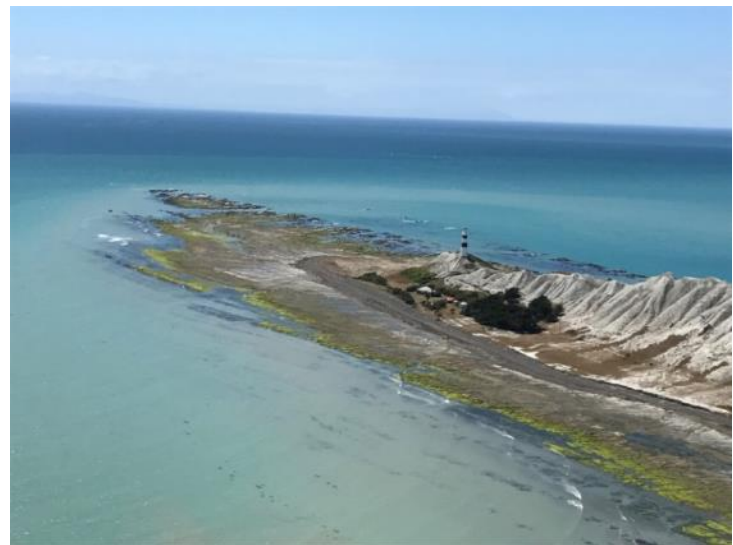
Figure 2: Cape Campbell/Te Karaka after the earthquake. Photo Mark Davies Jan 2017.

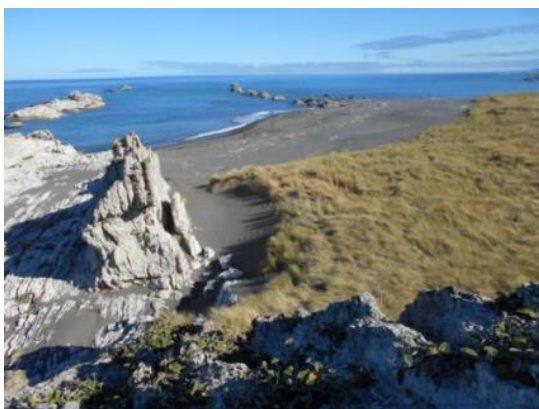
Figure 5: Chancet Rocks Scientific Reserve.

Chancet Rocks reserve has two main limestone ridges, separated by a low area. The once horizontal rock layers here were laid down on the sea floor, and have been tilted up almost vertically by deformation of the crust. The outcrop has long been known for its vase-shaped “fossil sponges”, which are now recognised as a trace fossil, or burrow, called Paramoudra, created by an unknown animal. More recently, a very complete section through the Cretaceous-Paleogene boundary was identified and confirmed by the presence of the 'iridium anomaly' with 10's of times the normal concentration of iridium (a very rare metal) in a thin clay layer. This layer has been recognised worldwide and marks the end of the Age of the Dinosaurs, caused by a devastating asteroid impact that struck part of where Mexico's Yucatan Peninsula is today. In these marine sediments Cretaceous microfossils become extinct at this layer, and earliest Paleogene ones occur immediately above it. [GNS Science]

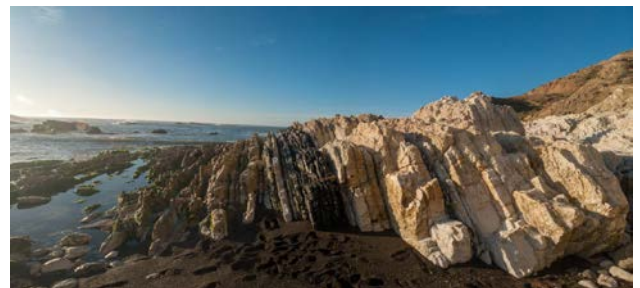
Figure 6: Waipawa Formation. Photo: Chris Hollis.

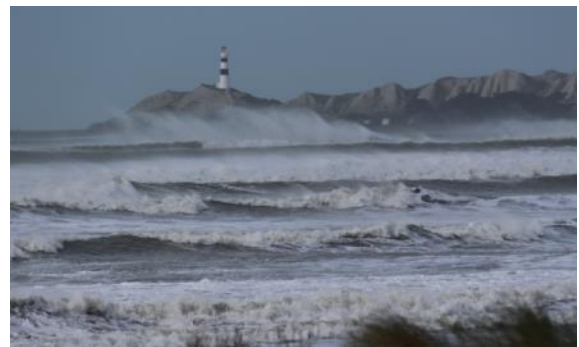
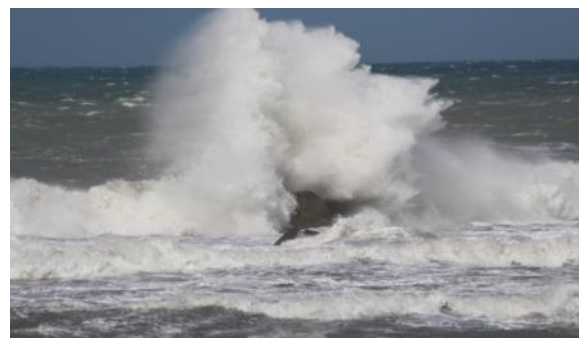
Figure 8: Marlborough's east coast is influenced by storms, September 2018. Photos: Rob Peter.

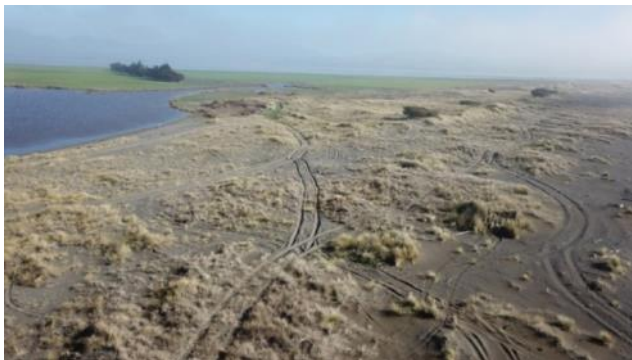
Figure 12: Vehicle tracks in dunes north of Marfells Beach.

The use of the east coast by ATV's has slowly increased over time. Prior to November 2016, access was restricted to up to two hours either side of low tide. More recently, following the uplift caused by the 2016 Kaikōura earthquake, ATV's are now joined by larger 4WD vehicles in increasing numbers and at virtually all tide levels. The impact of unrestricted access to Cape Campbell is threatening the ecological integrity of dunes, by crushing and killing plants. Continual disturbance of the new raised areas will impede or halt natural colonisation processes. There is obvious sign of vehicles damaging kowhangatara/spinifex runners and New Zealand native daphne [on Marlborough's east coast](#).

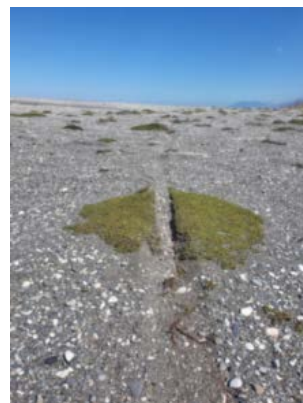
Figure 14: Vehicle tracks through New Zealand native daphne (*Pimelea prostrata*) at Needles Point. Photo: DOC.

There is evidence of damage to New Zealand native daphne at Needles Point.

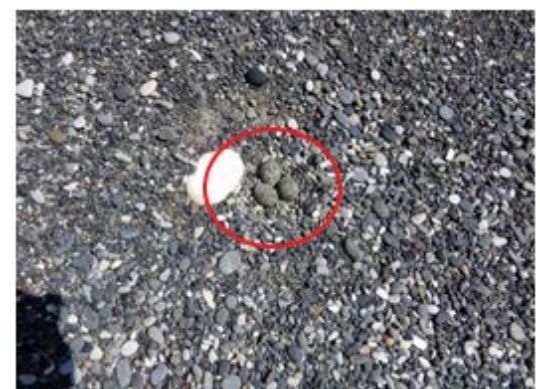
Figure 20: Did you spot the eggs?

Figure 15: Can you spot the dotterel nest in the pea gravels? See Figure 20.

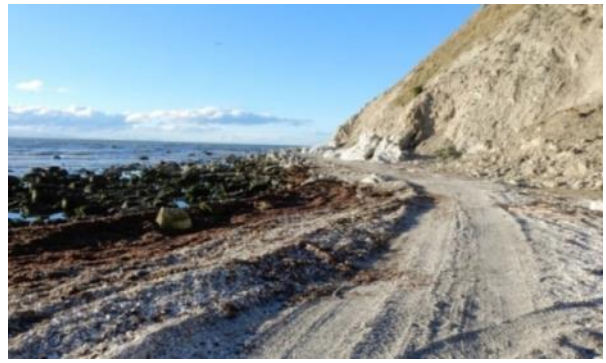
Figure 27: Well-worn vehicle route around Mussel Point. Photo: Mike Aviss, Council.

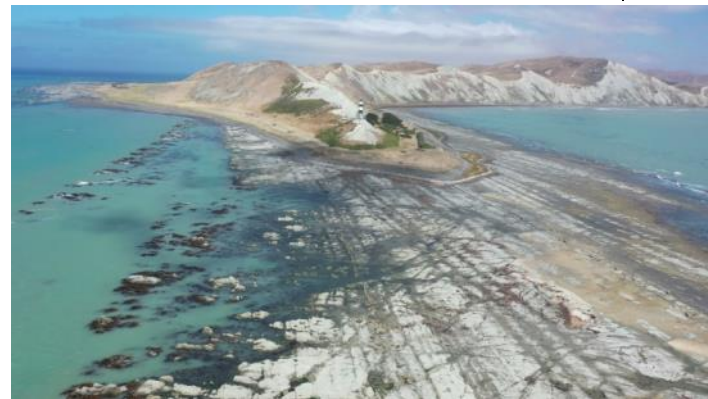
Figure 29: Cape Campbell/Te Karaka reefs after the earthquake. Photo: Shane Orchard, UC.

The coastal deformation that occurred in the Kaikōura earthquake is the most highly variable observed in any global earthquake in modern times. Along 110–km of coastline, the vertical displacement ranged from -2.5 to 6.5–m. GNS measured the coastal deformation using a combination of field surveying, satellite measurements and differencing between pre-and post-earthquake high-resolution topographic surveys. They defined the coastal stretch impacted by the earthquake as the region from Haumuri Bluff to Cape Campbell (a straight line distance of 110–km) then 80–km (73 %) of the coastline underwent uplift, with 48–km (44 %) undergoing uplift of >1 m. Around 28 km (25%) underwent a minor amount of subsidence (<0.5 m), with only a very localised area (2 km around the Kekerengu Fault) undergoing > 1–m subsidence. Only a very minor stretch (3–km, 2%) of coastline around Peketa was not impacted by coastal deformation. The entire Kaikōura Peninsula and much of the coastline north and south of the Peninsula was uplifted by between 0.8 and 1–m. Uplift of the Peninsula and the surrounding area is attributed to an entirely offshore fault called the Kaikōura Peninsula fault. Two strands of the Papatea fault cross the coastline at Waipapa Bay and between these faults the land was uplifted 5 -6-m, creating a new rocky coastal platform extending 200–300–m offshore from the pre-earthquake coastline.

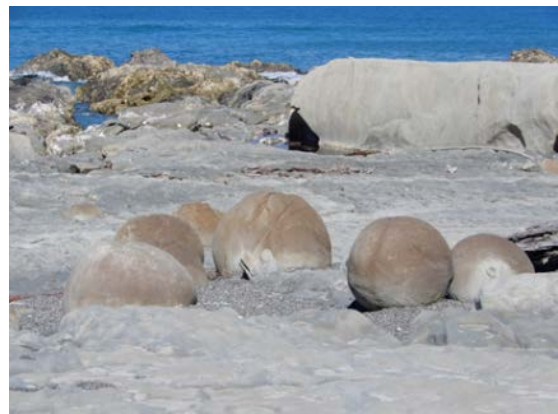
Figure 30: Moeraki type boulders appeared at Ward Beach after the earthquake.

In November, 2016, the Magnitude 7.8 Kaikoura Earthquake raised Chancet Rocks by about 2 metres, exposing large new areas of the tidal platform.

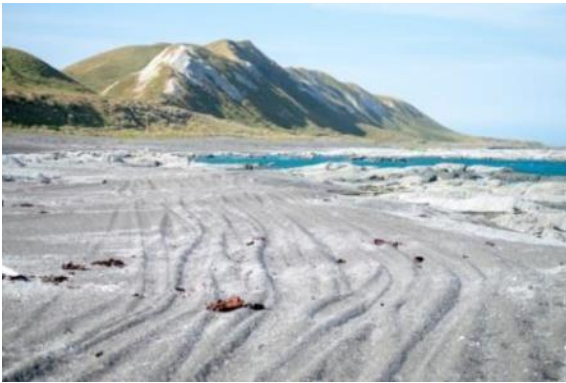
Figure 31: Uplifted pea gravels near Canterbury Gully. Photo: Shane Orchard, UC.

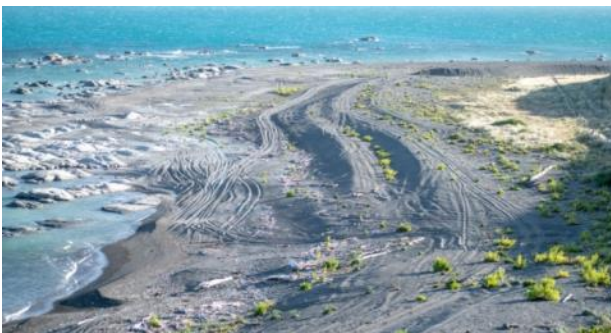
Figure 32: Vehicle tracks south of Cape Campbell/Te Karaka. Photo: Shane Orchard, UC.

Vehicle track marks are continuous in places, extending from reefs, coastal platforms and sand exposed at low tide, right into the dunes. There is a concern that vehicle tracks impact negatively on the landscape.

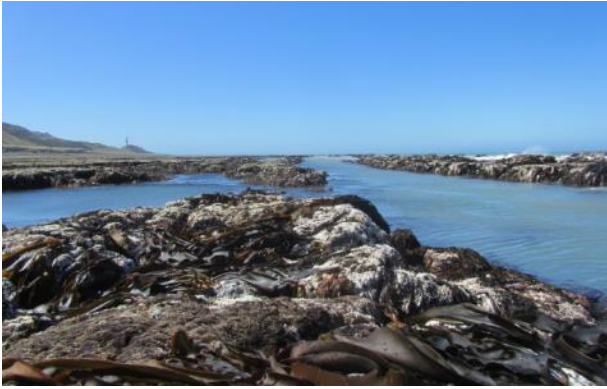
Figure 37: Post earthquake, November 2016.

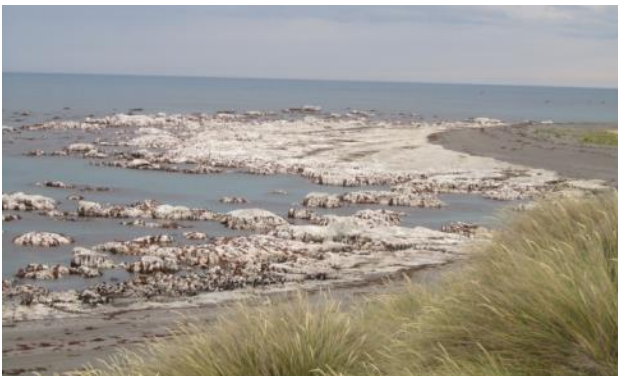
Figure 38: Four weeks after the earthquake.

“With increased temperatures due to little water coverage at high tide, more sediments that prevent attachment or smother organisms, and more wave exposure on vertical surfaces that remain after horizontal reefs were uplifted, the conditions required for many species have changed.” David Schiel, Professor of Marine Science, University of Canterbury.

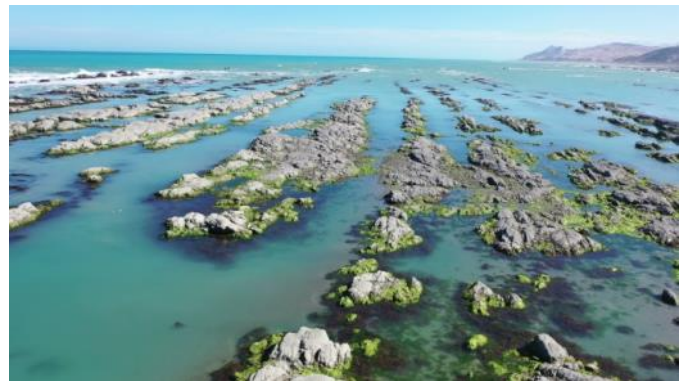
Figure 39: Drone view of reef platforms south of Cape Campbell/Te Karaka. Photo: Shane Orchard, UC.

On some platforms where tidal inundation still occurs, such as Cape Campbell/Te Karaka, the water is shallow, immersion times are short, and temperatures can reach lethal levels. In other areas, there is a vastly changed intertidal morphology, with often near-vertical topographies. Sediments are still clouding the nearshore waters in many areas, which reduces primary productivity and therefore the amount of food available to small invertebrates and other species in the coastal food web. On the positive side, post-earthquake recruit pāua (those up to around 50mm in shell length) are abundant in many sites where appropriate habitat exists. The ongoing task is to figure out how much juvenile pāua habitat remains on the coastline and how quickly these recruits can make their way into the fishery.

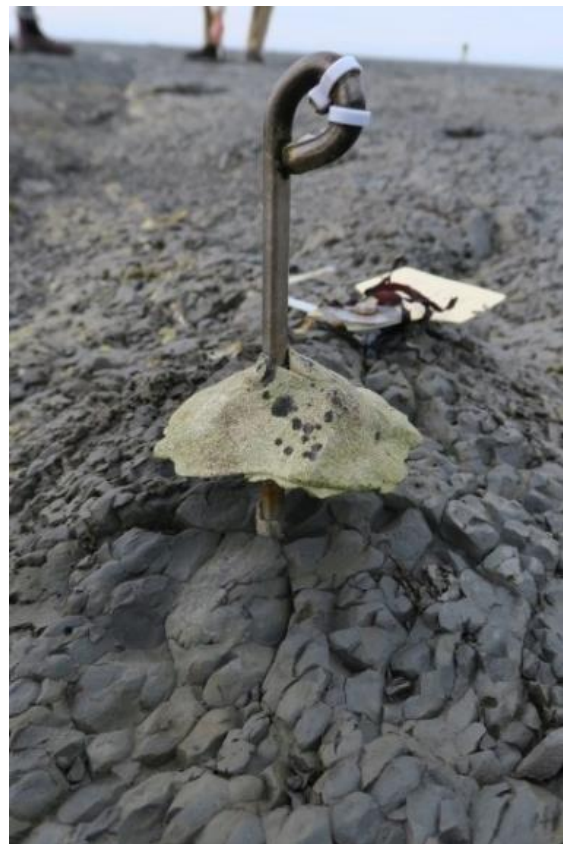
Figure 41: Measuring rock erosion.

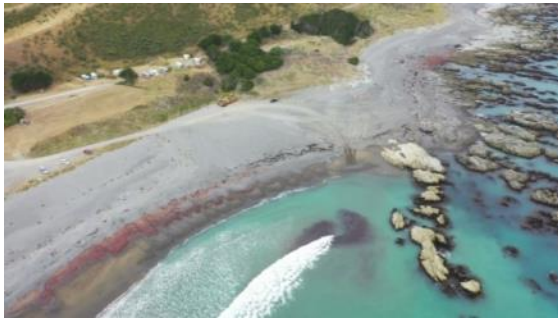
Figure 44: Ward Beach showing boat launching area. Photo: Shane Orchard, UC.

The presence of a new bar has created a surf break. This is impacting launching and retrieving in big swells. The surf break is a bonus for

surfers but difficult for fishers who are required to give way.

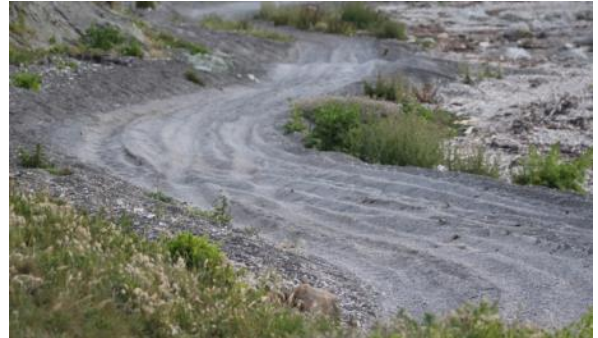
Figure 48: Vehicle track above the MHWL at Mussel Point.

The wheel marks left by all vehicles on the dunes and wider coastal environment are long lasting and have an impact on the visual look of this “Outstanding Coastal Natural Character” landscape as well as inhibiting the re-colonisation and re-adjustment of the natural fore dune ecosystems that would naturally occur after an event such as earthquake uplift.

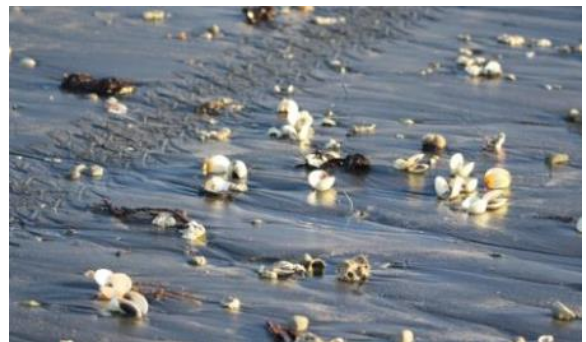
Figure 49: Vehicle track below the MHWL at Mussel Point.

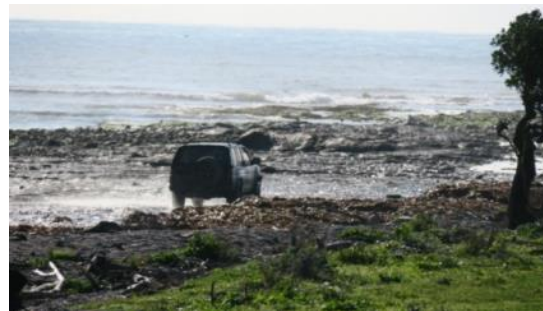
Figure 52: Vehicles can drive on multiple habitats, from coastal platforms to dunes.

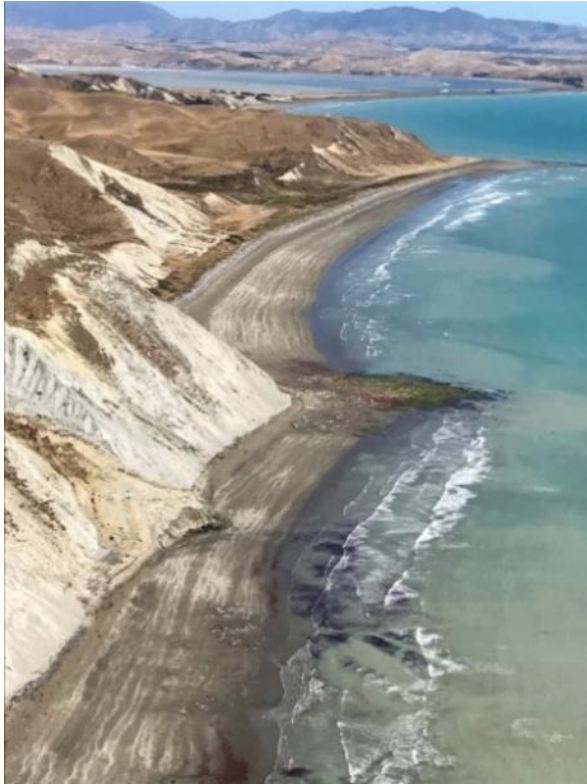
Figure 54: The new coast between Marfell's Beach and Cape Campbell/Te Karaka. Photo: Mark Davies Jan 2017.

Quake uplift means it’s now possible to walk or drive from Marfells Beach to Cape Campbell/Te Karaka, then around the Cape and south to as far as Chancet Rocks, at virtually any tide. This is a journey of approximately 30km in each direction. What was previously only a low-tide route is now accessible at most times by 4WD vehicles, 4-wheeler and trail-bikes as well as on foot.

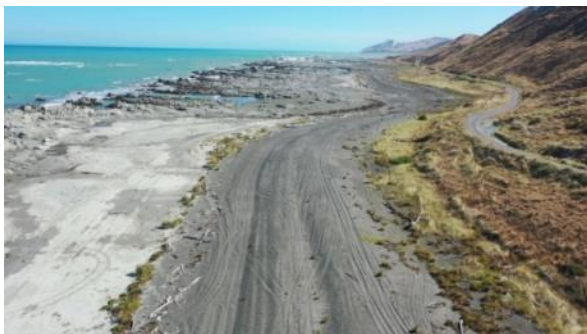
Figure 55: New uplifted coast south of Cape Campbell provides new opportunities. Photo: Shane Orchard, UC.
