# Water Quality in the Flaxbourne River Catchment

August 2022

MDC Technical Report No. 22-006006

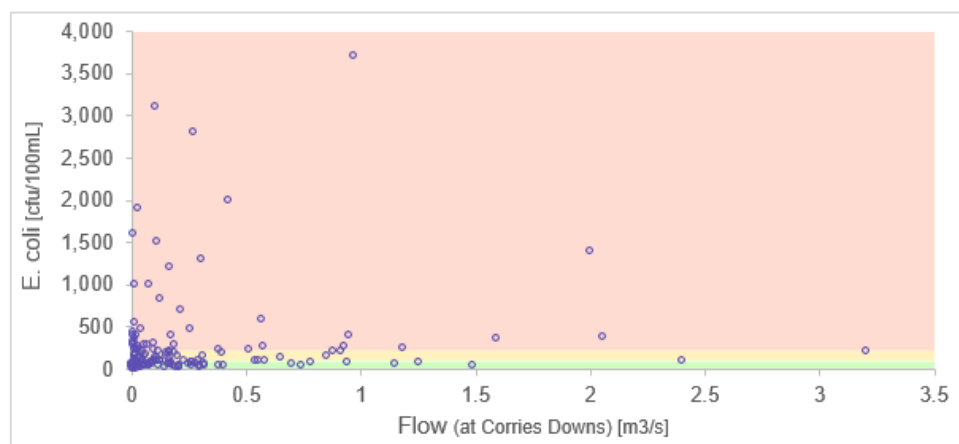
**Figure 5: *E. coli* concentrations in the Flaxbourne River at different flows. The Background shows the NPS-FM bands for *E. coli* median concentration.**

In many other rivers within the Marlborough region, high *E. coli* concentrations are mostly associated with higher flows when rainfall run-off carries animal droppings into waterways. In the Flaxbourne River, high *E. coli* concentrations are observed during all flow conditions but are particularly common during lower flows (Figure 5). This indicates that animals entering the waterways are a main source of faecal contamination.

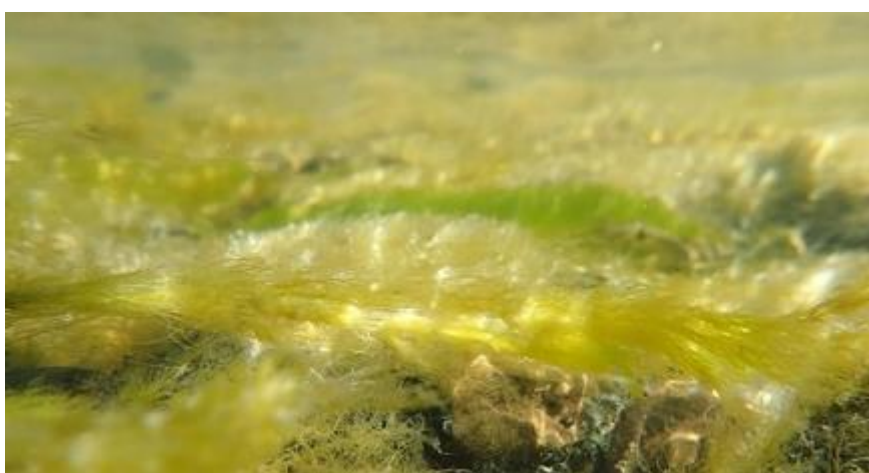
**Figure 7: Filamentous algae growing on the bed of the Flaxbourne River.**

Although some reduction in nutrient concentrations would slow the growth of algae, algae growth is also fuelled by ample sunlight reaching the stream bed. Most of the lower reaches of the Flaxbourne River and its tributaries lack continuous tall vegetation along the riverbanks, which would reduce the amount of sunlight available to algae. Control of periphyton will therefore be best achieved through a combination of nutrient reduction measures and the establishment of riparian vegetation to shade the stream bed.

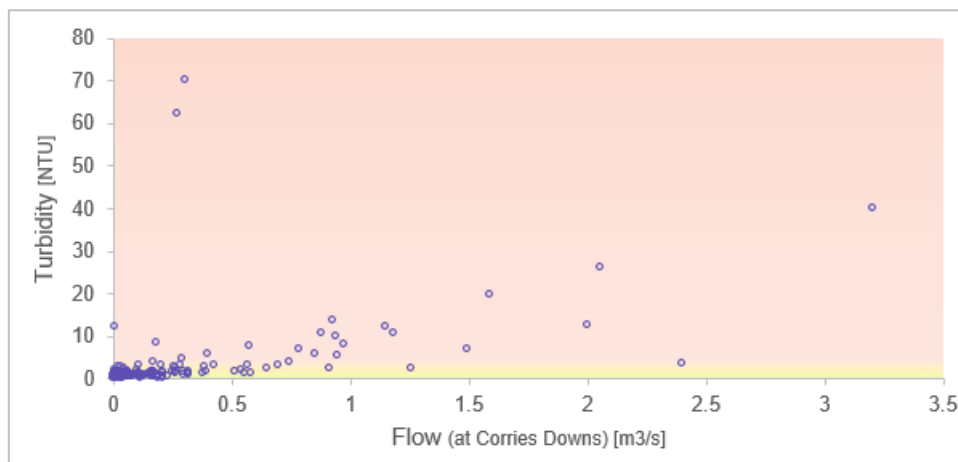
**Figure 8: Turbidity in the Flaxbourne River at different flows.**

However, at times turbidity is also elevated during low flow conditions in the Flaxbourne River. At lower flows sediment in the water is more likely to settle on the stream bed where it can significantly impact the habitat of aquatic animals. The most likely reason for higher turbidity at low flows is animal access to waterways. The animals damage streambanks, moving bank material into the stream as well as remobilising sediment already on the stream bed.

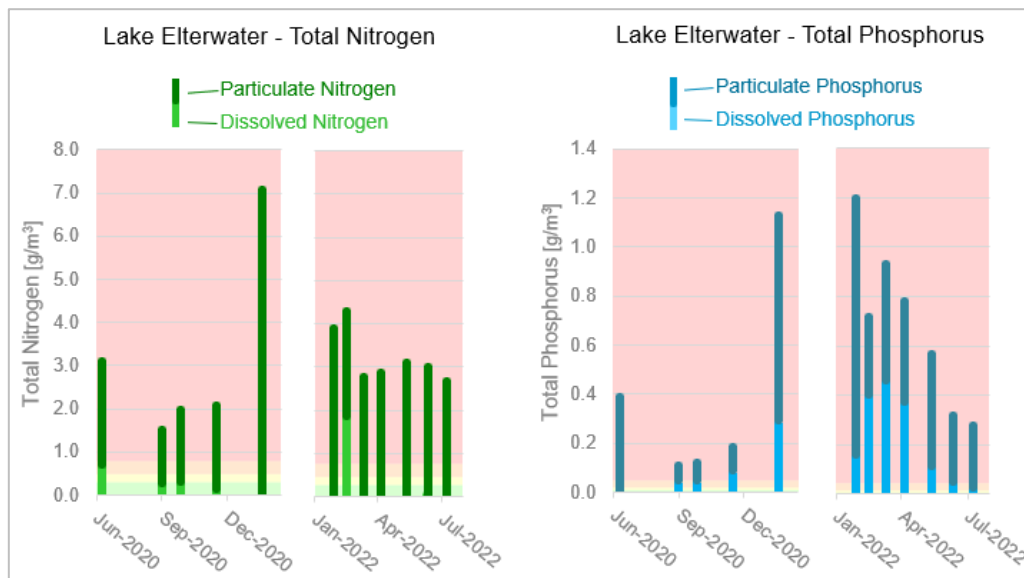
**Figure 12: Total Nitrogen and Total Phosphorus concentrations in Lake Elterwater measured during the Catchment Study and as part of the SoE programme. The background colours of the graphs show the NPS-FM bands for median concentrations (green = A-Band, yellow = B-Band, orange = C-Band, red = D-Band). Shown are also the dissolved and particulate fractions of the total concentrations.**

Both, Total Nitrogen and Total Phosphorus concentrations are consistently above the national bottom-line limits of the NPS-FM. The NPS-FM limits are for median concentrations, which means that exceedance of the limit is allowed fifty percent of the time. However, total nutrient concentrations in Lake Elterwater are consistently two to three times above the NPS-FM limit (Figure 12).

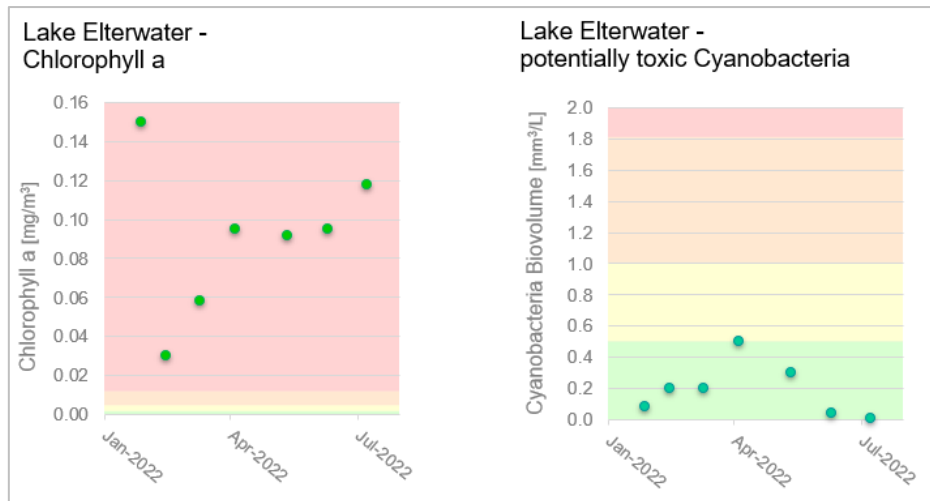
**Figure 13: Chlorophyll-a concentrations and Total Biovolume of potentially toxic Cyanobacteria in Lake Elterwater. The background colours in the graphs are based on NPS-FM bands – annual medians for Chlorophyll-a and 80<sup>th</sup>-percentile for Cyanobacteria Biovolume (green = A-Band, yellow = B-Band, orange = C-Band, red = D-Band).**

Algae are now sampled on a regular basis as part of the SoE monitoring of Lake Elterwater. Samples are analysed for the concentration of Chlorophyll-a, which is the green pigment used by algae for photosynthesis. It is a good indicator for general algae abundance. Not surprisingly, Chlorophyll-a concentrations in Lake Elterwater are consistently above the NPS-FM limit for the national bottom line (Figure 13).

Excessive algae growth also allows proliferation of potentially toxic algae, which make the lake water dangerous for livestock and humans, but also wildlife. Figure 13 shows the total biovolume of potentially toxic Cyanobacteria (blue-green algae). Fortunately, Cyanobacteria biovolumes have been comparatively low and were within safe levels in all samples taken. In samples with higher Cyanobacteria concentrations, Picocyanobacteria make up the majority of the biovolume. As the name suggests Picocyanobacteria are very small, with diameters of less than one micrometer.

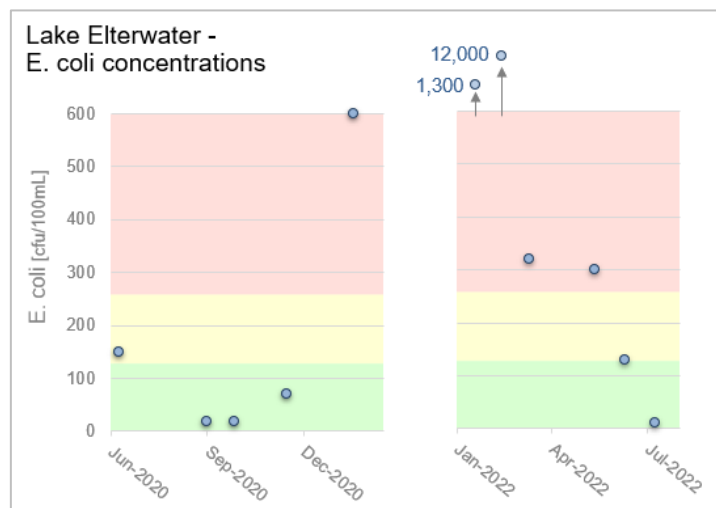
**Figure 14: E. coli concentrations in Lake Elterwater. The background colour in the graph represents the NPS-FM Median Bands (green = A-C Band, orange = D Band, red = E Band).**

E. coli concentrations in Lake Elterwater are very variable with a range of several orders of magnitude (Figure 14). The highest value of 12,000 cfu/100mL was associated with significant rainfall in the catchment. Surface run-off from the surrounding catchment is therefore a significant source of E. coli in the lake. As E. coli can survive for long periods in turbid water, the effects of the rainfall run-off can impact water quality in the lake for extended periods. Another source of E. coli is the large number of birds on the lake. Overall, E. coli concentrations are likely a function of rainfall events, lake volume (dilution capacity) and the number of birds present on the lake.

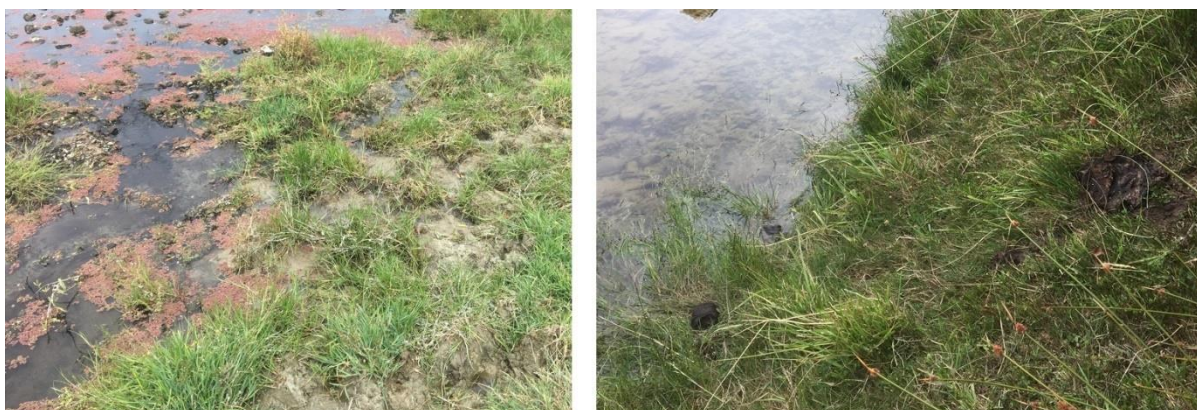
**Figure 15: Examples of signs of livestock access to the additional monitoring sites of the Flaxbourne Study.**

One of the main causes of degraded water quality is livestock access to waterways. Although, livestock was rarely encountered at the additional monitoring sites during sampling, the number of site visits was low, and signs of regular livestock were visible at all of the sites (Figure 15). The more frequent monitoring at the SoE site showed that high nutrient and E. coli concentrations as well as high turbidity during baseflow conditions was predominantly linked to the presence of livestock at the site or upstream when samples were taken.
