Salt Ecology Short Report 028. Prepared by Keryn Roberts for Marlborough District Council, June 2023

OVERVIEW

In March 2016, Marlborough District Council (MDC) commenced State of the Environment monitoring in Whangarae Estuary (125ha) to establish a broad-scale baseline record of intertidal substrate and vegetation (described in Stevens & Robertson 2016). In 2023, MDC contracted Salt Ecology to undertake repeat mapping, with outputs limited to provision of data, and a short report (presented here) summarising broad-scale results and any key changes since 2016.

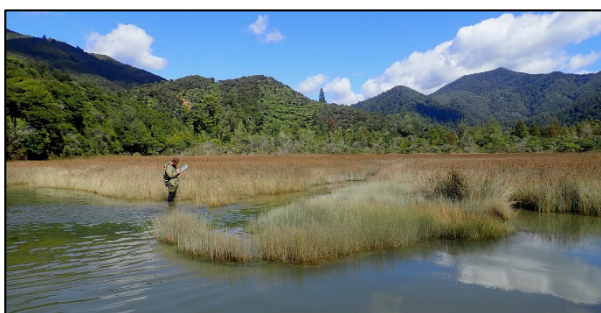
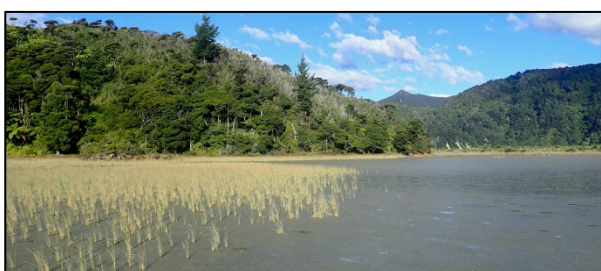
Rushland transitioning into native forest (top) and in the northern arm with sparse rushland cover on the seaward edge (bottom).

Salt marsh comprised 5.7ha of rushland (*Juncus kraussii* and *Apodasmia similis*) and 2.4ha of herbfield (*Samolus repens* and *Sarcocornia quinqueflora*; Fig. 1). The main area of rushland, located in the south-west arm, was growing in soft sandy mud, with sediments likely sourced from the Castor Stream catchment which is the main freshwater input to the estuary. Other areas of rushland in the northern arm, and along the fringing margins, were predominantly growing in gravels or muddy sand (<25% mud). Herbfield was most prominent near the estuary entrance growing in firm gravel and cobble substrates.

Since 2016, there has been a 1.2ha reduction in mapped salt marsh. Some of the reduction reflects improvements in mapping accuracy due to higher resolution aerial imagery being available in 2023 enabling better delineation of salt marsh margins. However, small losses were apparent in the northern arm where there was a reduction in the sparse rushland cover along the seaward edge (see photo). Other areas of salt marsh showed no appreciable change to those mapped in 2016 (Stevens & Robertson 2016).

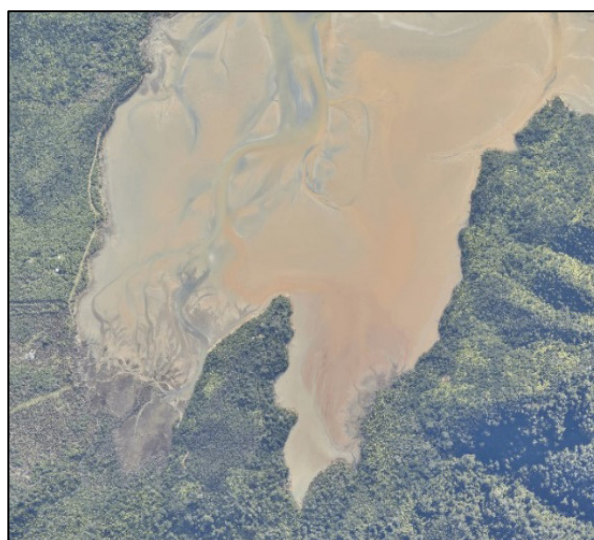
Imagery post-flood August 2022 (LINZ Data Service), orange areas represent deposition of fine sediments.

Outside of salt marsh areas, soft/very soft sandy mud (>50% mud) comprised 4.7% of the intertidal area and was located in the south-east arm. Since 2016, fine sediment (>25% mud) has expanded northward, with sediment plate monitoring recording an annual mean sedimentation rate of 4.4mm/y between 2016 and 2023 (a condition rating of 'poor' - see Stevens et al. 2023), indicating increased sediment deposition in the estuary. This has likely arisen from several large flood events in Marlborough in recent years. Although there was no evidence of residual fine sediments on the main sandy tidal flats in March 2023, aerial imagery taken post-flood in August 2022 (see photo below) shows extensive deposition of fine sediments in the south-east arm and on the eastern margin.

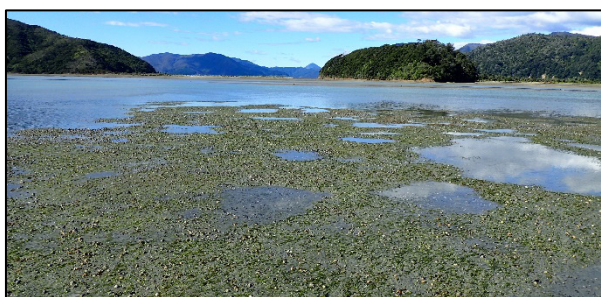
Seagrass patch looking toward the estuary entrance.

Seagrass comprised 1.4ha and was located on the lower estuary flats toward the entrance (Fig. 1). Since 2016, there has been a small decline and a shift in the location of patches and percent cover. Areas of seagrass on the margins of the eastern channel in 2016 had decreased in size, with areas on the western margin expanding in 2023. A cursory review of historic imagery indicates that seagrass in Whangarae Estuary has been spatially variable over time, likely owing to its location near the main channels. However, there has been a large, estimated decline (~74% loss) in overall extent since 1943 (first available aerial imagery), with ~50% of the losses occurring between 1943 and 1974. In March 2023, the remaining seagrass appeared in good condition with only a sparse cover of macroalgae and a small amount leaf discoloration observed in the northern most patch.
