## Appendix 1

Some Observations of Erosion as a Result of the 28 December 2010 Storm Event

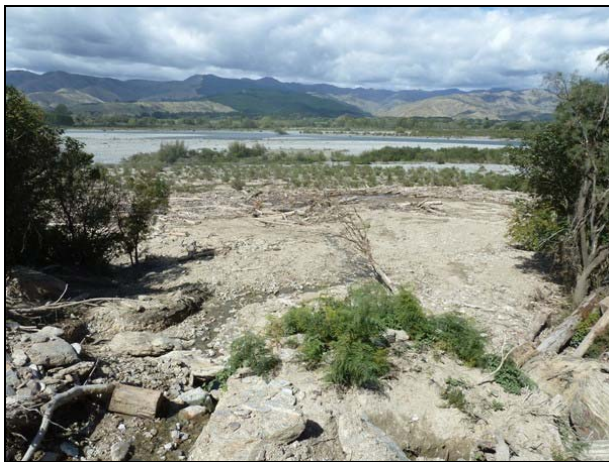
Site	Site 1
GPS	1635584 5397071
Land cover	Pines < 10 years
Type of erosion	2Da 3Df
LUC Class	7e12
Infrastructure damage	Public road closure

Figure A1 Site 1 erosion in pines <10 years

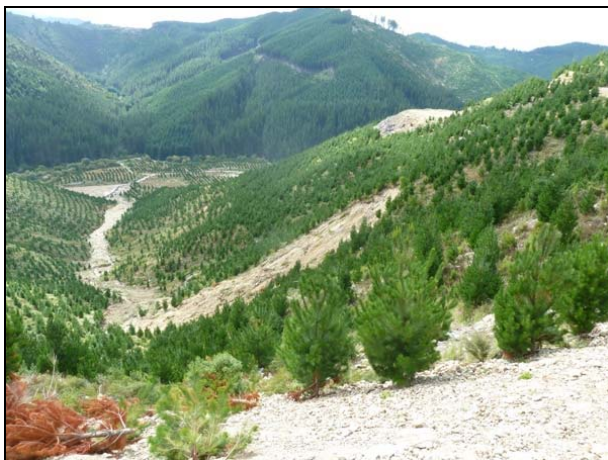
Site	Site 4
GPS	1634676 5401704
Land cover	Pines < 10 years
Type of erosion	3Da 4Df 2Ss
LUC Class	7e12
Infrastructure damage	Processing site damage

Figure A4 Site 4 erosion in pines <10 years

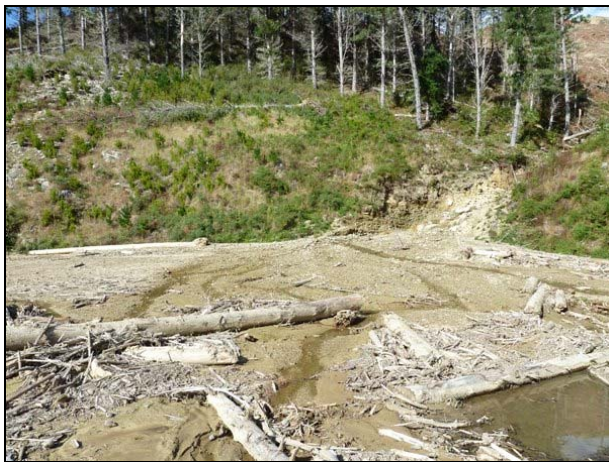
Site	Site 5
GPS	1634676 5402032
Land cover	Recently harvested
Type of erosion	2Da 2Df 2Ss
LUC Class	7e12
Infrastructure damage	Forestry road closure

Figure A5 Site 5 erosion in recently harvested pines

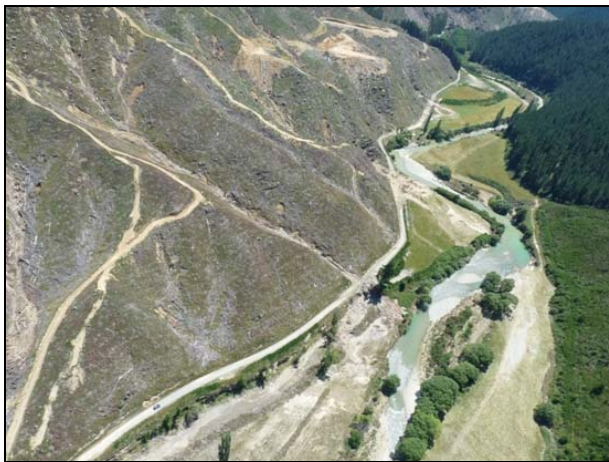
Site	Site 7
GPS	1649583 5407315
Land cover	Recently harvested
Type of erosion	2Ss 2Da 2Df
LUC Class	7e12
Infrastructure damage	Public road closure

Figure A7 Site 7 erosion in recently harvested pines

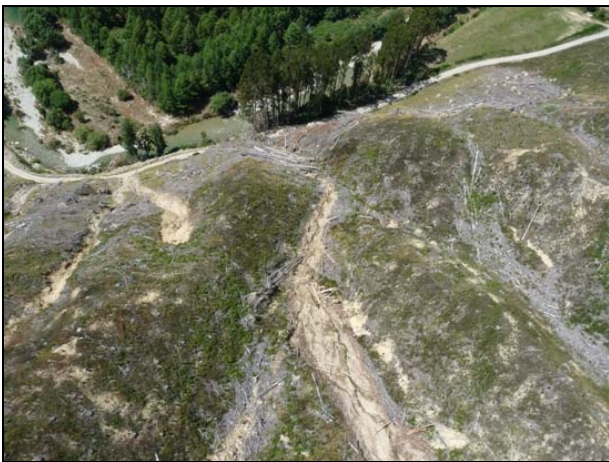
Site	Site 8
GPS	1649622 5407225
Land cover	Recently harvested
Type of erosion	3Ss 3Da 2Df
LUC Class	7e12
Infrastructure damage	Public road closure

Figure A8 Site 8 erosion in recently harvested pines

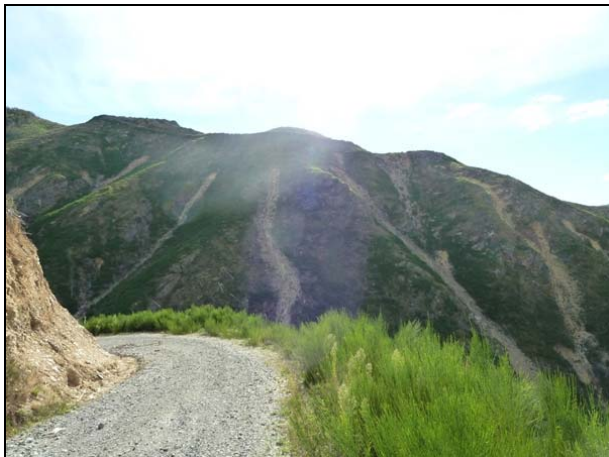
Site	Site 9
GPS	1649251 5407244
Land cover	Recently harvested
Type of erosion	2Ss 4Da
LUC Class	7e12
Infrastructure damage	Forestry road closure

Figure A9 Site 9 erosion in recently harvested pines

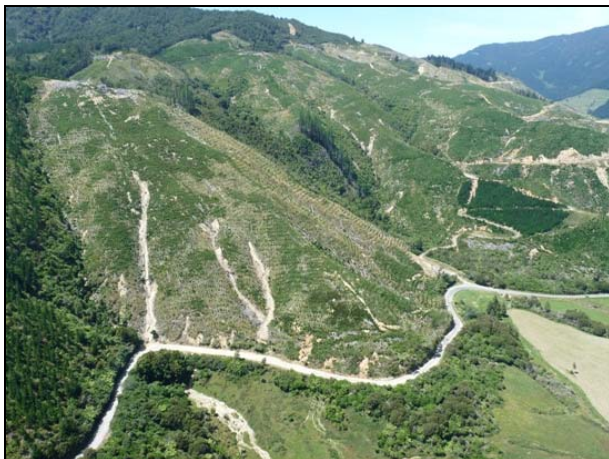
Site	Site 27 a, b, c
GPS	1672856 5429526
Land cover - a	Recently harvested
Land cover - b	Pines < 10 years and recently harvested
Land cover - c	Recently harvested
Type of erosion - a	2Ss 2Da
Type of erosion - b	2Ss 3Da 3Df
Type of erosion - c	1Ss
LUC Class - a	7e9
LUC Class - b	7e9
LUC Class - c	6e11
Infrastructure damage	Public road closure

Figure A27 Site 27 a, b, c erosion in pines <10 years and recently harvested

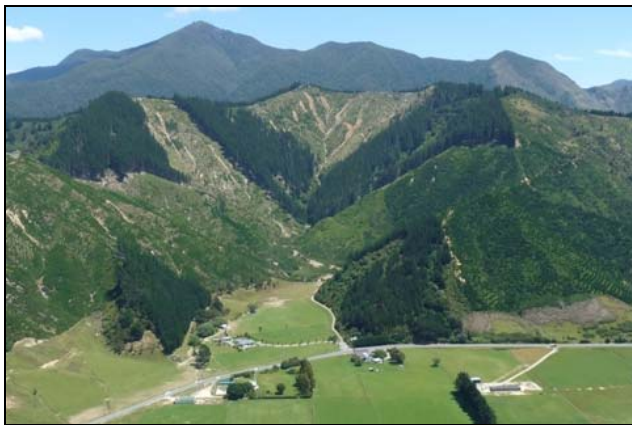
Site	Site 11
GPS	1662324 5414920
Land cover	Pines < 10 years
Type of erosion	3Da 3Df
LUC Class	7e12
Infrastructure damage	None noted

Figure A11 Site 11 erosion in pines <10 years

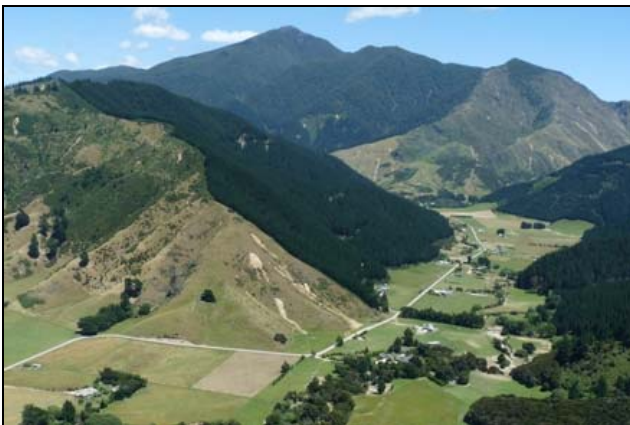
Site	Site 12
GPS	1663456 5416047
Land cover	Exotic pasture
Type of erosion - a	1Ss
LUC Class	6e11
Infrastructure damage	None noted

Figure A12 Site 12 erosion in exotic pasture

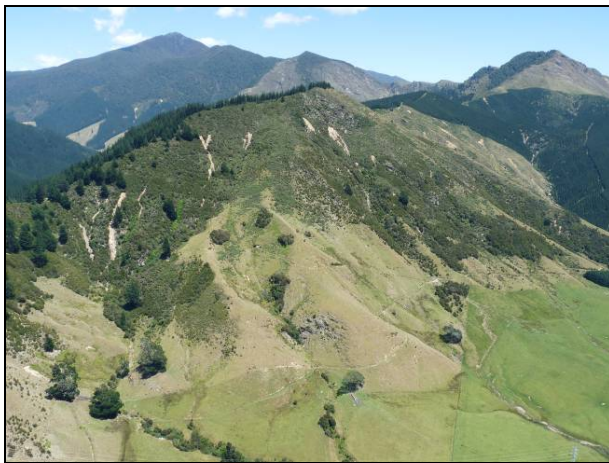
Site	Site 13 a, b
GPS	1663449 5417284
Land cover - a	Scrub
Land cover - b	Exotic pasture
Type of erosion - a	2Ss 2Da
Type of erosion - b	2Ss
LUC Class - a	7e9
LUC Class - b	6e11
Infrastructure damage	None noted

Figure A13 Site 13 a, b erosion in recently harvested pines

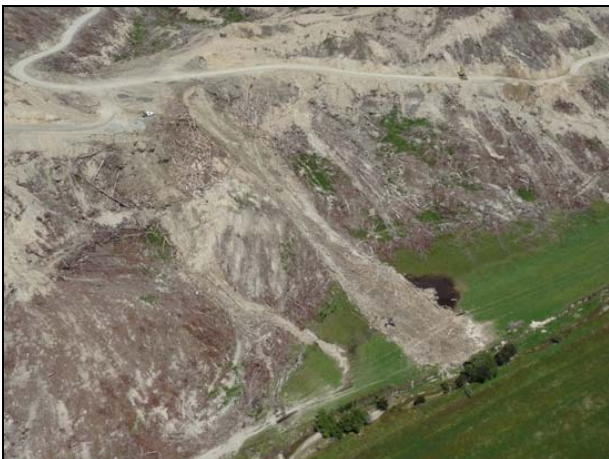
Site	Site 18
GPS	1656715 5426745
Land cover	Recently harvested
Type of erosion	2Ss 3Da 3Df
LUC Class	6e11
Infrastructure damage	None noted

Figure A18 Site 18 erosion in recently harvested pines
