Phase II: Remote mapping of landslides triggered by the July 2021 and August 2022 Marlborough storms, and selected field investigations of landslide impact

**GNS Science Report 2023/20
July 2023**

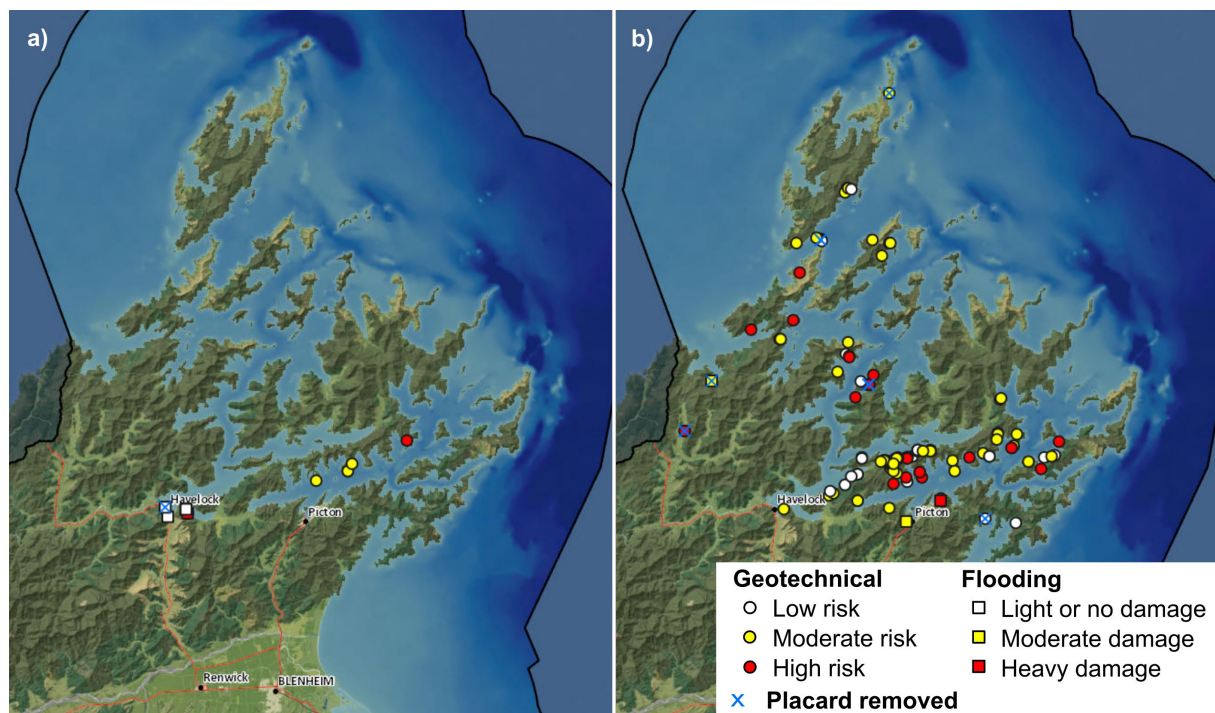
Figure 1.1 Rapid assessments of flood and geotechnical (landslide) damage completed by Marlborough District Council (MDC) after the (a) July 2021 and (b) August 2022 rainfall events. In 2021, three properties were assessed as being at high risk of landslide damage (red, Placard 4 or 5) and six as moderate risk (yellow, Placard 2 or 3). In 2022, 33 properties were deemed to be at high risk and 68 at moderate risk of landslide damage. Placards were removed by MDC after further assessment (source: pers. comm., MDC 2022).

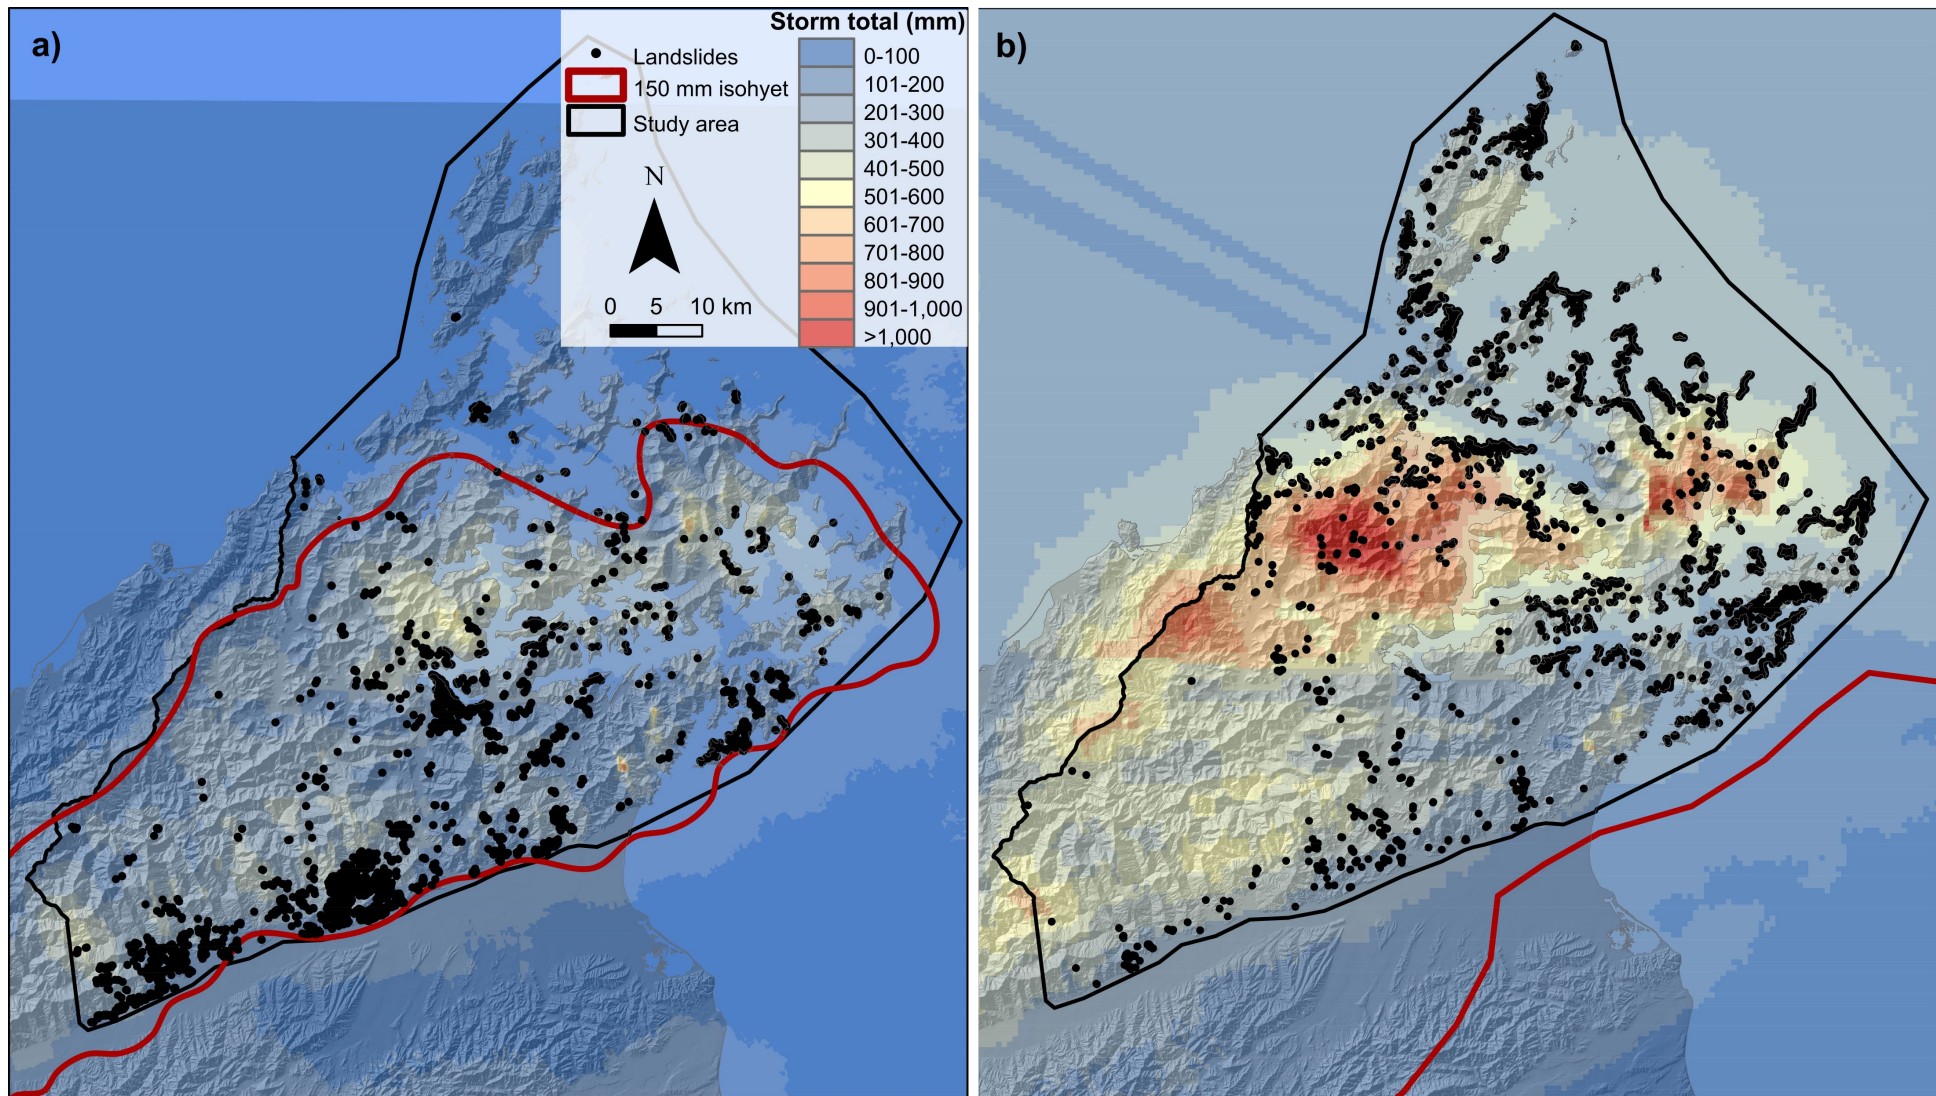
From the desktop-based mapping using aerial and satellite photography, a total number of 3792 landslides were mapped for the 2021 event (Figure 3.3) and 3805 landslides for the 2022 event (Figure 3.4). The distribution of all 7597 landslides in relation to rainfall, geology and land cover are discussed in the next sections for each storm event separately.

Figure 3.3 Landslide distribution and rainfall for the (a) July 2021 and (b) August 2022 storm events. Rainfall totals are listed as total storm amounts. Gauge-corrected rain radar was provided by MetService.

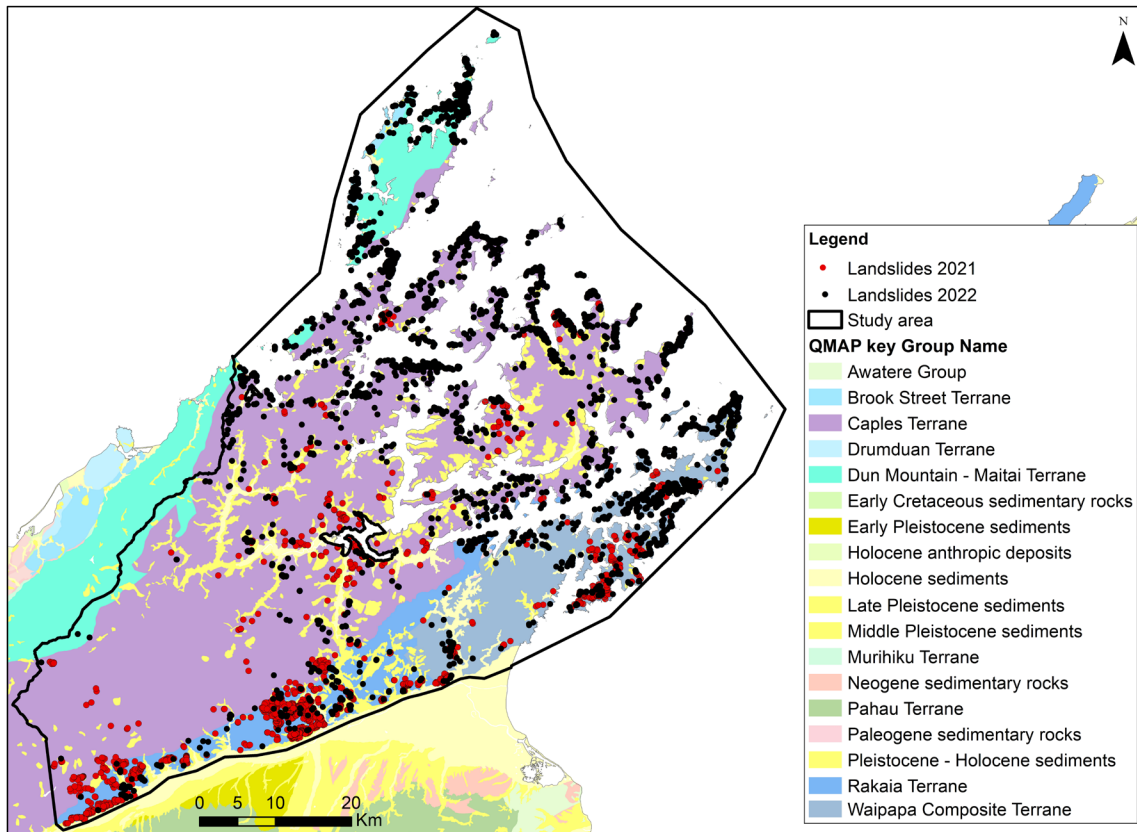
Figure 3.4 Locations of landslides triggered by the July 2021 (red) and August 2022 (black) storm events, shown in relation to the underlying geology from QMAP (Heron 2020).

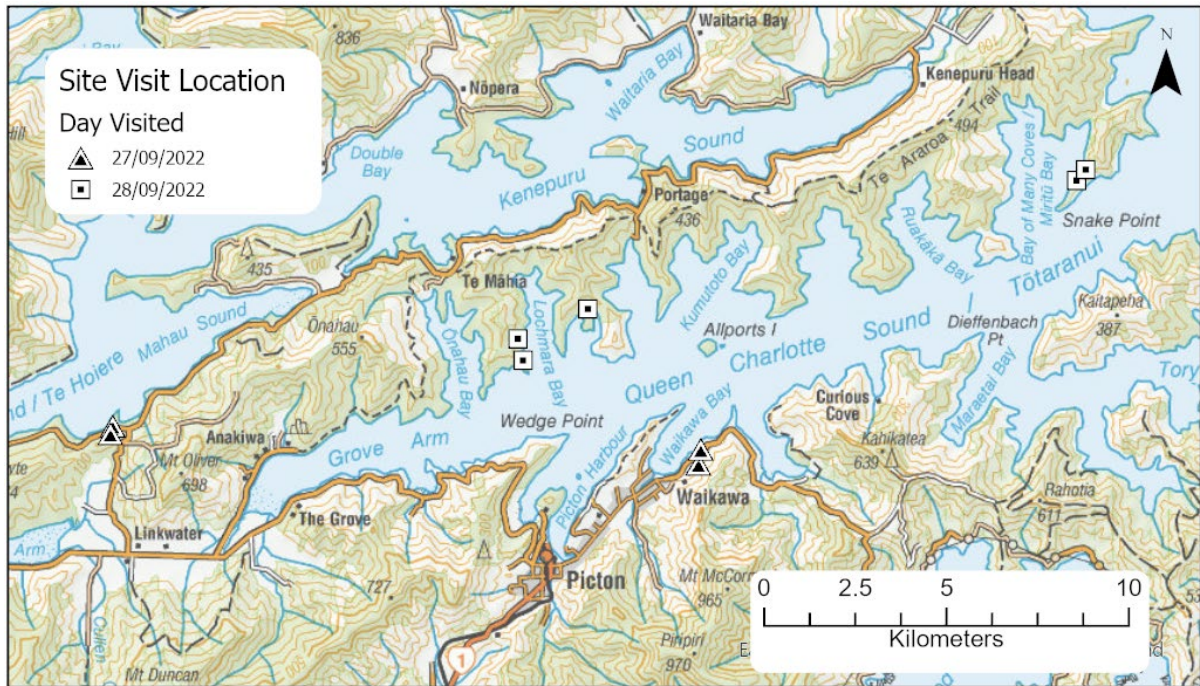
Figure 4.1 Location of landslides triggered by the August 2022 storm selected for detailed site investigations.

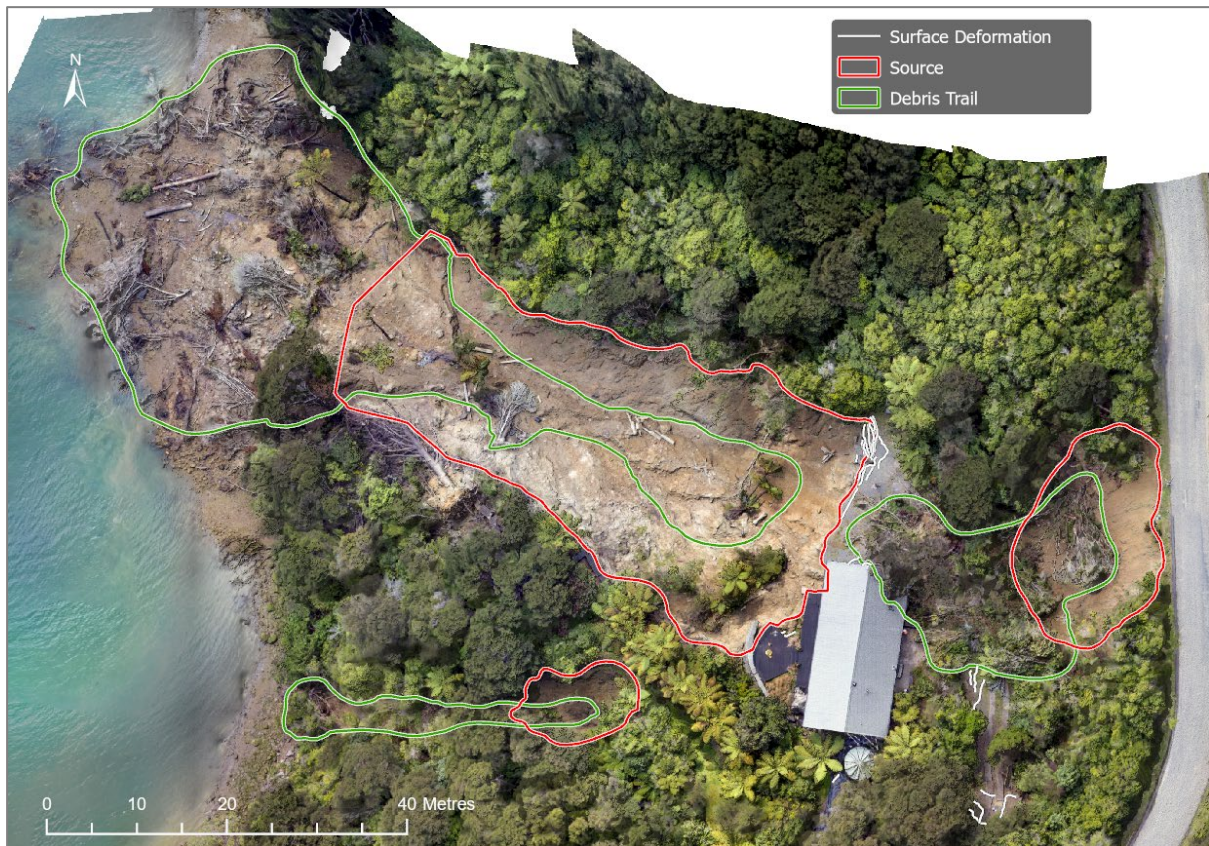
Figure 4.2 Example of landslide mapping based on RPAS imagery.

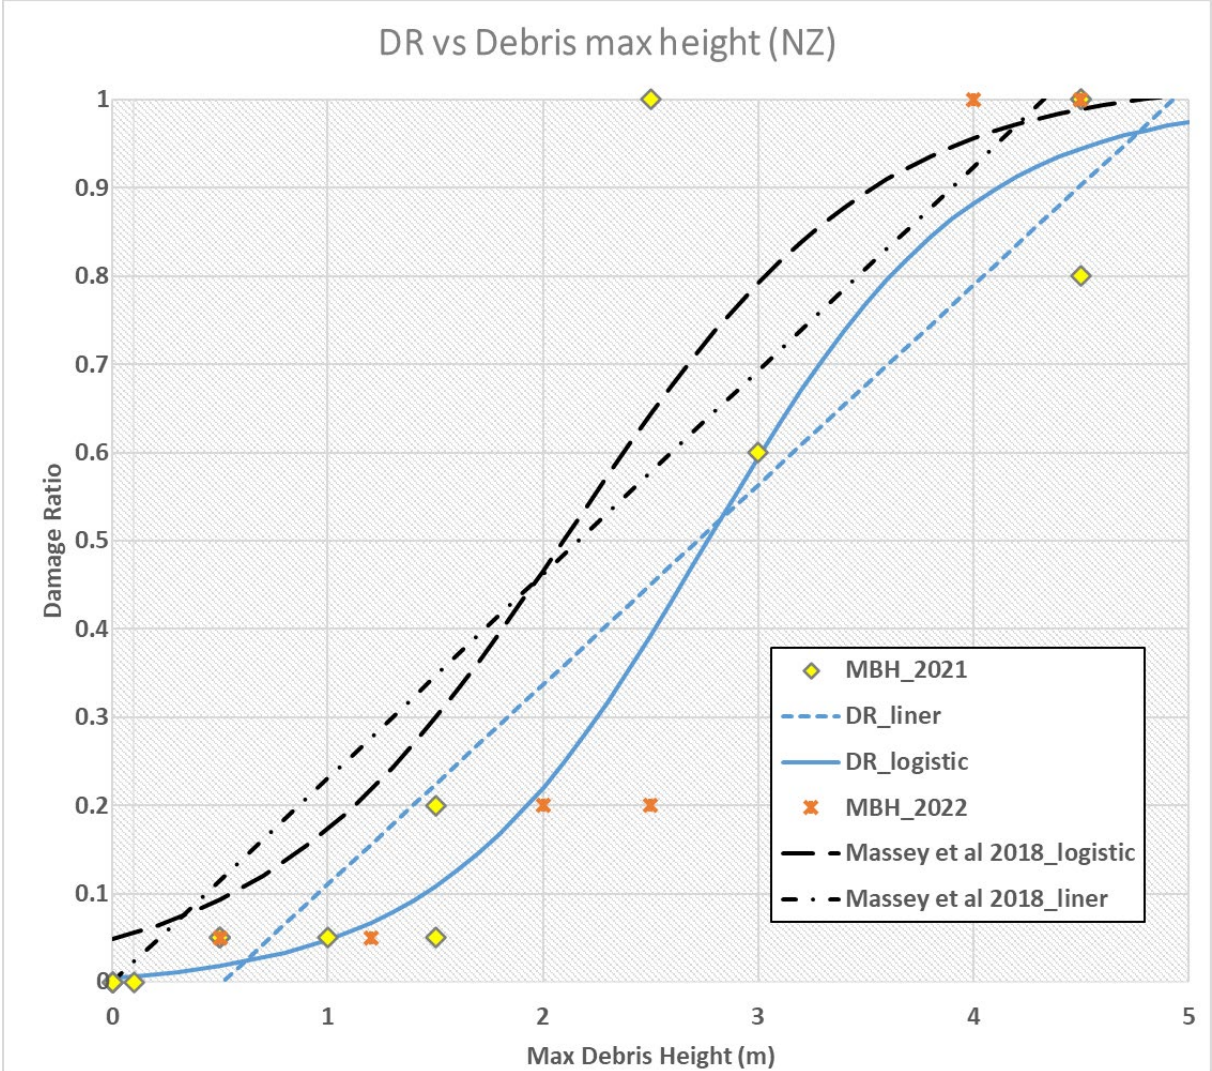
Figure 4.6 Preliminary results of building vulnerability functions from the 2021 and 2022 storm events in the Marlborough Sounds using the relationship between observed damage state and estimated damage ratio.

The damage ratio of buildings in the Marlborough region compared to maximum debris heights of landslides for the July 2021 and August 2022 storms are shown in Figure 4.6. Compared with earthquake-triggered landslides (Massey et al. 2019), damage ratios appear to be lower for rainfall-triggered landslide impacts. Note that this work is currently being refined as part of an ongoing research project at GNS Science.

Note that it was difficult and impractical for the field team to determine the building repair cost on the ground. However, we were able to capture the building damage state and gain a preliminary understanding of building performance from the recent landslide events in the Marlborough Sounds based on the recorded damage state of the surveyed buildings, along with the suggested damage ratio as shown in Table 4.2 and Figure 4.6.

The preliminary vulnerability models are expected to be refined once building insurance claim information (hence repair cost) becomes available. The improved building vulnerability functions can then be applied in risk modelling software to estimate the potential impact and loss sustained by landslide hazards in future storm events.

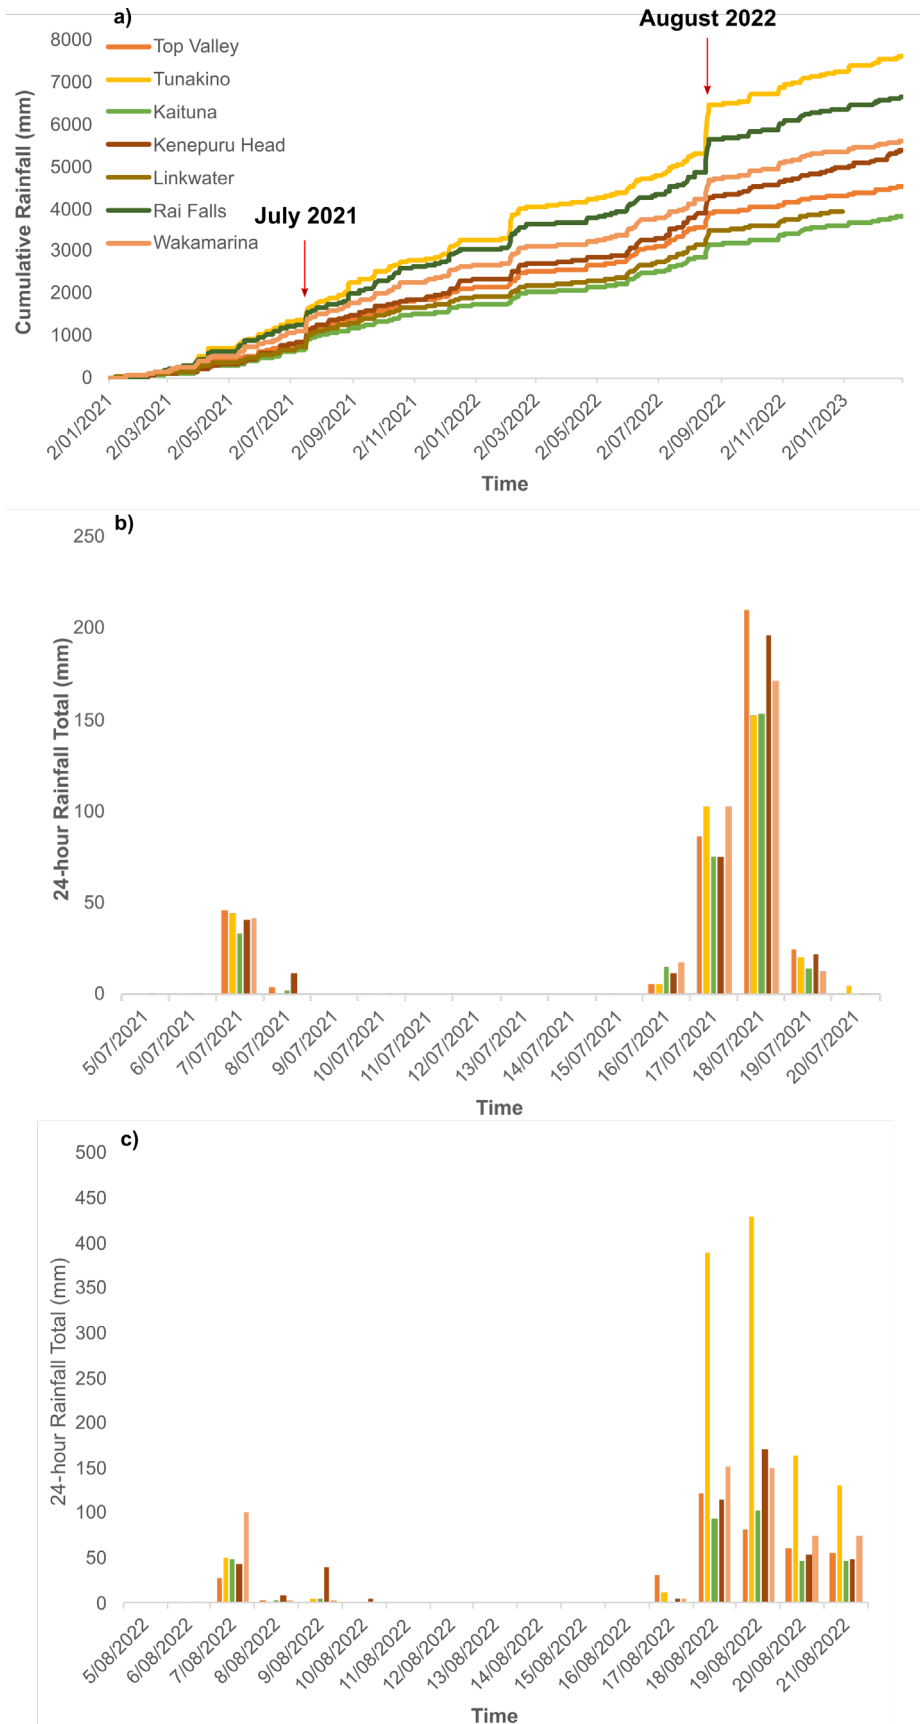
Differences in the antecedent rainfall might help to explain differences in the landslide distributions for the 2021 and 2022 storms. Antecedent conditions in August 2022 were wetter than those in 2021 for representative MDC rain gauge stations in the Marlborough region (Figure 5.1), particularly at Kenepuru Head and Wakamarina (~100 mm in the 12 days before the 2022 storm). The Tunakino rain gauge had the highest cumulative rainfall from 2021 to 2023, receiving >7600 mm in the 2.5-year period, whereas Kaituna received the lowest rainfall with ~3800 mm over 2.5 years. During the 2021 storm event, Top Valley received the highest peak daily and total rainfall at 326 mm. During the 2022 storm event, the Tunakino station recorded the highest peak daily and total rainfall (1126 mm). The higher antecedent and storm rainfall amounts, as well as longer storm duration, in 2022 could in part explain the higher occurrence of ground cracking (incipient landsliding) and relict landslide re-activations observed in 2022 (see also Section 5.2).

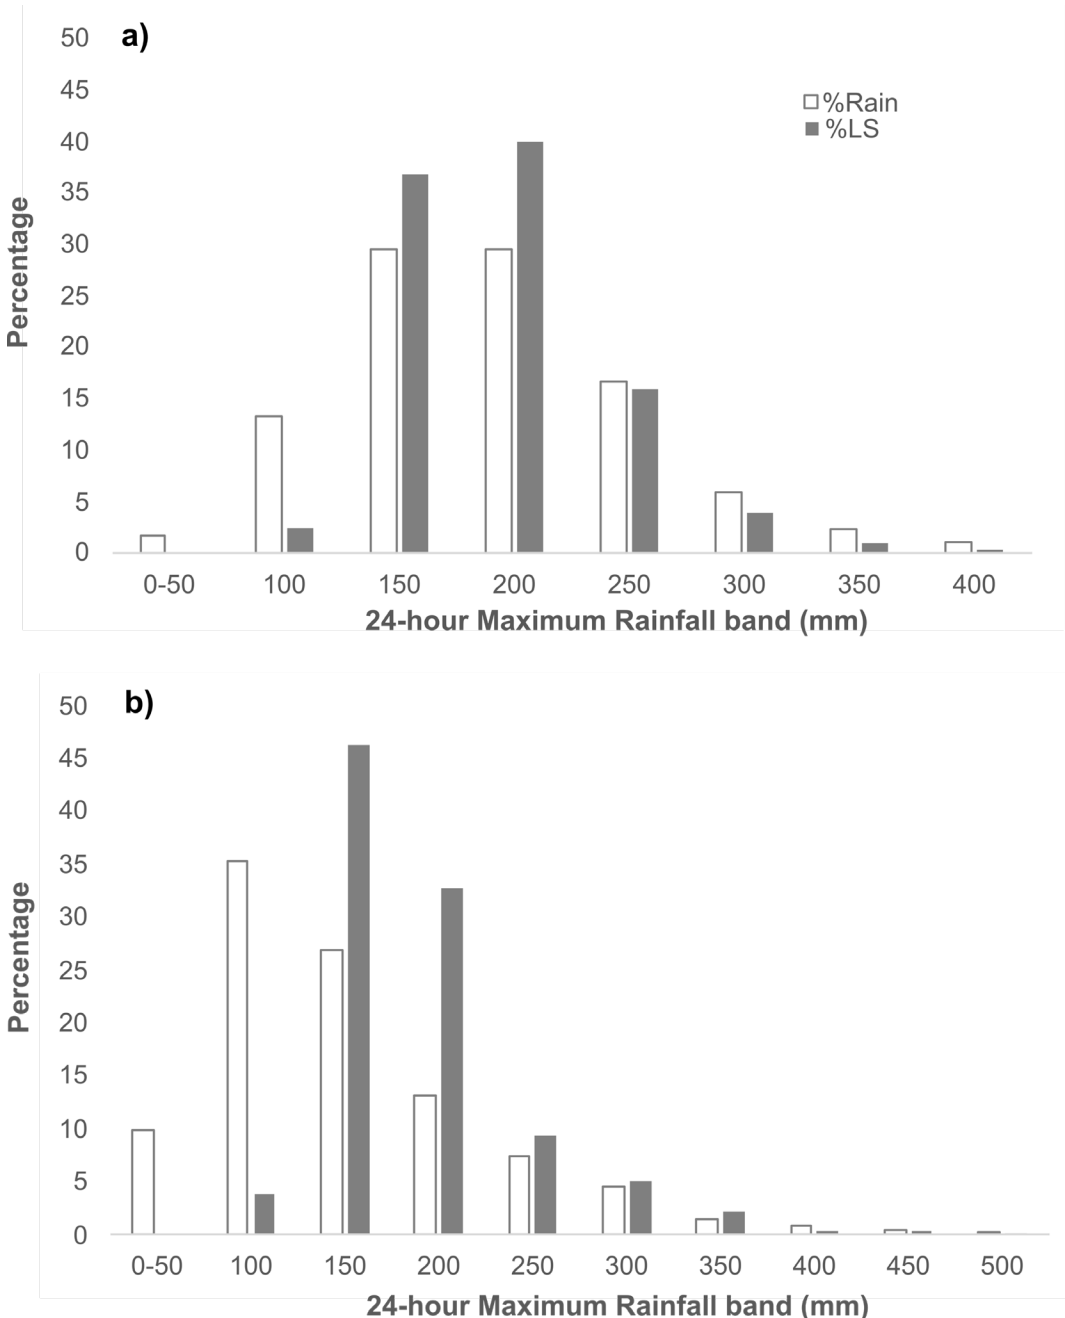
Figure 5.2 Maximum 24-hour rainfall over the study area in (a) 2021 and (b) 2022, showing the percentage of areas that received rainfall in each band and the percentage of landslides initiated in those rainfall bands.

Storm total rainfall thresholds for ≥ 1.5 LS/km² landslide density in the July 2021 storm were 150–350 mm over the storm duration (54 hours) and 250–400 mm over 96 hours in August 2022. This correlates to an average of 67–178 mm over 24 hours (for two consecutive days) and 63–100 mm over 24 hours (for three days), respectively. Areas receiving >178 mm in 24 hours in 2021 comprised only 3% of the total study area, and 2.2% of landslides occurred on slopes receiving high rainfall amounts. Areas receiving >100 mm in 24 hours in 2022 comprised 50% of the total study area, but only 30% of landslides occurred in these areas. Maximum 24-hour rainfall (based on rain radar) was significantly higher than the average – 379 mm in 2021 and 466 mm in 2022. Landslides occurred disproportionately in areas that received 100–200 mm maximum rainfall in 24 hours in 2021 and 100–400 mm in 2022. Thus, proportionally, more landslides occurred in areas with lower rainfall during both storms. For both storms, the greatest number and density of landslides did not occur in the areas that received the highest rainfall.

Landslide distributions in July 2021 and August 2022 do not seem to be controlled by the rainfall distribution alone.

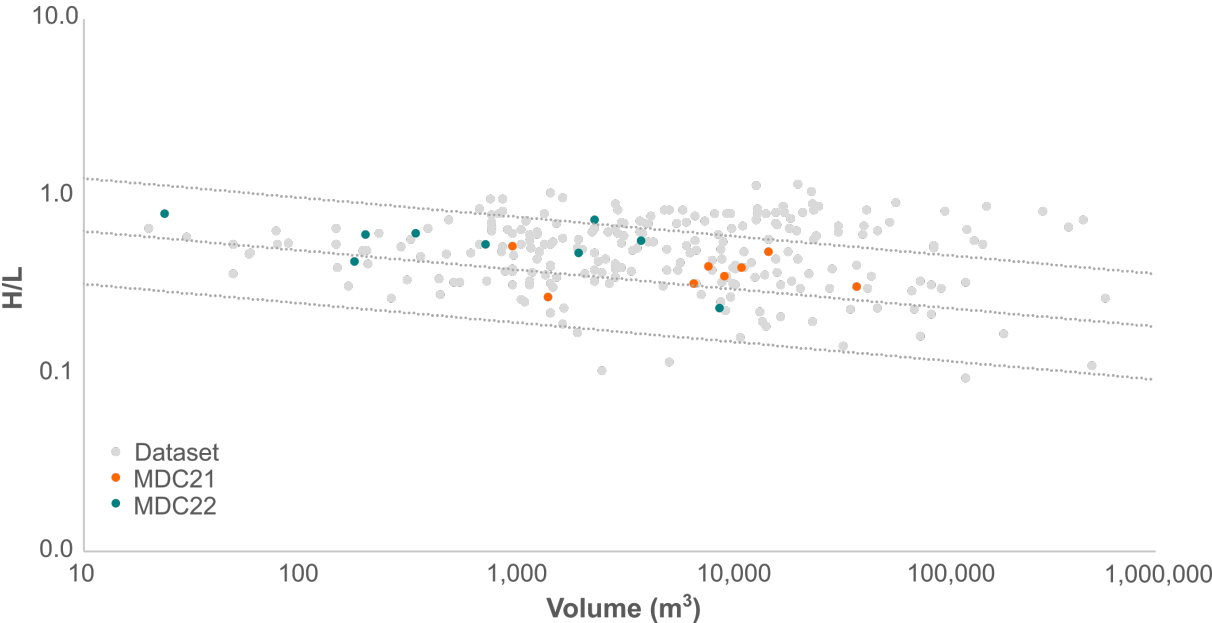
The landslides visited in the field in August 2022 were less mobile than average literature values (above the mean line in Figure 5.1) and smaller than the July 2021 sites visited (to the left on Figure 5.1).
