## **Report to Council's Environment Committee – 16 February 2016**

### **Inventory of slips from Sounds roads into coastal waters**

## **SOME IMPACTS OF ROADING AND FLOOD DAMAGE ON SOUNDS ROADS**

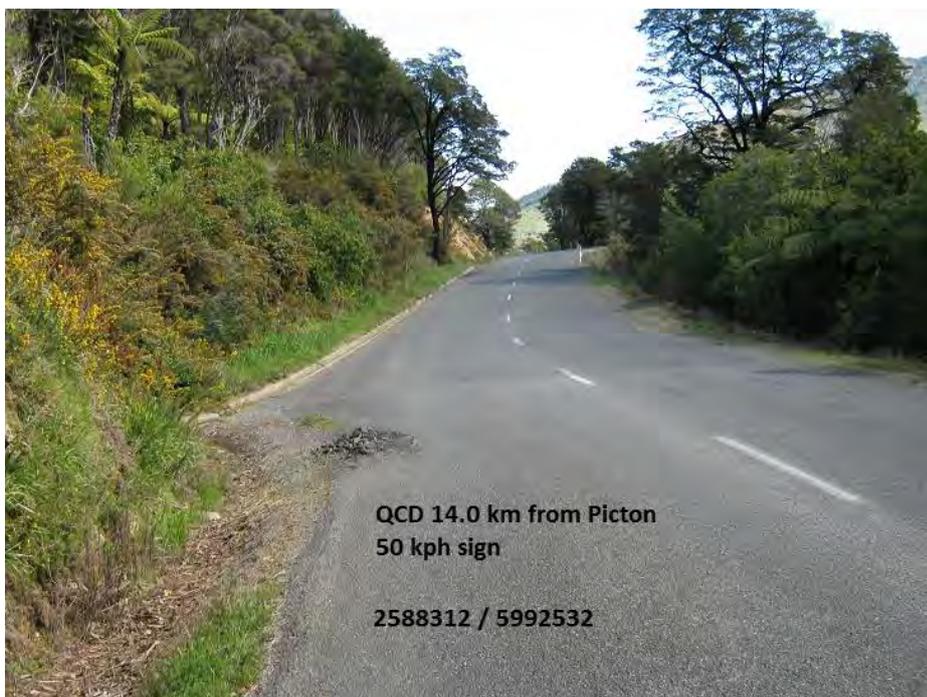
SITE 12  
2588312 / 5992532

Note the pavement has again been resurfaced over the area, indicating there has been a further event since 2004, and I noted the outer edge of the pavement appears to be slowly subsiding again.

I consider the damage is the result of a natural slip and that the road simply sits within that slip plane ( see sketches -2 pages )

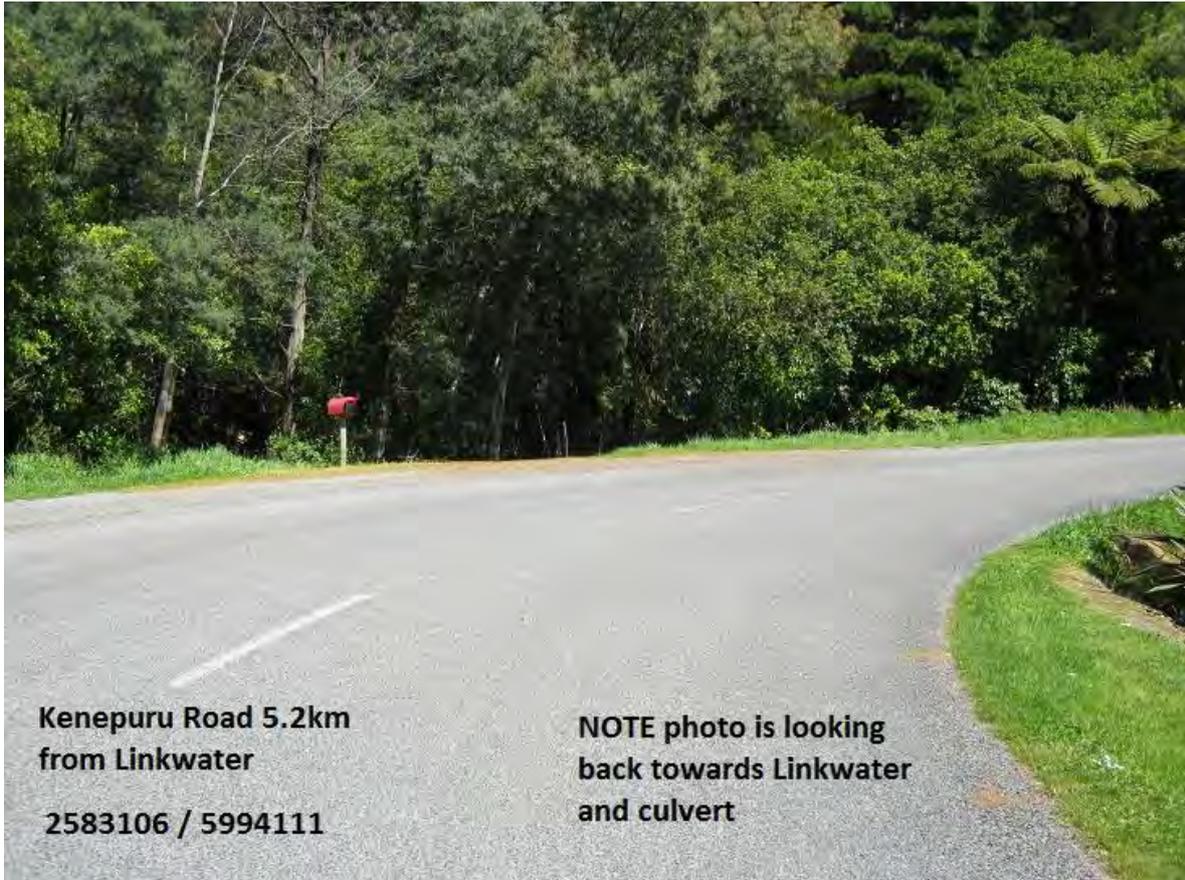
**Kenepuru Road 5.2km  
from Linkwater  
2583106 / 5994111**

This is one of the largest structures of its type in Marlborough being a pipe arch of near 9 m span and 5.2 m rise . It must have been an impressive sight when it was flowing to capacity as occurred during the event ( debris evidenced the height of the flood waters post event )

**NOTE photo is looking  
back towards Linkwater  
and culvert**

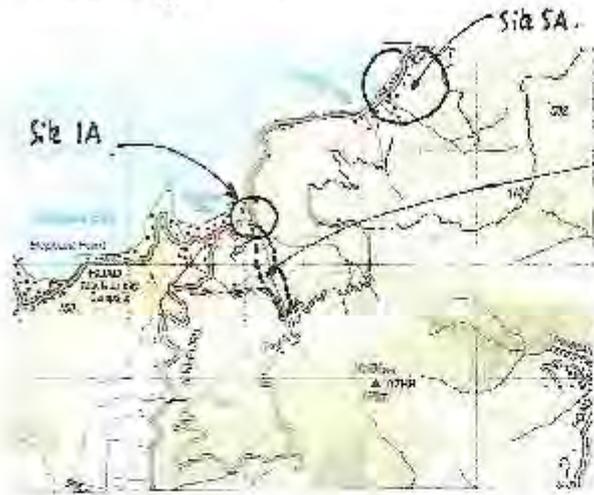
KENEPEHU ROAD - EASTERN SIDE  
 SITE 1A - 5.2 KM FROM LINKWATER  
 2583106 / 5994111

Following clearing  
 this whole section collapsed.  
 Watercourse was completely bare  
 and Arroso pipe arch  
 app. 9 x 5 m was completely full  
 (estimated velocity > 4 m sec!!)

There was > 2000 m<sup>3</sup> of slash and material went thru culvert.  
 (following event it was possible to drive a large 4wd vehicle from  
 coast right through culvert!)

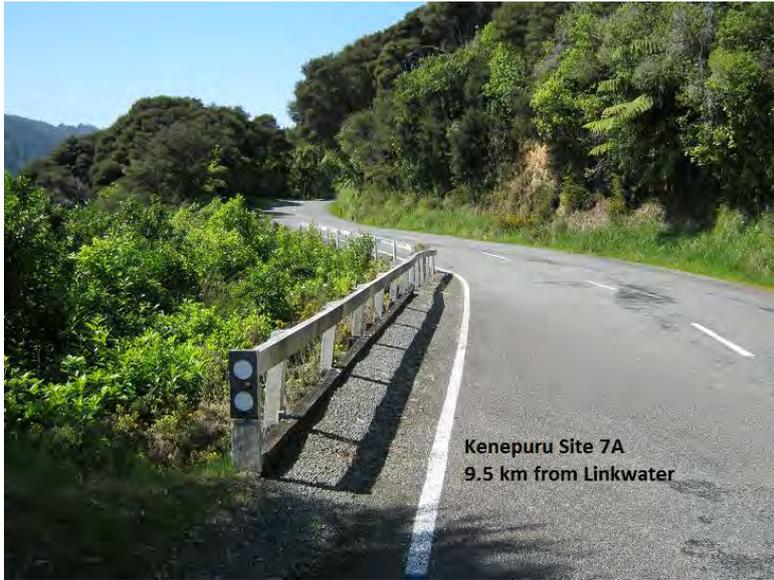
**Kenepuru Site 7A**  
**9.5 km from Linkwater**

I consider this site and the others referred to above would have been significantly contributed to by the original 'sidling' fills unbenched and uncompacted which simply collapsed when saturated.

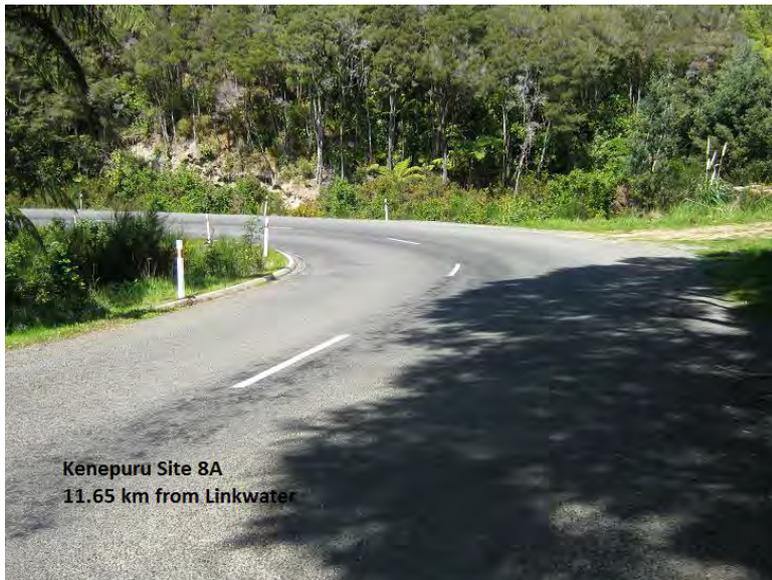
KENEPURU ROAD  
SITE 8 A

The event followed clearfelling of forestry above the road and the slips referred to above contributed to the damage caused.( probably the sole contributor to the event )

There was estimated to be in excess of 5000 m<sup>3</sup> of material which flowed down the watercourse to the sea. Large quantities of slash and other material was evident floating in the Sound for some time after the event.

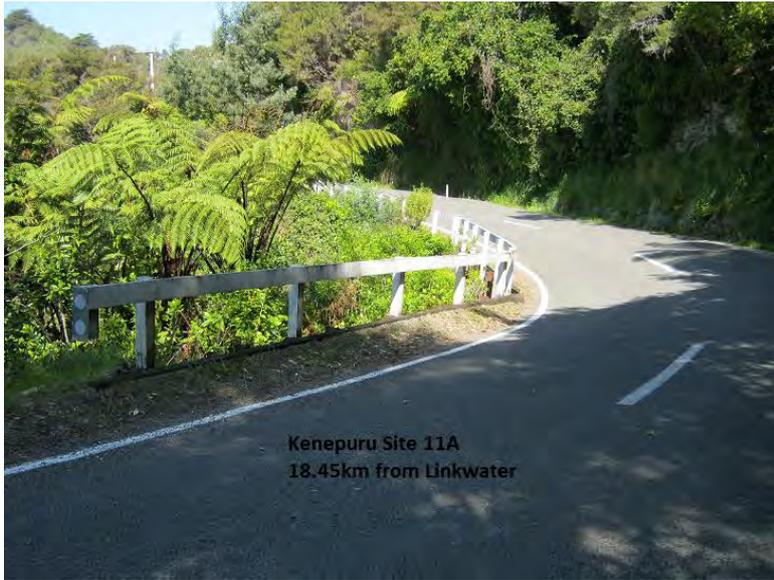
**Kenepuru Site 11A**  
**18.45km from Linkwater**

I believe the event was caused by instability of the formed road.

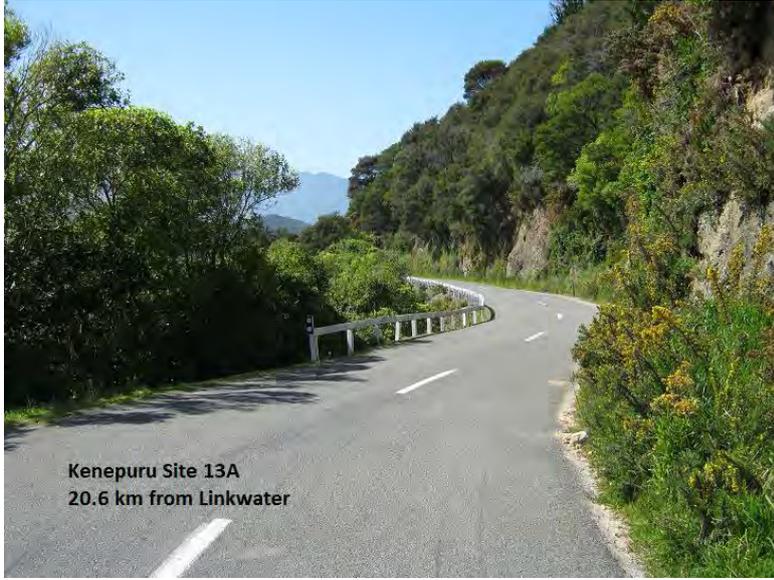
**Kenepuru Site 13A**  
**20.6 km from Linkwater**

It has obviously stayed in position and retained the road , however ,it has rotated since construction as evidenced by the rails which have been straightened and replaced several times. ( aesthetically it would have to be considered pretty poor )

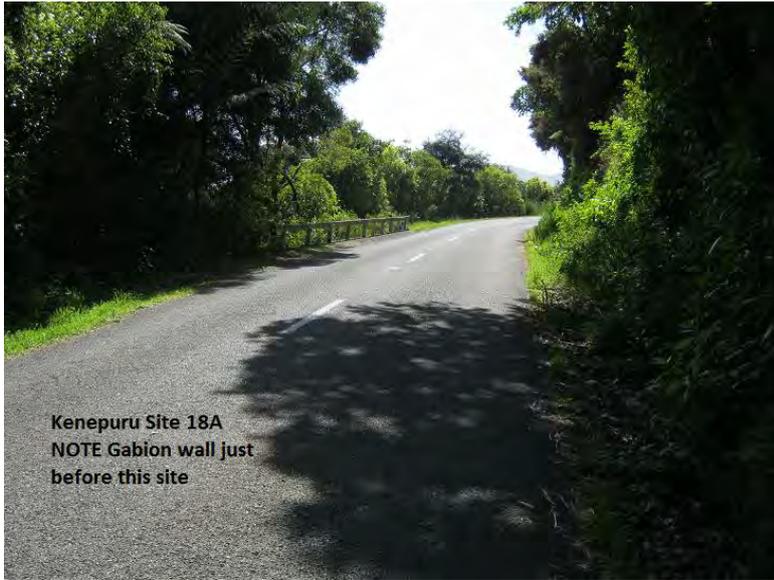
**Kenepuru Site 18A**  
**NOTE Gabion wall just**  
**before this site**

There are 2 areas here where the excavated banks above the road collapsed ( still visible in places ) collapsed onto and over the road and down to the creek and out to the sea.

I consider events 16A and 18A were the result of land disturbance as a result of road widening ; events 17A were natural erosion well away from the road proper.

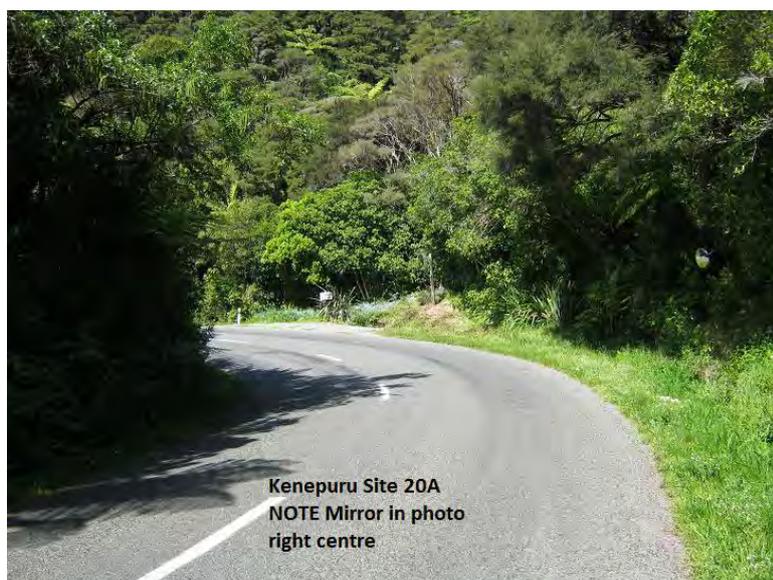
SITE 20A

The culvert was a large 'Armco' steel pile which was destroyed ; remnants of it are visible in the creek below . it was replaced with a 1.5m concrete pipe.

There was app. 2000 m3 of material to the sea / coast and I consider it was a natural erosion event ; the slips emanated well above and away from the road.

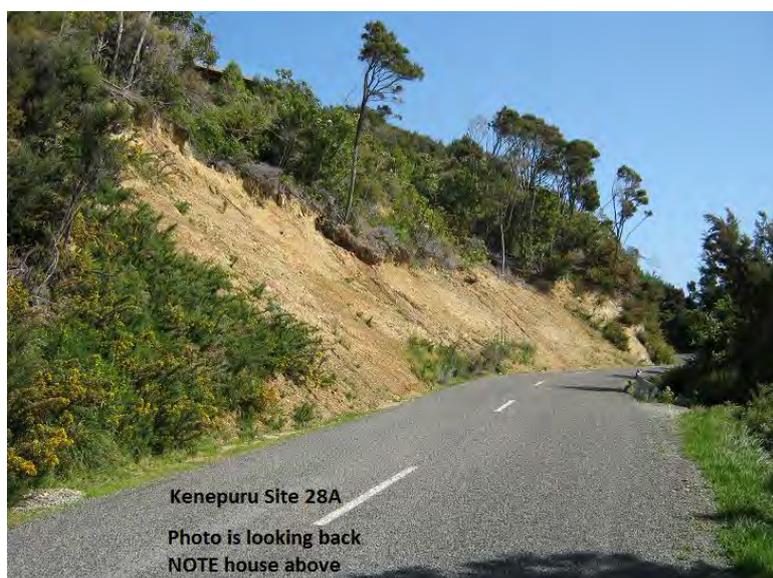
## Site 28A

**Date :** the 600 m<sup>3</sup> event was about 1996.

The photo is looking back

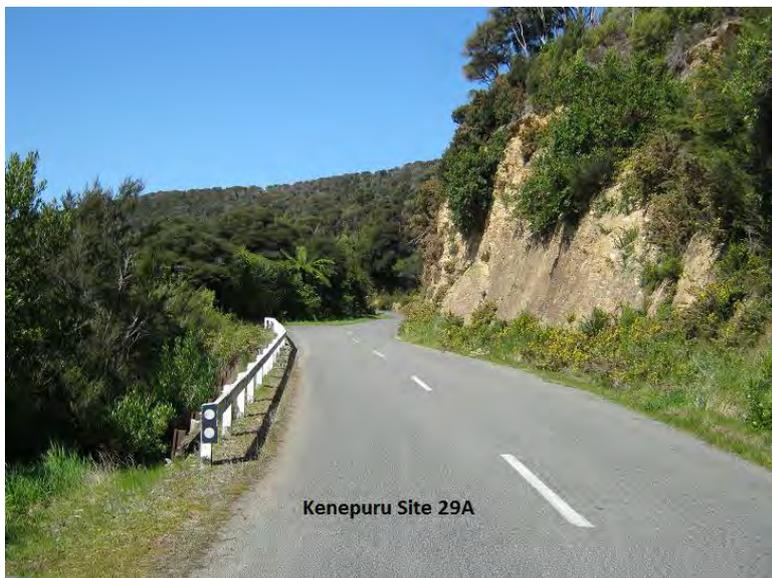
## Site 29A

Probably roading related.

**Date :** the event first occurred in app. 1992 ( there have been subsequent smaller falls at this site.).

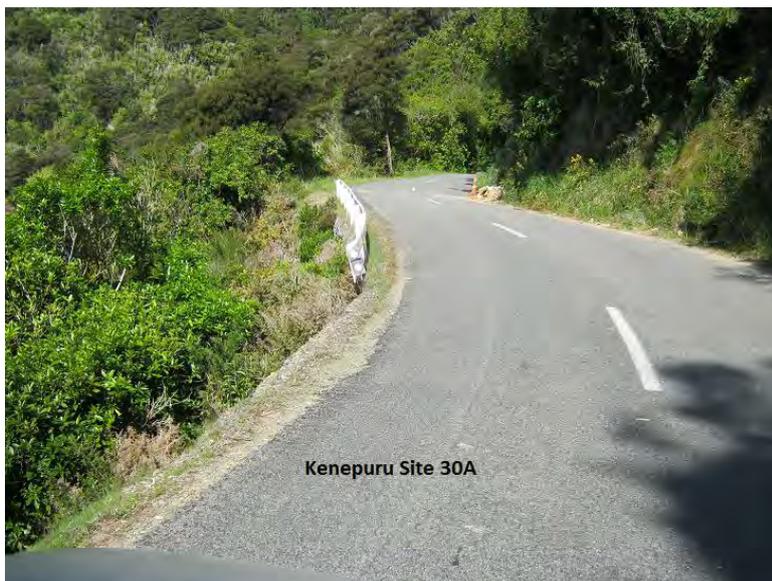
## **Site 30A**

Probably roading related.

**Date :** The event occurred app. 1996

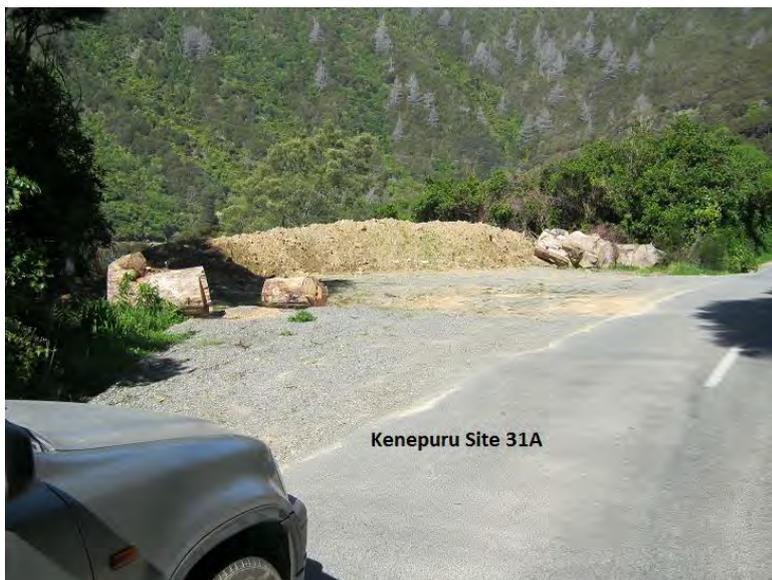
## Site 31 A

The site contains over 15,000 m<sup>3</sup> of spoil.

**Date :** work commenced in about 1996 and has continued to the present time.

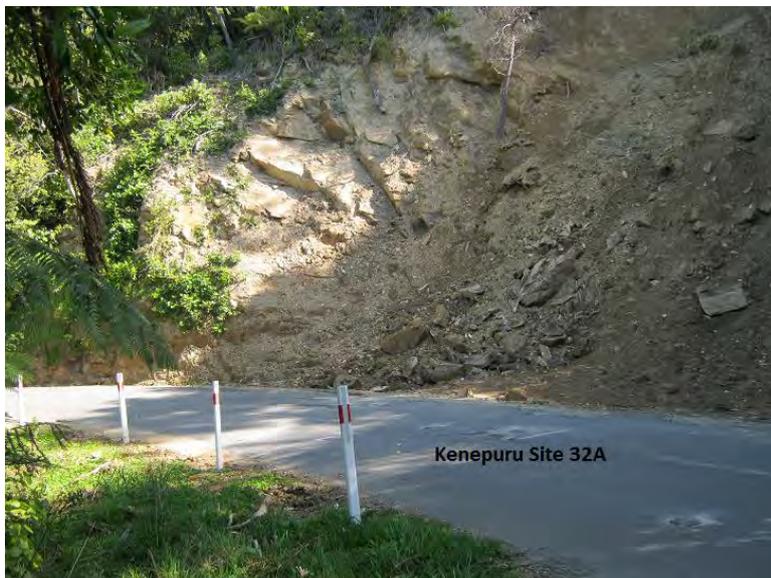
## Site 32 A

The cause is probably roading related.

**Date :** The event was app. 2004 till the present ?

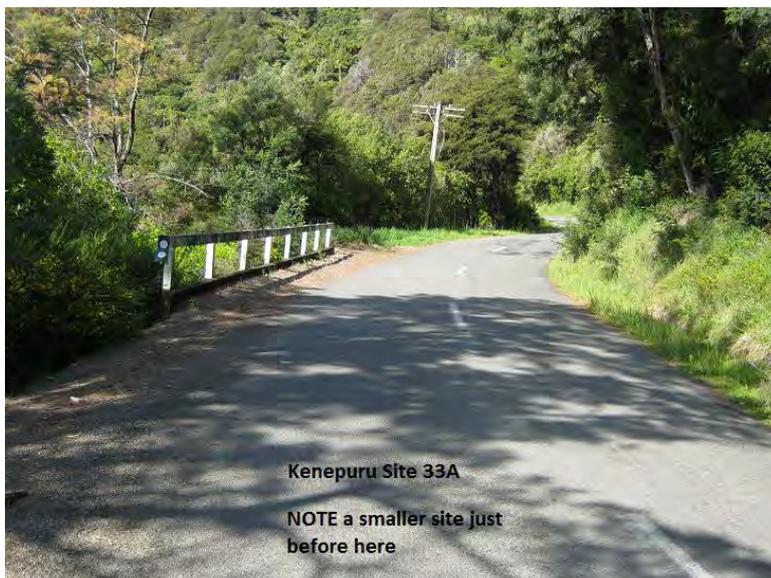
## Site 33A

Probably roading related.

**Date** : the event occurred app. 1998

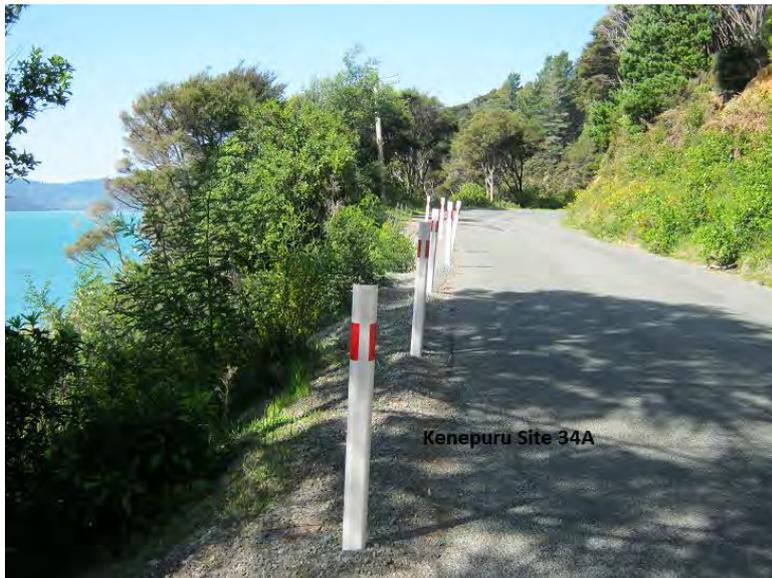
## Site 34A

The damage is apparent at this site.

I suspect some slip material from RHS may have been stacked here to dry and has contributed to the event.

**Date;** The event occurred app. 2002

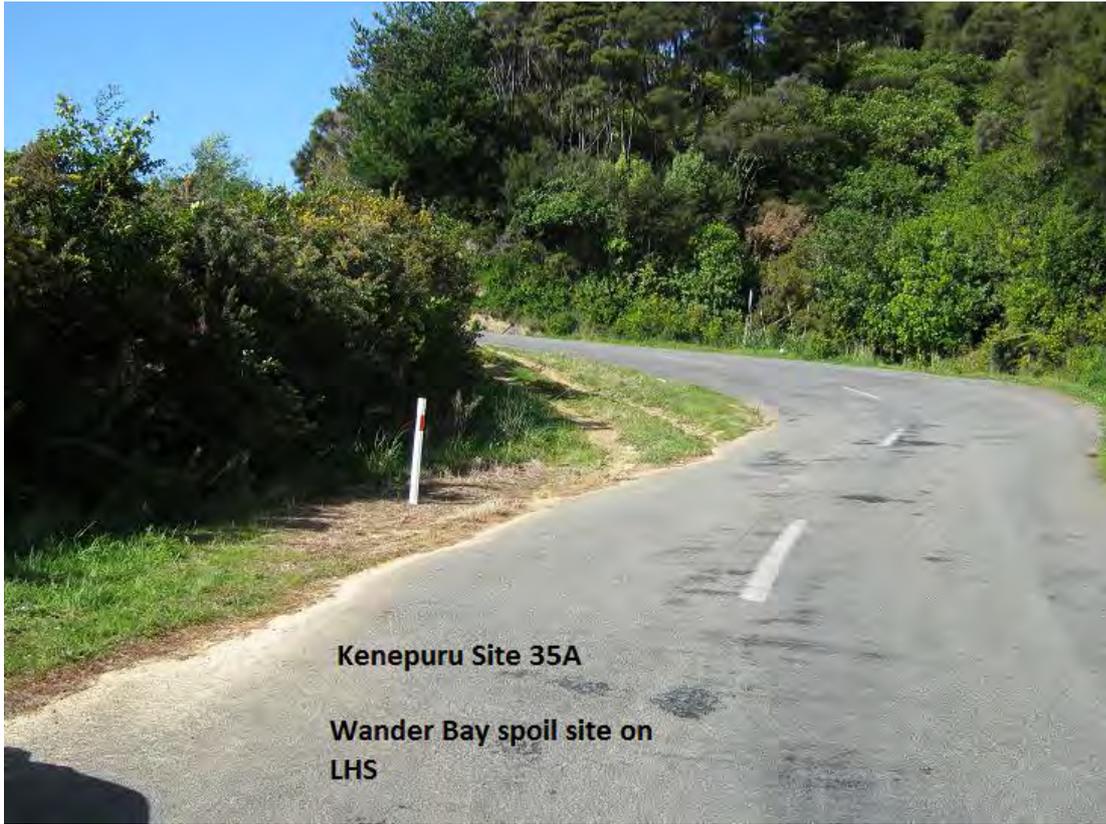
## **Site 35 A**

I recall the site holds over 24,000 m3 of material

**Date :** the spoil site started in about 2004.

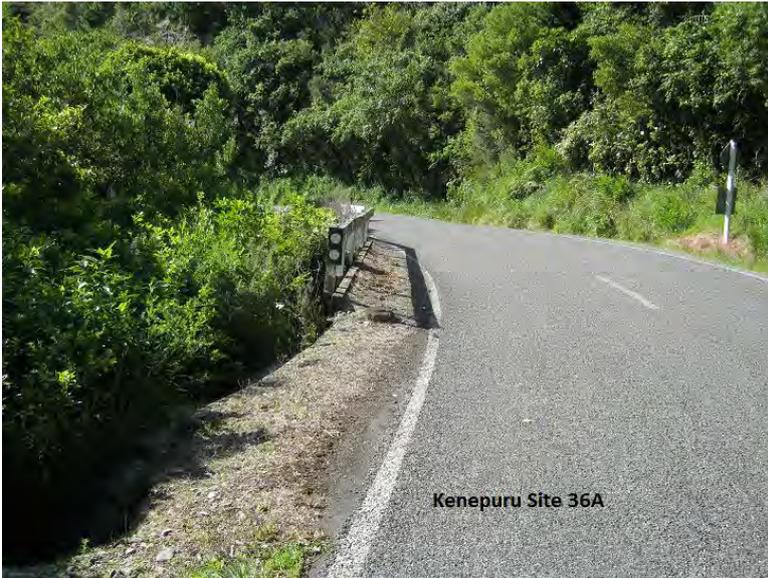
## **Site 36A**

**Date :** the event occurred in 1996 I consider it was a combination of road widening works and natural erosion that caused the event.

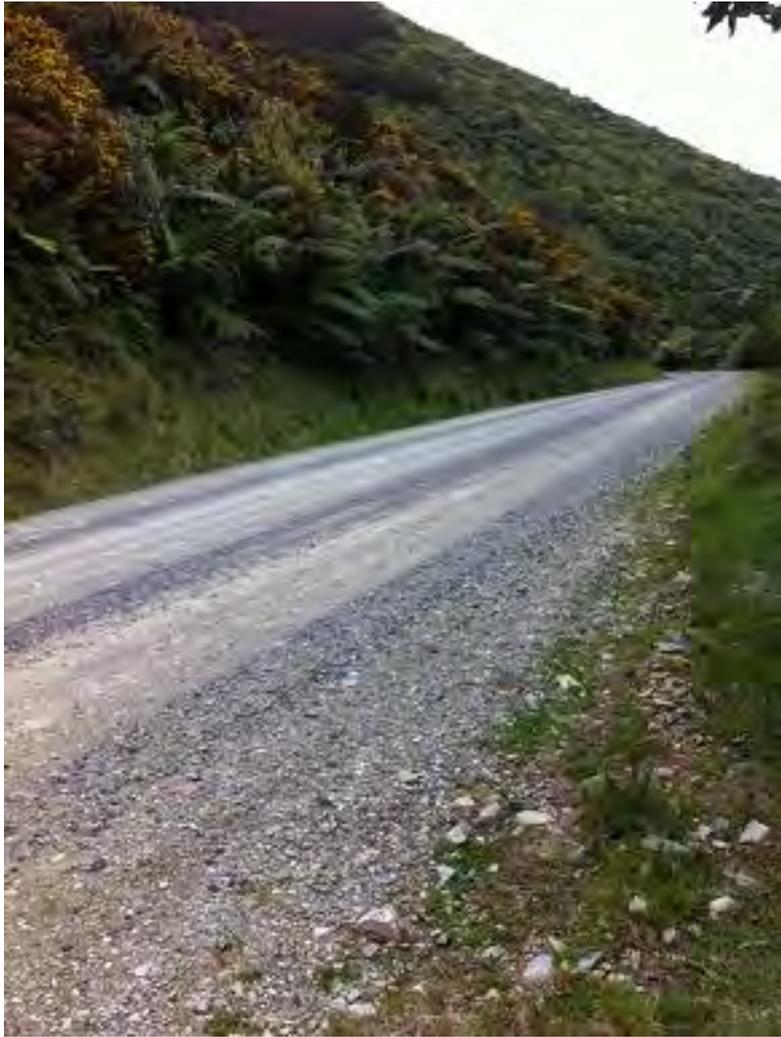
### **Site 3 B**

It is difficult to believe the scale and scope of this event with the growth of Gorse and Broom etc. covering virtually all evidence of the damage.

Photo is taken looking back towards the 'Heads' note the extensive Gorse etc. growth covering the slip face ( both sides of road )

Although not evidenced in the photo , this section is quite steep uphill from photo distance.

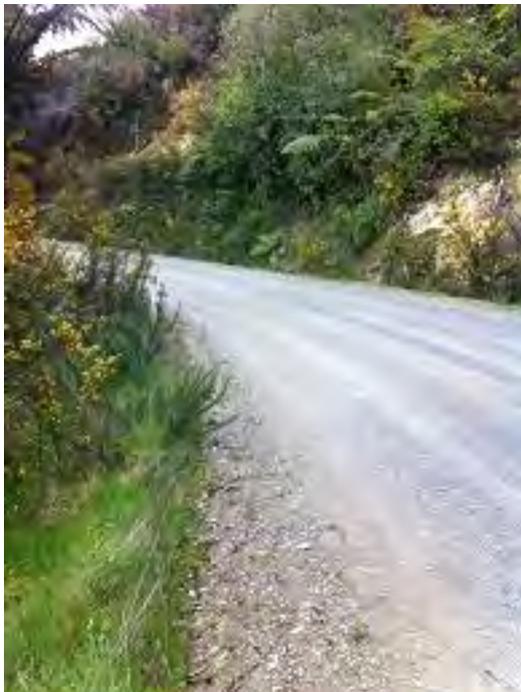
## Site 4 B

I consider it may have been precipitated by what was a new cut batter at the time which collapsed and the material 'pouring' over the road collapsed the outer edge which would have only been an old sidling fill.

Date : the event occurred about 1994.

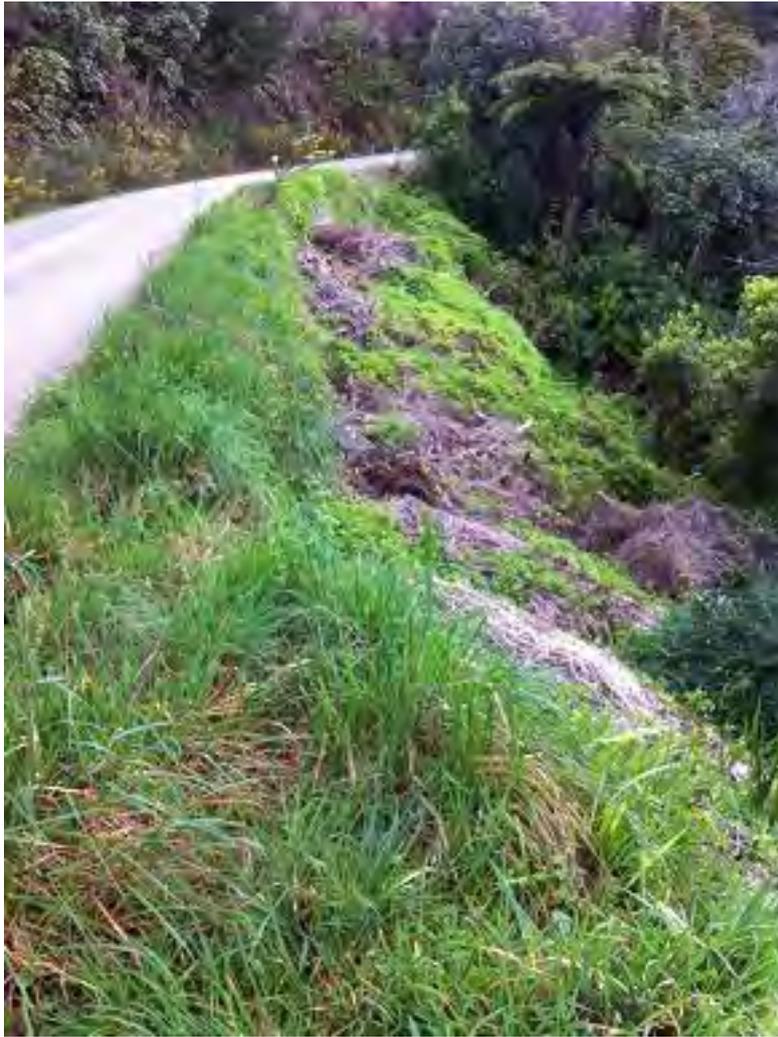
**Kenepuru site 5 B**

I consider this event was probably caused by the excavation above the road steepening the cut batter face.

The contractor that repaired this site was C.Pxxxxxxx.
