Technical Council on Lifeline Earthquake Engineering (TCLEE)
Report of the
4 September 2010 M_w 7.1 Canterbury (Darfield), New Zealand Earthquake
By: John Eidinger, Alex Tang, Thomas O'Rourke

Summary

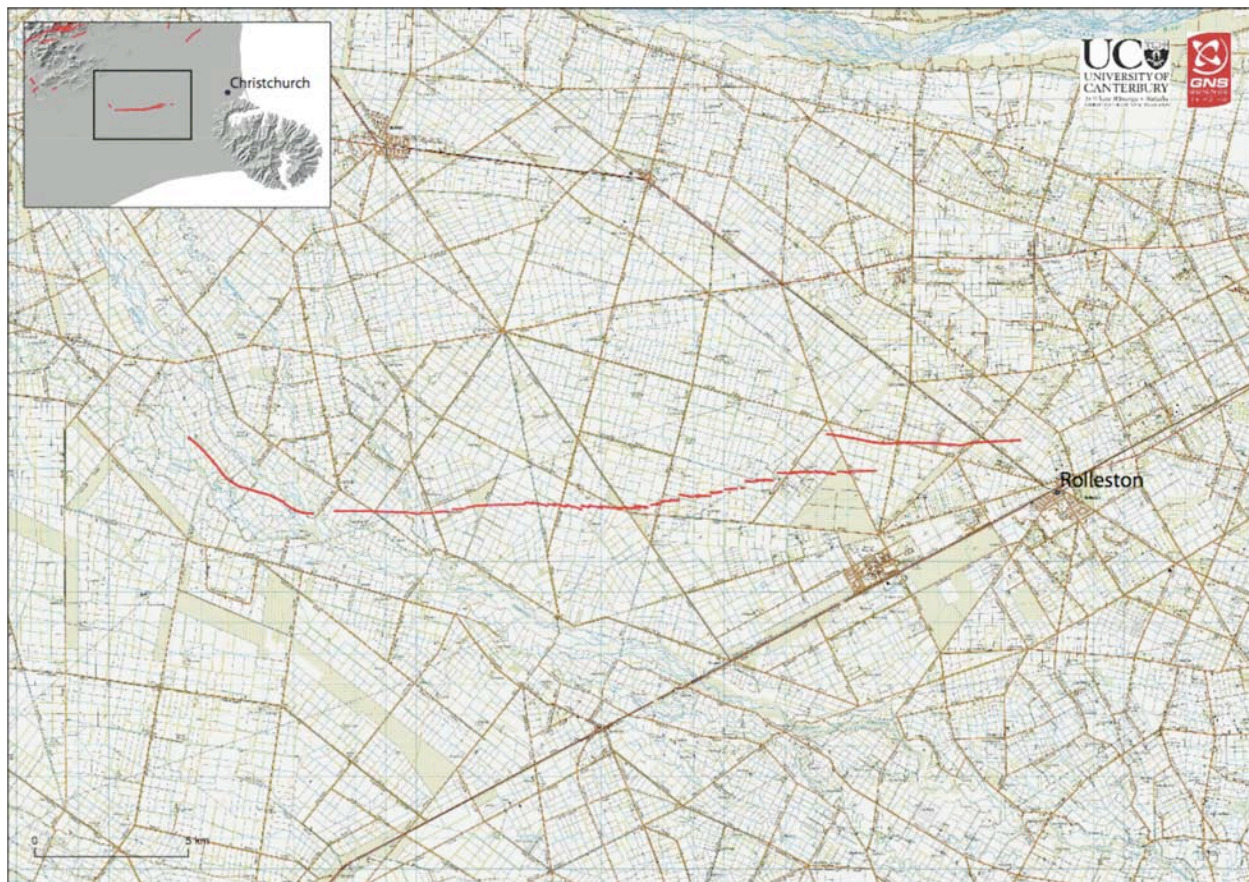
Figure 6. Fault Rupture Map

The earthquake occurred on a previously unknown fault, since named the Greendale fault. The surface rupture of the main shock occurred in an almost east-west direction, extending for about 29 km, see Figure 6. Surface offsets were largely right lateral in nature, ranging up to about 4 meters of right lateral offset near the center of the rupture zone, reducing to about 1 meter of right lateral offset near the tail edges at either end of the rupture zone. The dip of the broken fault over the top 10 km of the crust was nearly vertical. Common width of offset zone was about 10 meters, characterized by a series of en echelon cracks in the ground. In some places, there was

coincident uplift on the south side of the fault of about 1 meter, in other places some uplift was observed on the north side, and in many places there was no coincident uplift. Average right lateral offset over the entire fault length was about 2.3 meters.

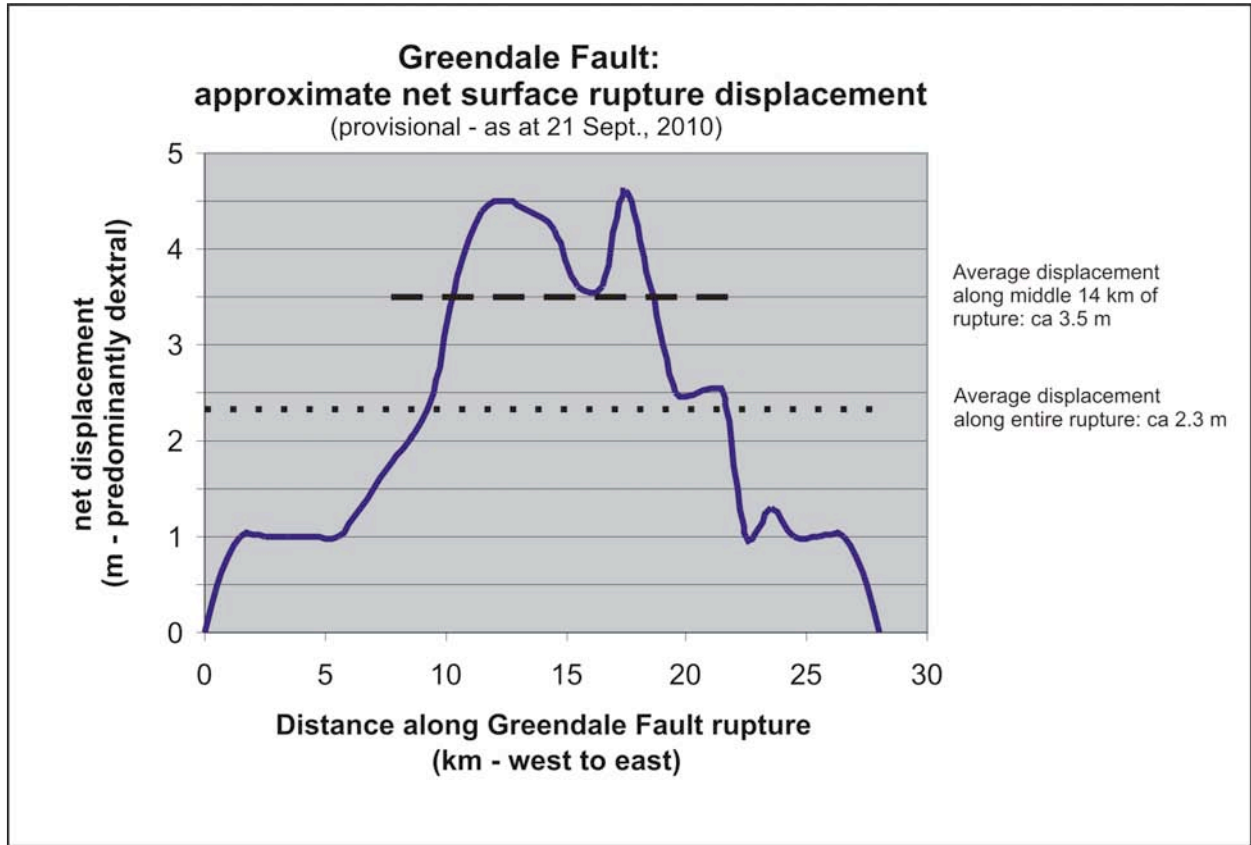
Figure 7. Measured Fault Offset

These offset amounts are the cumulative amounts as of about September 21, 2010 (Figure 7). Almost without doubt the original offset was lower than these values, and there was ongoing aftershock creep that was leading to increasing amounts of total offset; as evidenced by the need to reset train track rails over the fault, multiple times, in the weeks after the earthquake.

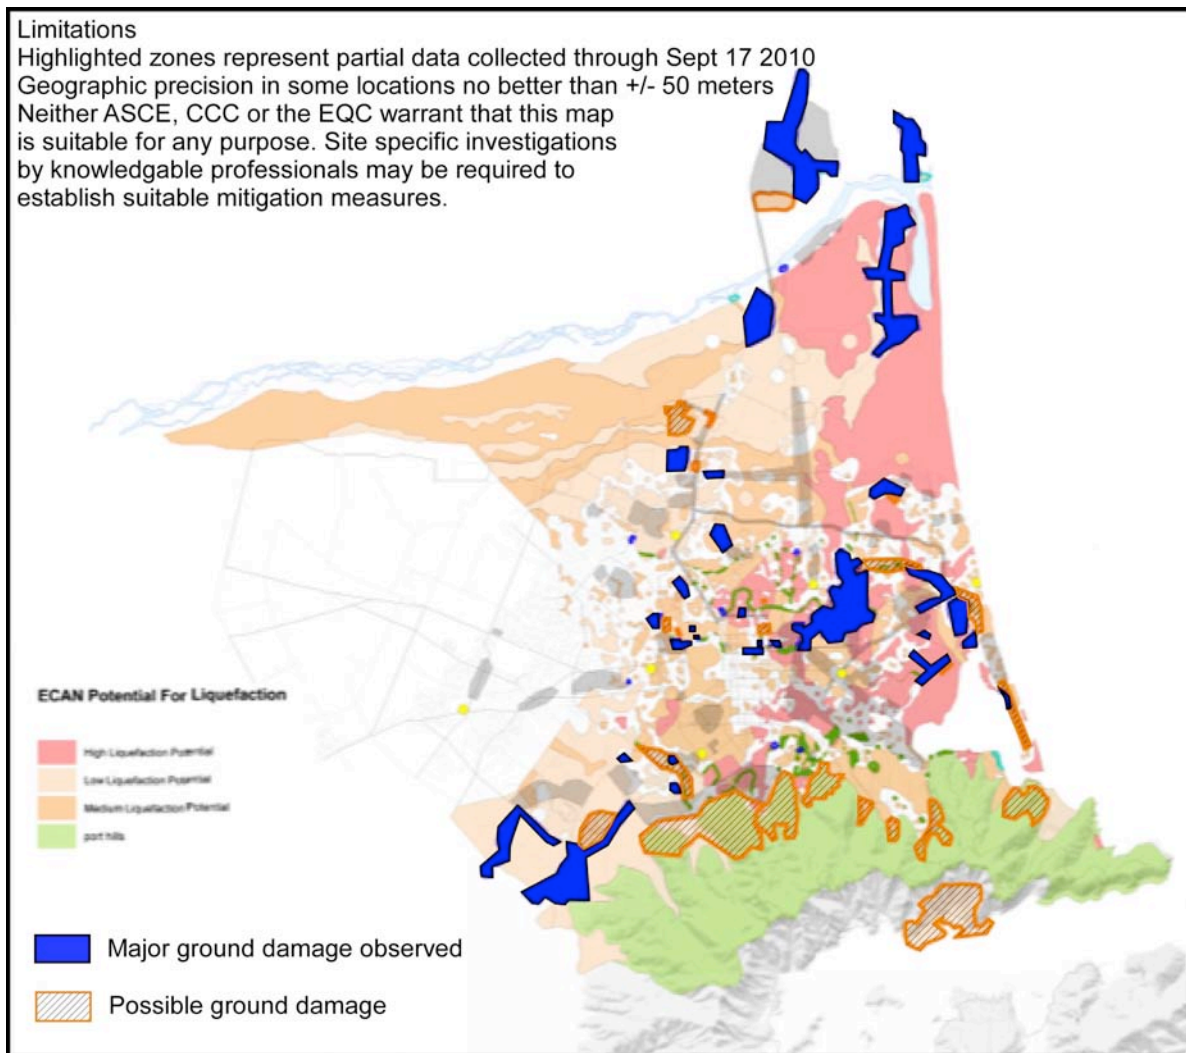
Figure 11. Map Showing Observed Liquefaction (Blue diagonal)

Of particular interest in Figures 3, 10 and 11 are that only a portion (about 5% to 10%) of the Christchurch and Springston Formations (Figure 3) or the "red" zones (Figure 10) actually did liquefy to the extent to produce observable major ground deformations. This may be in part due to the relatively short duration of strong ground shaking in this earthquake (perhaps 8 seconds or so) coupled with site specific geologic and ground water conditions. Other indications suggest that the zones that did have major ground deformations represent soils which have the highest liquefaction susceptibility; the remaining areas still remain a liquefaction threat in future larger or longer duration earthquakes (Misko Cubrinovski, personal communication, 2010). Maps prepared by the water and wastewater utilities showing actual locations of damaged buried pipes will likely be substantially more accurate indicators of permanent ground displacements, as the broken pipes act like "gages" to show locations of high ground strains.

It is evident from Figure 11 that the earthquake triggered widespread liquefaction in Christchurch and surrounding communities (blue zones). Sand boils were a common site. Many of these areas had been developed as single family residential communities, with the most common type of building being wood frame single-story atop concrete slab-on-grade. An estimated 2,900 structures in these blue zones were exposed to some type of settlements, and a portion of these were also exposed to lateral spreads. Estimated permanent ground settlements ranged from about 5 cm (2 inches) (perhaps a third of affected structures) to 10 cm (4 inches) (perhaps another third of affected structures). The remaining third of affected structures were exposed to a combination of settlements and lateral spreads; the spreads ranged from a few inches to as much as 1 meter (3 feet) or so.

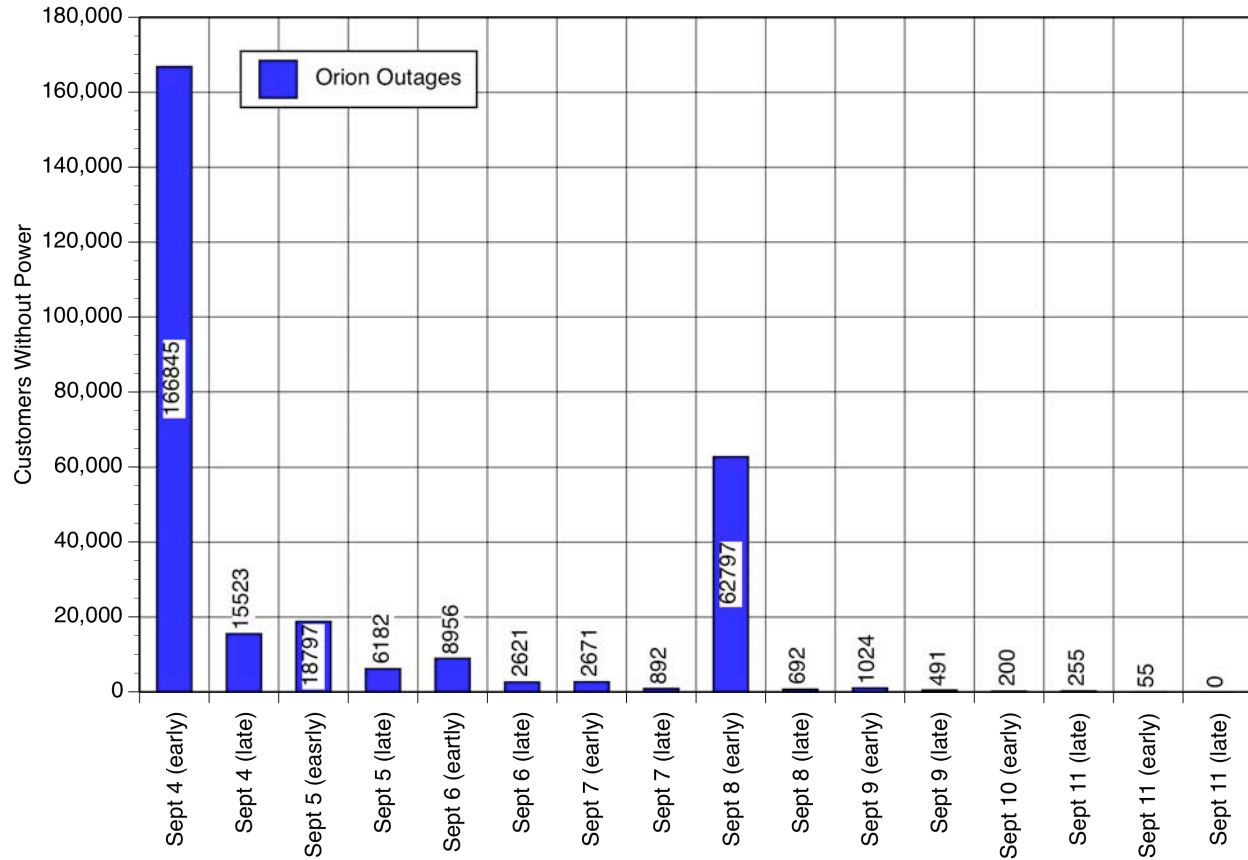
Figure 18. Customer Outages, Orion System

The earthquake caused loss of power to Orion from Transpower, as well as some damage within the Orion system. The combined effect was to cause a total of 90 million customer-minutes of outages. Orion has 198,000 customers; so this is the same as saying the "average" customer had about an 8 hour outage. In comparison, Orion customers have had long outages due to several events in the past 18 years: 1992 wind storm: ~36 million customer-minutes; 2006 winter storm: ~20 million customer-minutes. In some respects, the outages from this earthquake were similar to about 3 to 4 times worse than major winter storms. Figure 18 shows the customer outages at selected times; the Magnitude 5.1 aftershock of early September 8 resulted in the spike in

outages; these lasted a short time, and were largely a result of shaking-induced activation of safety devices on power transformers. The data in Figure 18 include an estimated 1,000 customers off due to faults in low level (400 volt) circuits (as of September 6), reducing by about 200 per day to zero by September 11.

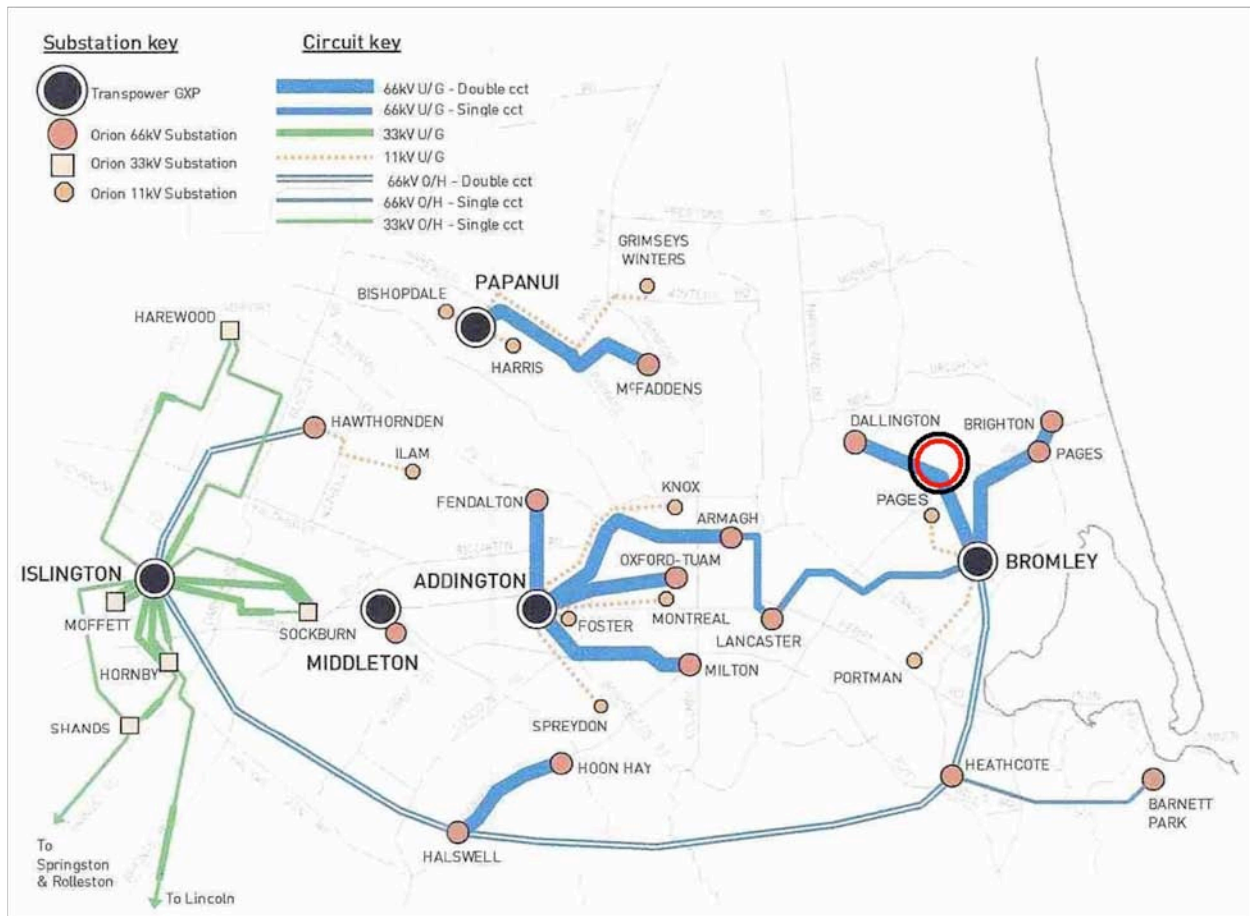
Figure 19. Orion System

Figure 19 shows the main transmission lines of the Orion system. The circled location on the Bromley-Dallington double circuit 66 kV line was damaged due to settlement and lateral spread.

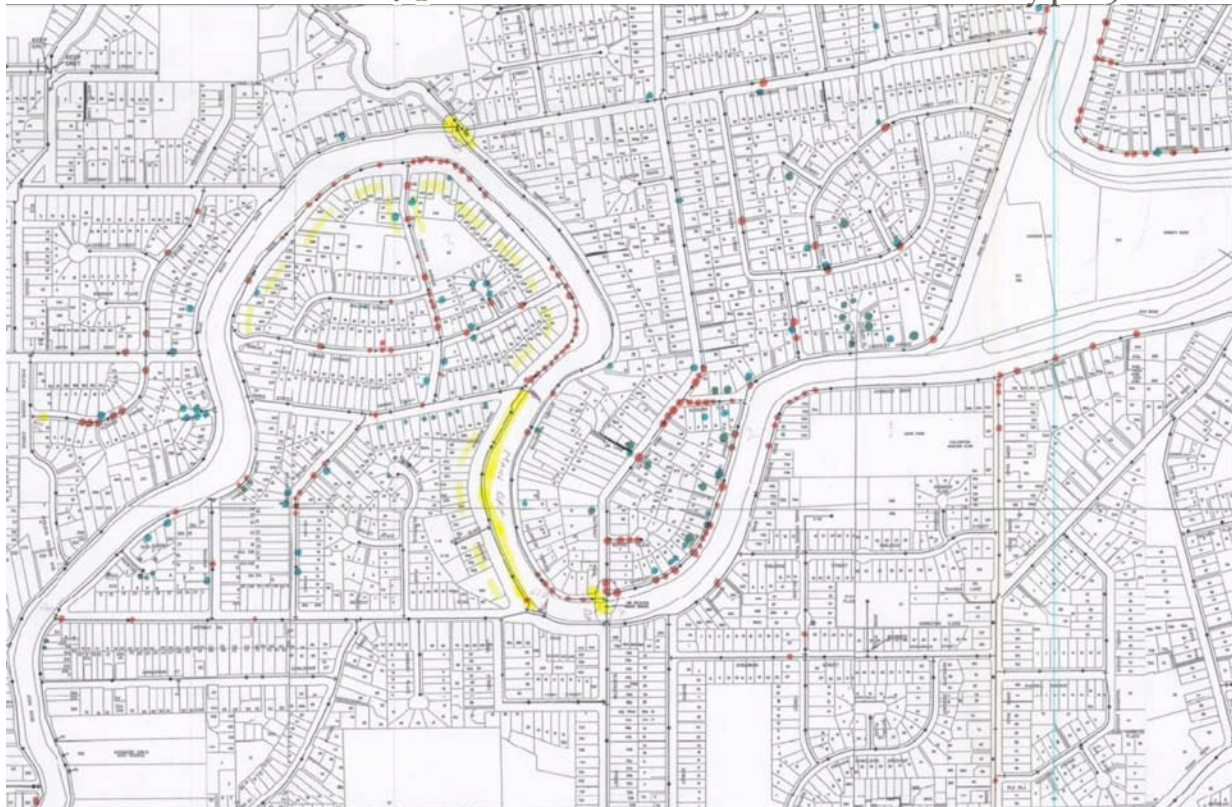
Figure 25. Map of Water Pipe Repairs, Christchurch City Council, as of September 15, 2010 (partial)

Due to widespread liquefaction, covering perhaps 5% to 10% of the urbanized area within the CCC system (Figure 10), there have been a great number of failures to buried water pipes.

AC pipe sustained massive damage where exposed to 2 to 4 inches of settlement or 12 to 40 inches of lateral spreads. In many such areas, the AC pipes will need to be replaced entirely. Where damage was more limited, pipes were repaired using external clamps; new sections of PVC pipe cut into damaged pipes, etc.

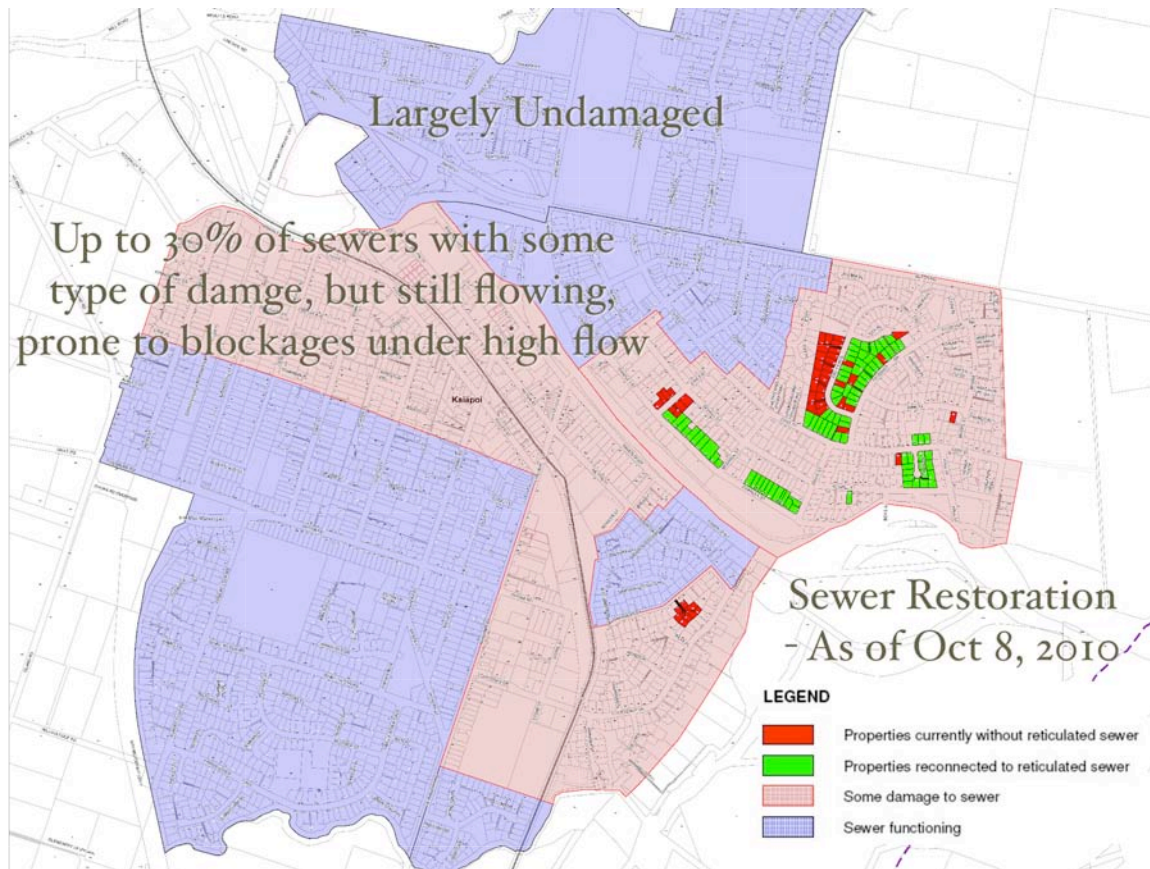
Figure 31. Map of Sewer Restoration, Kaiapoi, MDC, as of October 8, 2010

Damage to sanitary sewers (Figures 29, 30) in many places led to direct discharge of untreated sewage into local rivers, leading to contamination warnings. Damage to the sewers has also resulted in substantial inflows of silts, leading to clogging of sewers, as well as infiltration of water. Figure 31 shows a map for Kaiapoi highlighting where the wastewater collection had failed and portable toilets were still in use 6 weeks after the earthquake; more than 200 structures were also so-affected in Christchurch.

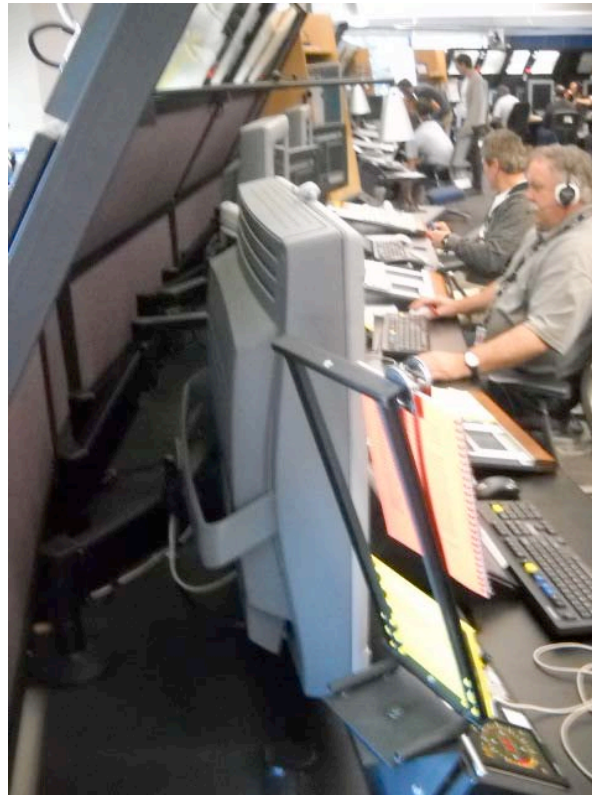
Figure 34. Air Traffic Control (photo J. MacKenzie)

nearby air traffic control facility sustained limited structural damage, but with no material non-structural damage (Figure 34), and it was in service shortly after the earthquake.

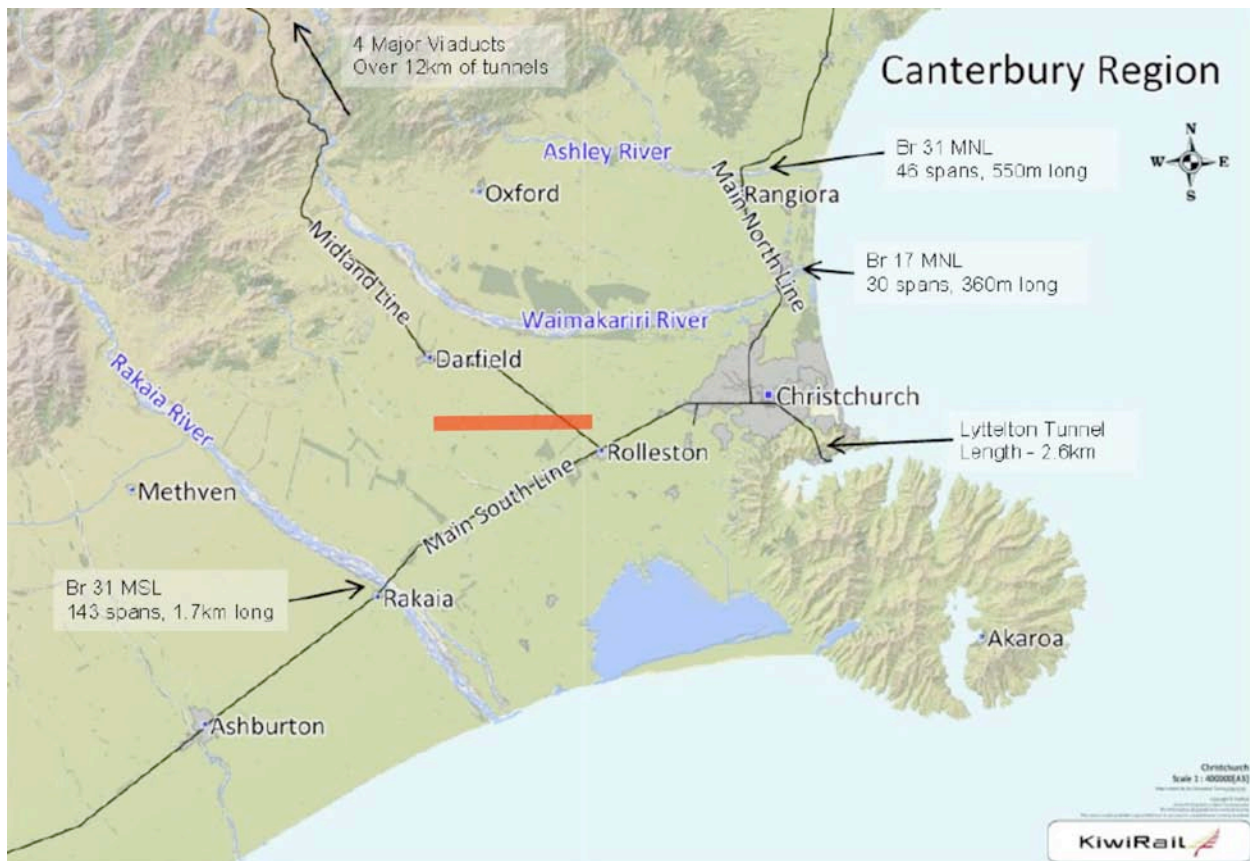
Figure 40. Rail System in the Canterbury Region

The main rail traffic in the Canterbury region is transport of coal from the western side of the South Island to the Port of Lyttelton, via the Midland Line, see Figure 40. Figure 41 shows the buckled rails where the right lateral fault (red line in Figure 40) crossed the Midland Line. This track was repaired within 5 hours after the earthquake. Ongoing fault creep required the track to be repaired a few times in the days and weeks following the earthquake.

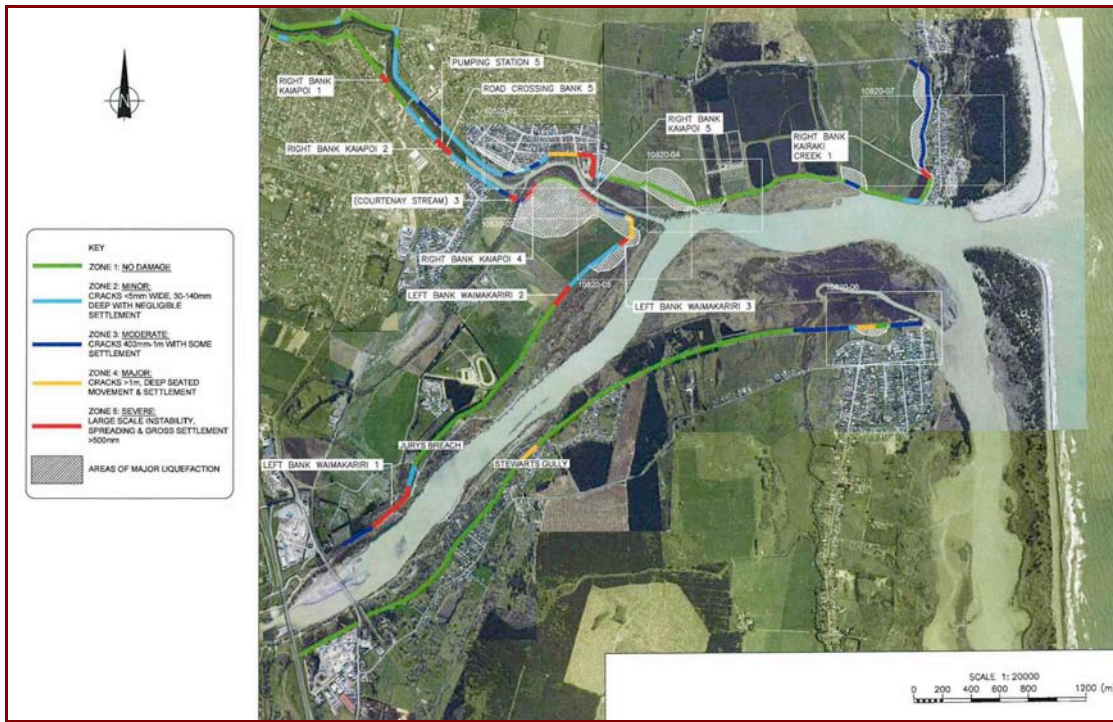
Figure 43. Stopbank damage surveyed by Riley Consultants

The stopbanks impacted by the earthquake are in the area close to river mouth of Waimakariri River and the junctions of Kaiapoi River and Kairaki River, Figure 43. About 5 km of levees

suffered severe to major damage. Severe damage included cracks greater than 1 m in width, with deep seated movement and settlement. Major damage included large scale instability, with lateral spreading and settlement exceeding 0.5m.

As the rainy season will soon arrive, the focus to keep water from flooding the urbanized areas is high. Priority and repair strategy were set to minimize the impact of loss due to flooding.
