**MARLBOROUGH
DISTRICT COUNCIL**

Water Quality in the Are Are Creek Catchment

**Technical Report No: 15-004
May 2015**

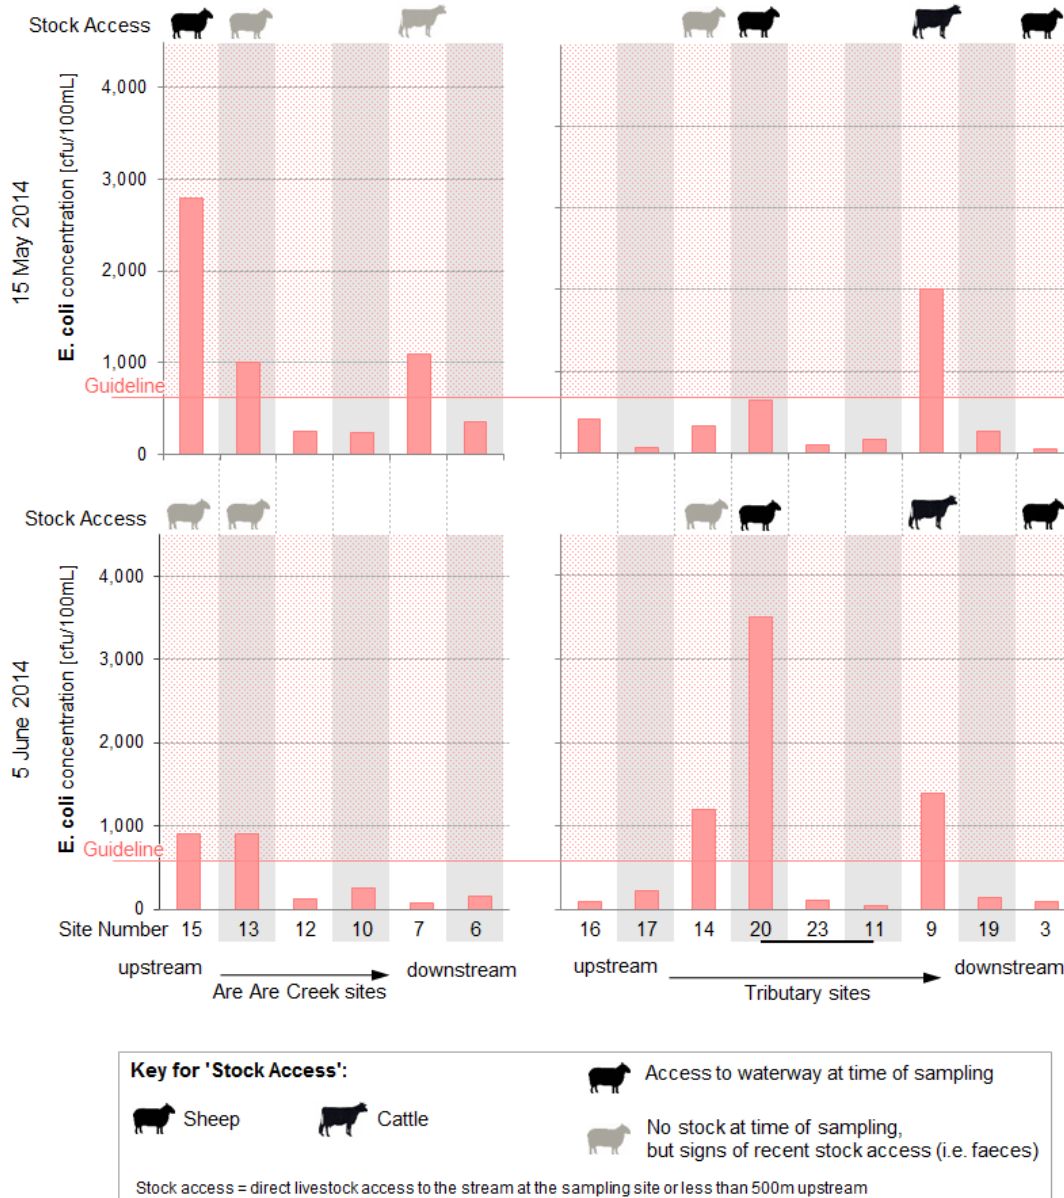
Upstream of the Site 5 tributary elevated E. coli concentrations were mostly the result of livestock with direct access to the waterways, either at the sampling site or in reaches upstream. There are several factors influencing the impact stock access has on the water quality of the stream. These include the type of livestock; the stock density and the amount of time stock have been on a particular paddock. For example when a comparatively large number of sheep is confined to a relatively small paddock, the impact on water quality can be substantial, particularly for smaller waterways. An example is Site 15, when sampled on the 15 May 2014 (Figure 17). High E. coli concentrations at Site 20 on the 5 June 2014, on the other hand, are a result of a prolonged period of grazing by a similar number of sheep on a larger paddock. The number of sheep with access to the waterway upstream of Site 3 was very small (10 sheep) resulting in negligible impacts on water quality.

Figure 17: E. coli concentrations and direct livestock access to the waterways at sites sampled on two sampling occasions.

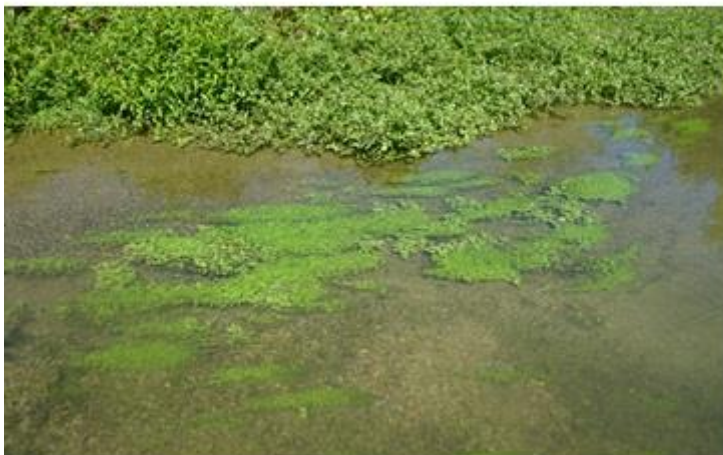
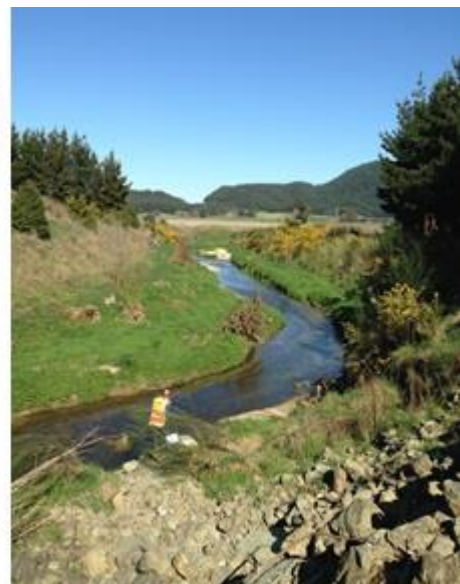
The land use surrounding the site was predominantly plantation pine forest, with no stock access or evidence of previous stock access on any of the sampling occasions. The riparian zone comprised long grasses, with some patches of bare earth. The bed was completely covered with periphyton in November 2013 (70% algal mats; 30% filamentous algae), with cover ranging from 40 to 85% on the five subsequent sampling occasions. Macrophytes covered around 20% of the bed in March 2014 (see photograph below). Coverage by fine sediment ranged from 10 to 40%, and the water was observed to be slightly turbid on three of the six sampling occasions, in one instance due to eel activity upstream!

Figure 25: Site 4 on 6 March 2014 (left) and looking upstream on 8 September 2014 (right).

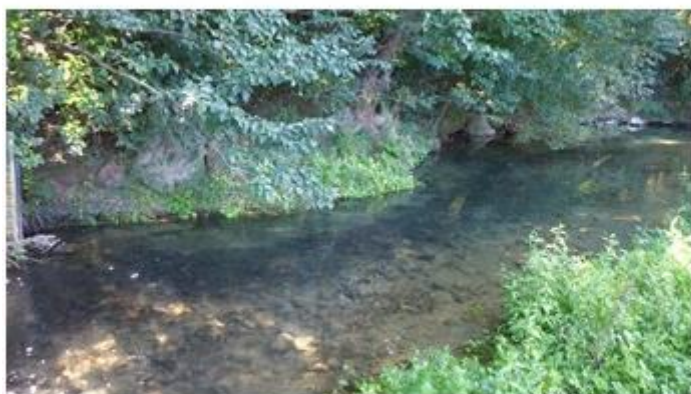
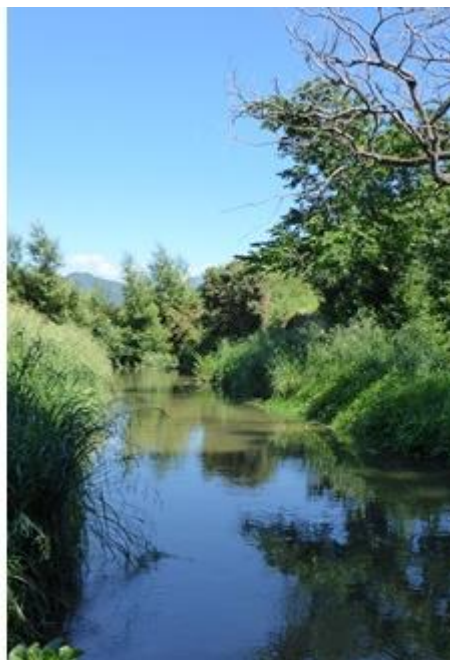
Adjacent land use was vineyards, with the riparian zones comprising long grasses, shrubs and tall trees (3 m wide) on the true left bank, and long grasses, shrubs and small trees (3 - 5 m wide) on the true right bank. No stock access to the site was observed. A high proportion of the bed was covered with periphyton on all six occasions (80% to 100% cover; most commonly filamentous algae, but also brown algal mats). Around 5% of the bed was covered with aquatic plants in November 2013 and March 2014. 10% to 20% of the bed was estimated to be covered with fine sediments on all six occasions, however, a more extensive thin layer of fine sediment was observed to cover all or most of the bed in November and June and was incorporated into the periphyton.

Figure 26: Site 2 on 6 March 2014 and looking upstream on 21 November 2013.

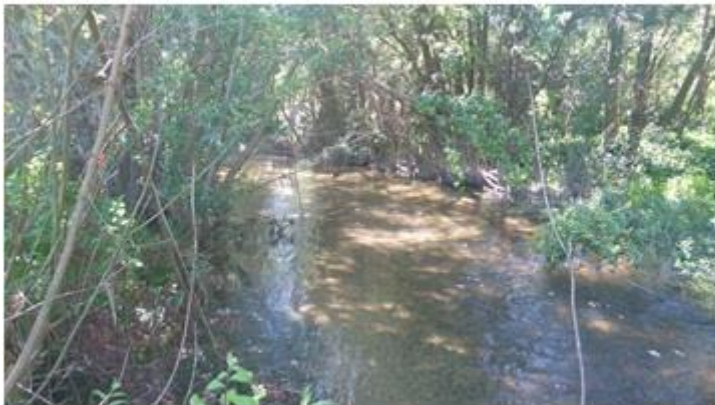
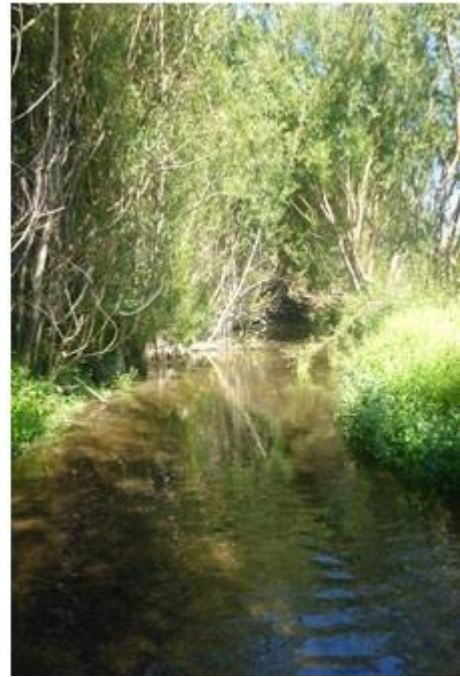
The land use adjacent to Site 1 was vineyards (with sheep-grazing at times) and reserve land. The riparian zone comprised tall trees on both banks, with some long grasses also present. Stock access (sheep) was observed in May, June and September 2014, and evidence of recent stock access was found in July 2014. No stock access was observed during the November 2013 or March 2014 sampling occasions. Periphyton was estimated to cover between 60% and 90% of the bed on all six occasions, with the dominant kind of algae varying between thin algal mats and short brown filamentous algae. A small amount of the bed (2%) was covered by cyanobacteria mats in September 2014. Aquatic plants covered a small proportion of the bed (5%) in November 2013 and March 2014. Fine sediment was observed to cover between 5% and 30% of the bed on all six occasions.

Figure 27: Site 1 on 21 November 2013 and 6 March 2014.

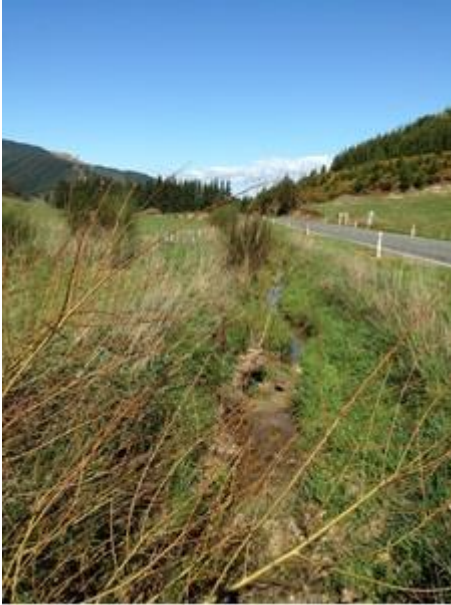
Flows through roadside reserve / residential land (beside old Okaramio Tavern), with long grasses growing in the riparian zones of both banks. No stock access was observed. The bed was commonly observed to have 5 – 10% coverage by fine sediments, and coverage by periphyton (mainly algal mats) on the five occasions varied between 20% and 80%.

Figure 29: Site 17, looking downstream on 8 September 2014.

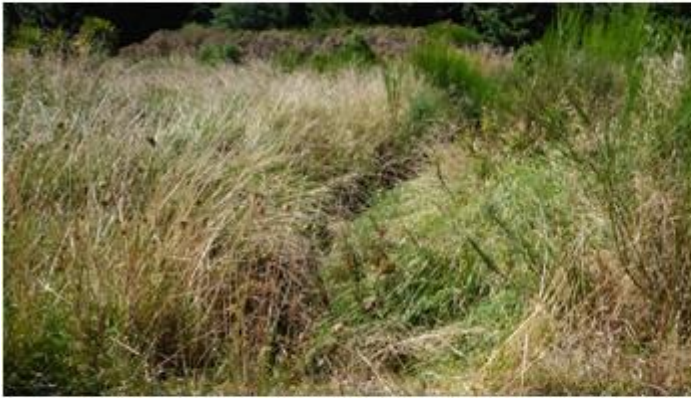
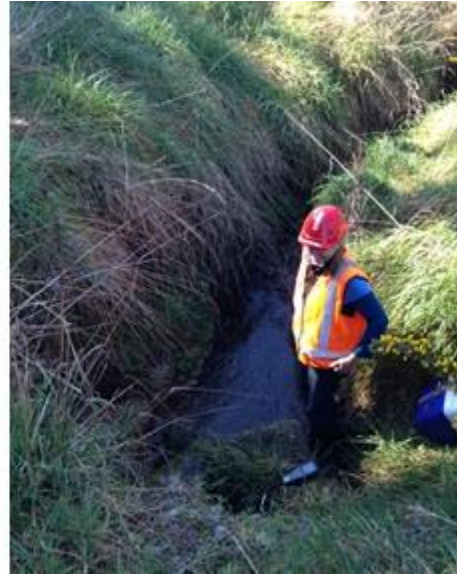
The land adjacent to, and just upstream of this site is pasture and plantation pine forest. The riparian zones on both banks are predominantly covered with long grasses, with some trees also present on the true left bank. The grasses obscured the channel in March and May (see photograph below), but the channel was noted to be more open in July and September as the grasses had been flattened. Stock access was not observed on any of the sampling occasions. At times, the bed had a high proportion of fine sediment (May: 50% cover; July: 50% cover; September: 80% cover). Emergent macrophytes covered almost all (95%) of the bed in March. Some periphyton cover was observed in June (30% thin mats), July (30% thin mats) and September (20% filamentous algae).

Figure 36: Site 19, looking upstream on 6 March 2014 and downstream of the road culvert on 8 September 2014.

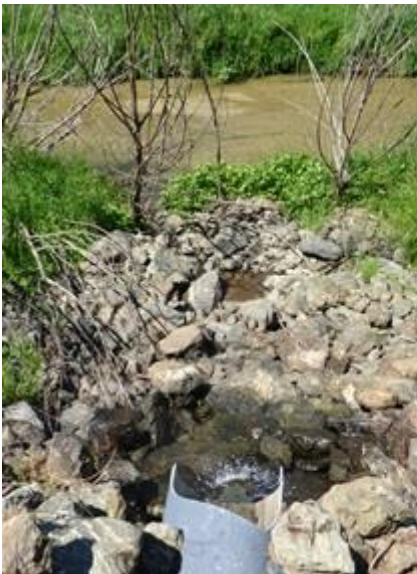
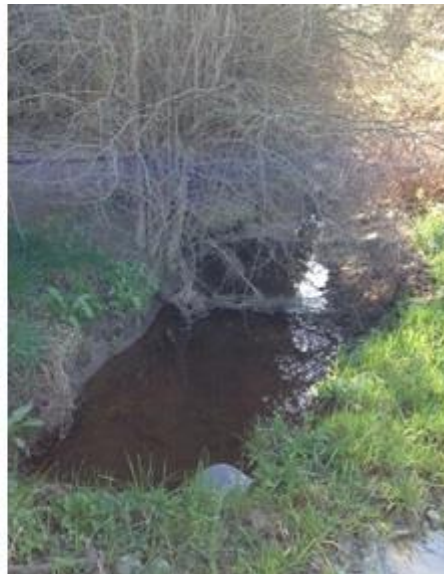
Site 3

This tributary flows through plantation pine forest, and both riparian zones are planted with tall trees (mainly pine). At its lower end, it flows into Are Are Creek through a culvert which directs the water down a rocky bank (see photograph below). Stock access was observed on four of the five sampling occasions, with around 10 sheep on the land upstream of the culvert. The bed was covered with fine sediment, and abundant leaf litter was also observed, probably due, at least in part, to the pool that had formed upstream of the culvert. The water was observed to be a yellowish or tannin brown colour on several occasions.

Figure 37: Site 3, looking downstream at the confluence with Are Are Creek on 8 September 2014 (left) and looking upstream of the culvert (right) on 21 November 2013.
