**MARLBOROUGH
DISTRICT COUNCIL**

Dairyshed Effluent and Stream Crossing Survey 2016/2017

**Technical Report No: 17-004
July 2017**

MDC Report No. 17-004

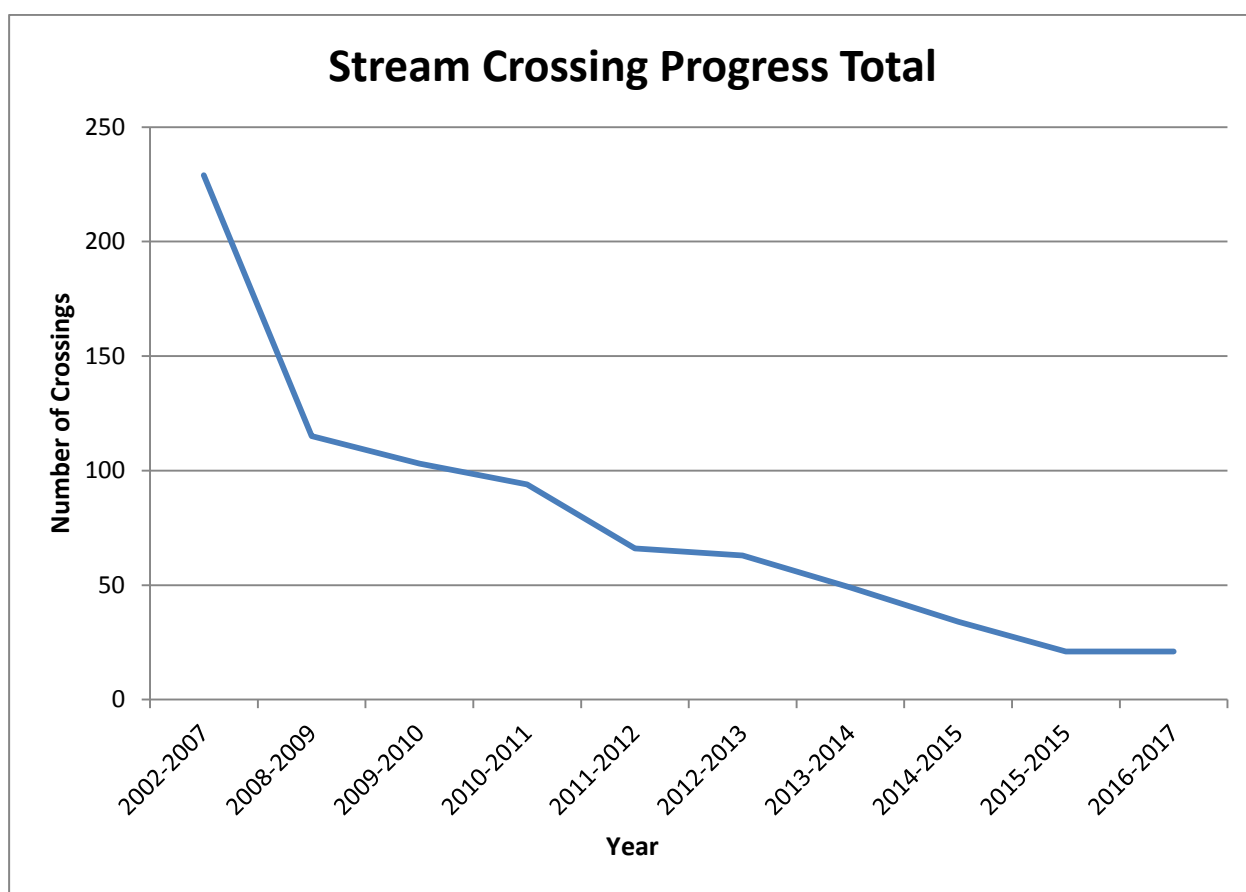
Unfortunately there has been no improvement in eliminating the remaining stream crossings since last season. The remaining 21 stream crossings are on eight farms (one of which has 10 crossings not eliminated), all remaining stream crossings were initially rated low-priority. The remaining stream crossings have been highlighted to the farmers concerned and plans for elimination have been put in place to be followed up.

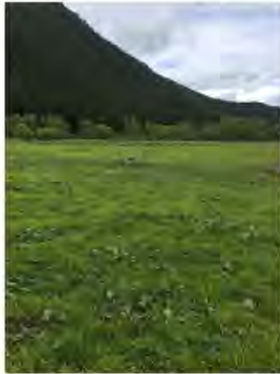
Farm Name:	I C Cows
Inspection Date:	7 October 2016
Herd #:	310
Disposal area:	11
Method of irrigation:	Travelling Irrigator

The property has a disposal area of 11 ha this is less than the recommended minimum size for the herd size on this property. There were no signs of overloading at the time of the inspection however the application area should be increased to at least 5 ha per 100 cows. Use of a nutrient plan would also assist with demonstrating compliance with this rule.

The sump was 1/2 full no issues noted with storage of effluent. Pond available as a back up contingency.

Effluent storage was well maintained. Effluent discharge to land had occurred morning of inspection. No issues noted, effluent discharge being managed well following wet conditions.
