**Phase I: Reconnaissance report on landslides  
caused by the 16–18 July 2021 rainstorm in the  
Marlborough region**

**GNS Science Report 2022/08  
March 2022**

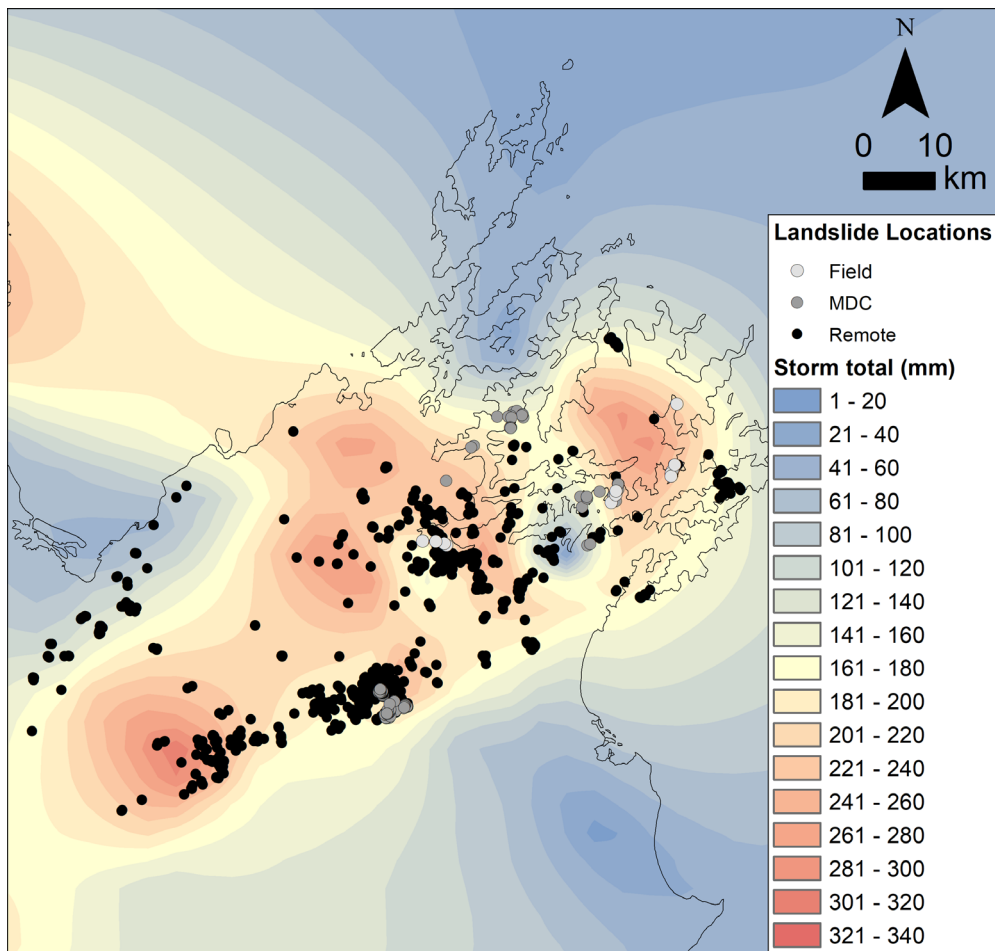
Landslides triggered by the July heavy rain were widespread in the eastern Marlborough Sounds, from Okiwi Bay to Tory Channel; however, the highest concentrations of landslides were observed along the north bank of the Wairau River between Bartletts Creek and Kaituna (including Onamalutu) and at the head of Pelorus Sound, near Havelock. Landslides were also common on Arapaoa Island (see Appendix 1).

Landslides occurred on slopes with land cover of exotic forestry, indigenous forest, scrub and regenerating indigenous forest and pasture; however, preliminary observations suggest that the majority of landslides (~60%) were triggered in exotic forestry plantations, including on slopes with established forest (Figure 3.1a), areas that had been recently logged (Figure 3.1b, c) and areas that had been recently replanted. There were considerable numbers of landslides in recently logged areas and indigenous forest near Koromiko and Windermere. In the areas of established exotic forestry, most of the failures appear to have initiated on old skid sites (possibly end-tipped fill) or landings constructed of woody debris and fill or from existing or old forestry roads. These initial findings will be validated and quantified in the Phase II report.

Figure 3.3 Preliminary distribution of landslides triggered by the July 16–18 storm event shown in relation to 24-hour maximum rainfall measured by the rain radar (rain radar data provided by MetService). Also shown are landslide locations mapped by MDC (dark grey) and sites visited during the field assessments (light grey).

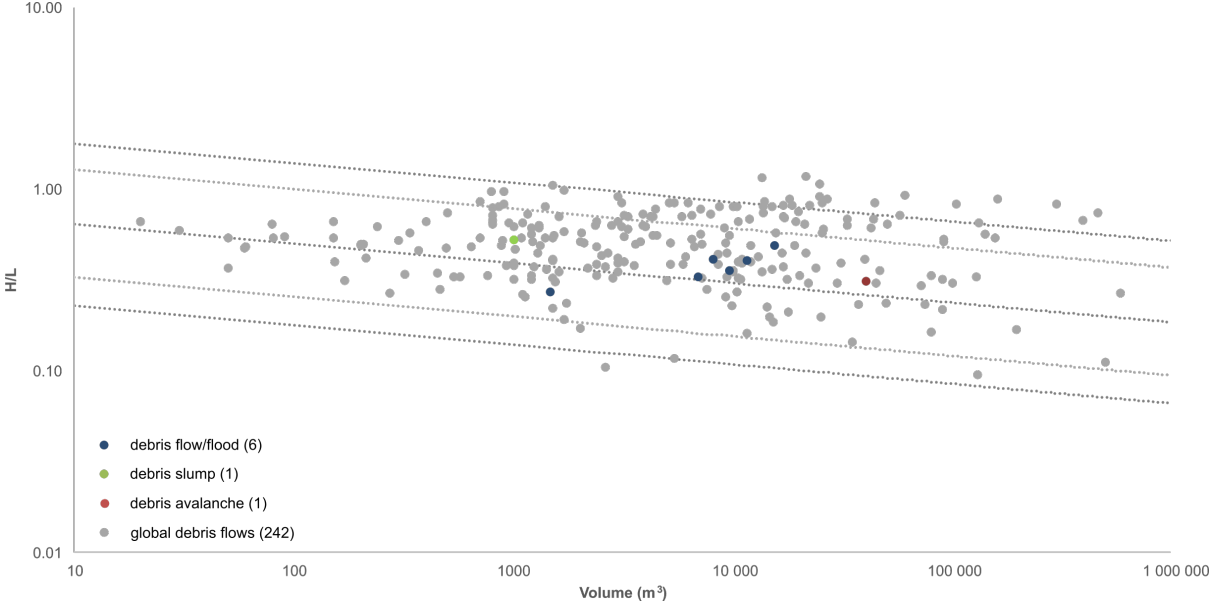
The eight surveyed landslides were compared to a global dataset on landslide runout collected at GNS Science (Brideau et al. 2021). The landslide height / travel distance (H/L) is plotted against landslide volume in Figure 4.1, a common method to assess landslide mobility.<sup>7</sup> The six debris flows plot slightly above (n = 5) or below (n = 1) the mean trendline of the global dataset, indicating that they displayed typical to low mobility. The two other landslides also plot above the mean trendline. This suggests that most landslides initiated during the July 2021 storm did not travel as far as expected given their volumes. Landslide mobility was likely limited by impacting dwellings. Entrainment of vegetation and large woody debris may have affected mobility as well. Given the uncertainty in volume calculation due to vegetation, it is possible that volumes were over-estimated. Changes in landslide volume would result in landslide points shifting right or left on the volume versus H/L graph, thus affecting interpretations of mobility.

Figure 4.1 Landslides studied as part of the July storm landslide response plotted against existing datasets of debris flows worldwide (Brideau et al. 2021). The dashed lines indicate the mean trendline from linear regression analysis, +2σ and +3σ (standard deviations) and -2σ and -3σ of the global dataset. Numbers in legend refer to counts included in each category.

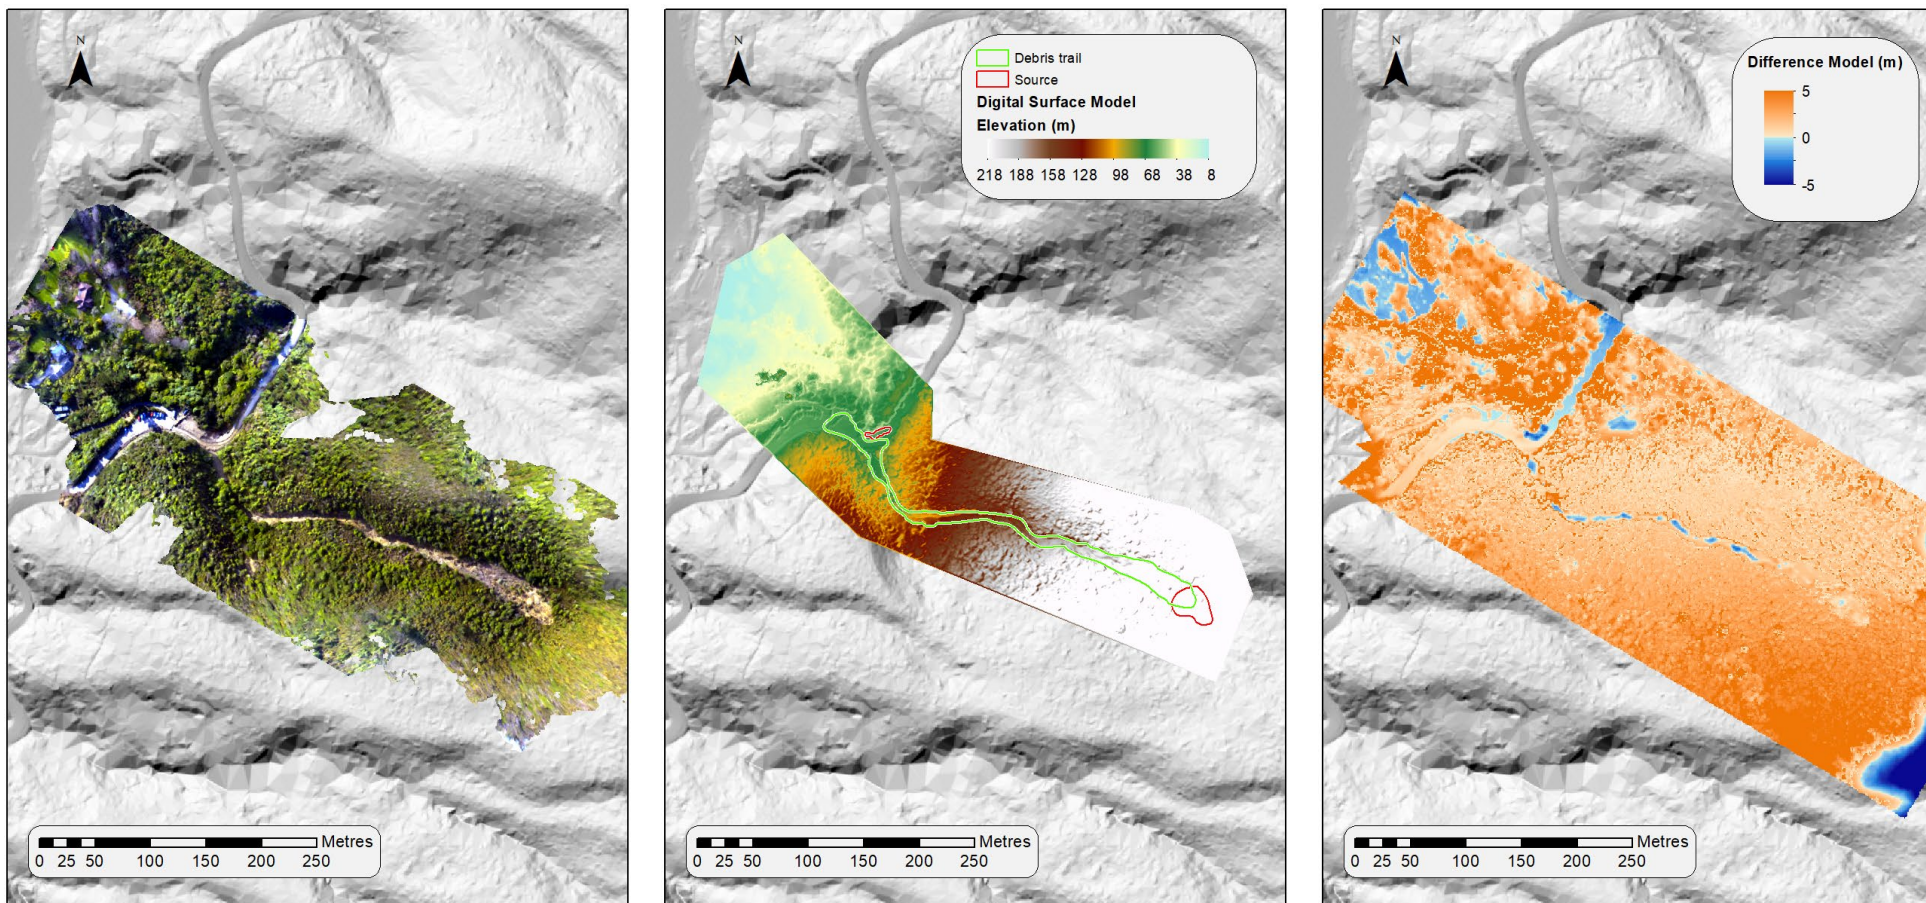
Figure A2.10 LSID 2: (Left) Orthophoto 23181x17659 pixels, 2.82 cm/pixel. (Centre) Digital Surface Model 12755x10100 pixels, 5.64 cm/pixel. (Right) Difference model.

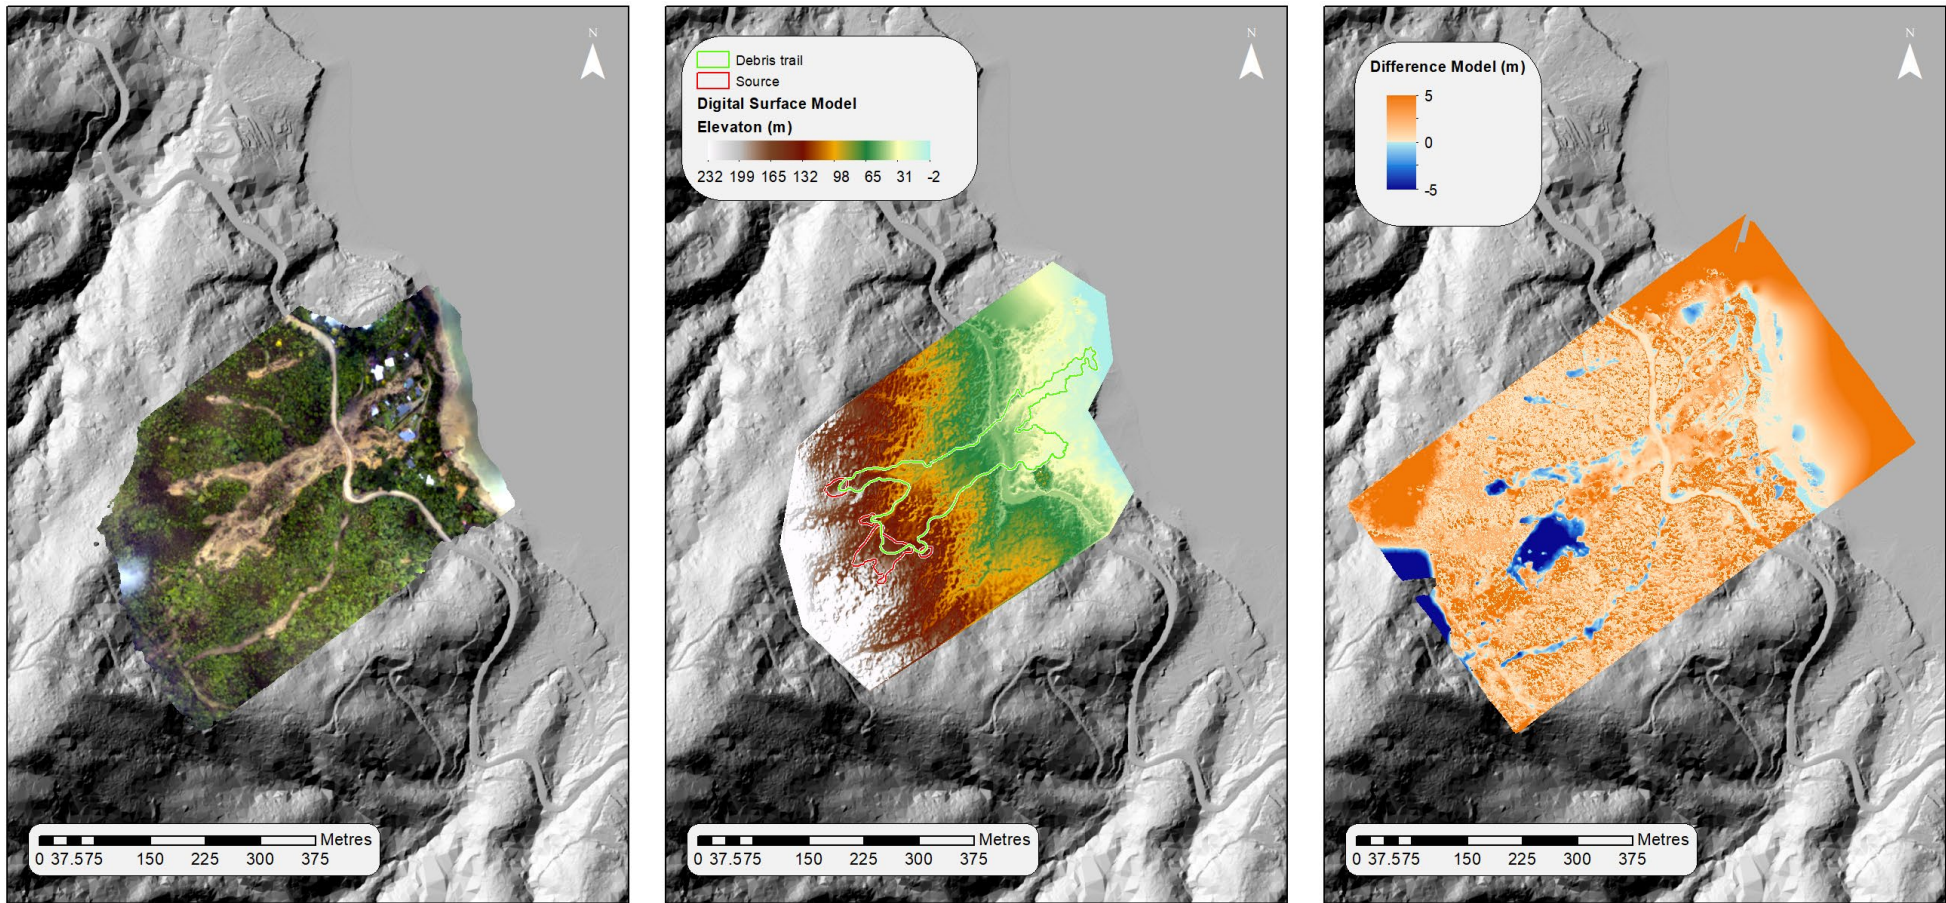
Figure A2.11 LSID 3: (Left) Orthophoto 18368x19495 pixels, 3.12 cm/pixel. (Centre) Digital Surface Model 12495x11486 pixels, 6.23 cm/pixel. (Right) Difference model.

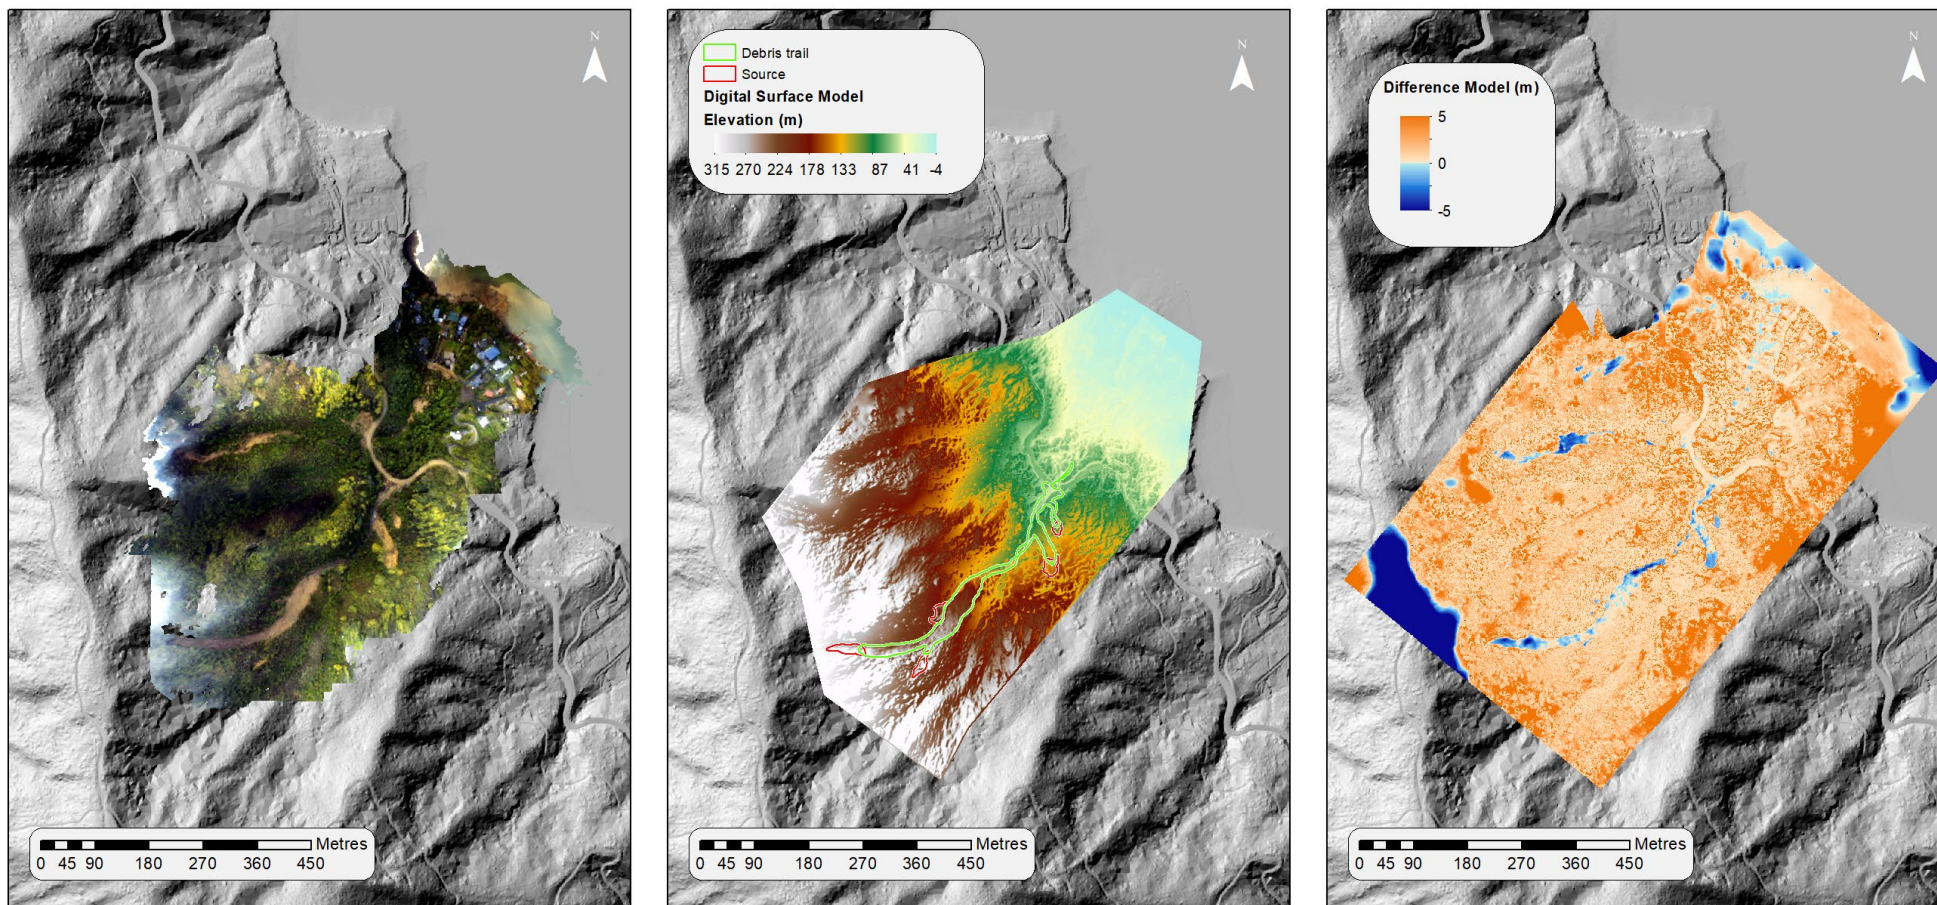
Figure A2.12 LSID 5: (Left) Orthophoto 30664x31765 pixels, 2.94 cm/pixel. (Centre) Digital Surface Model 16996x17884 pixels, 5.89 cm/pixel. (Right) Difference model.

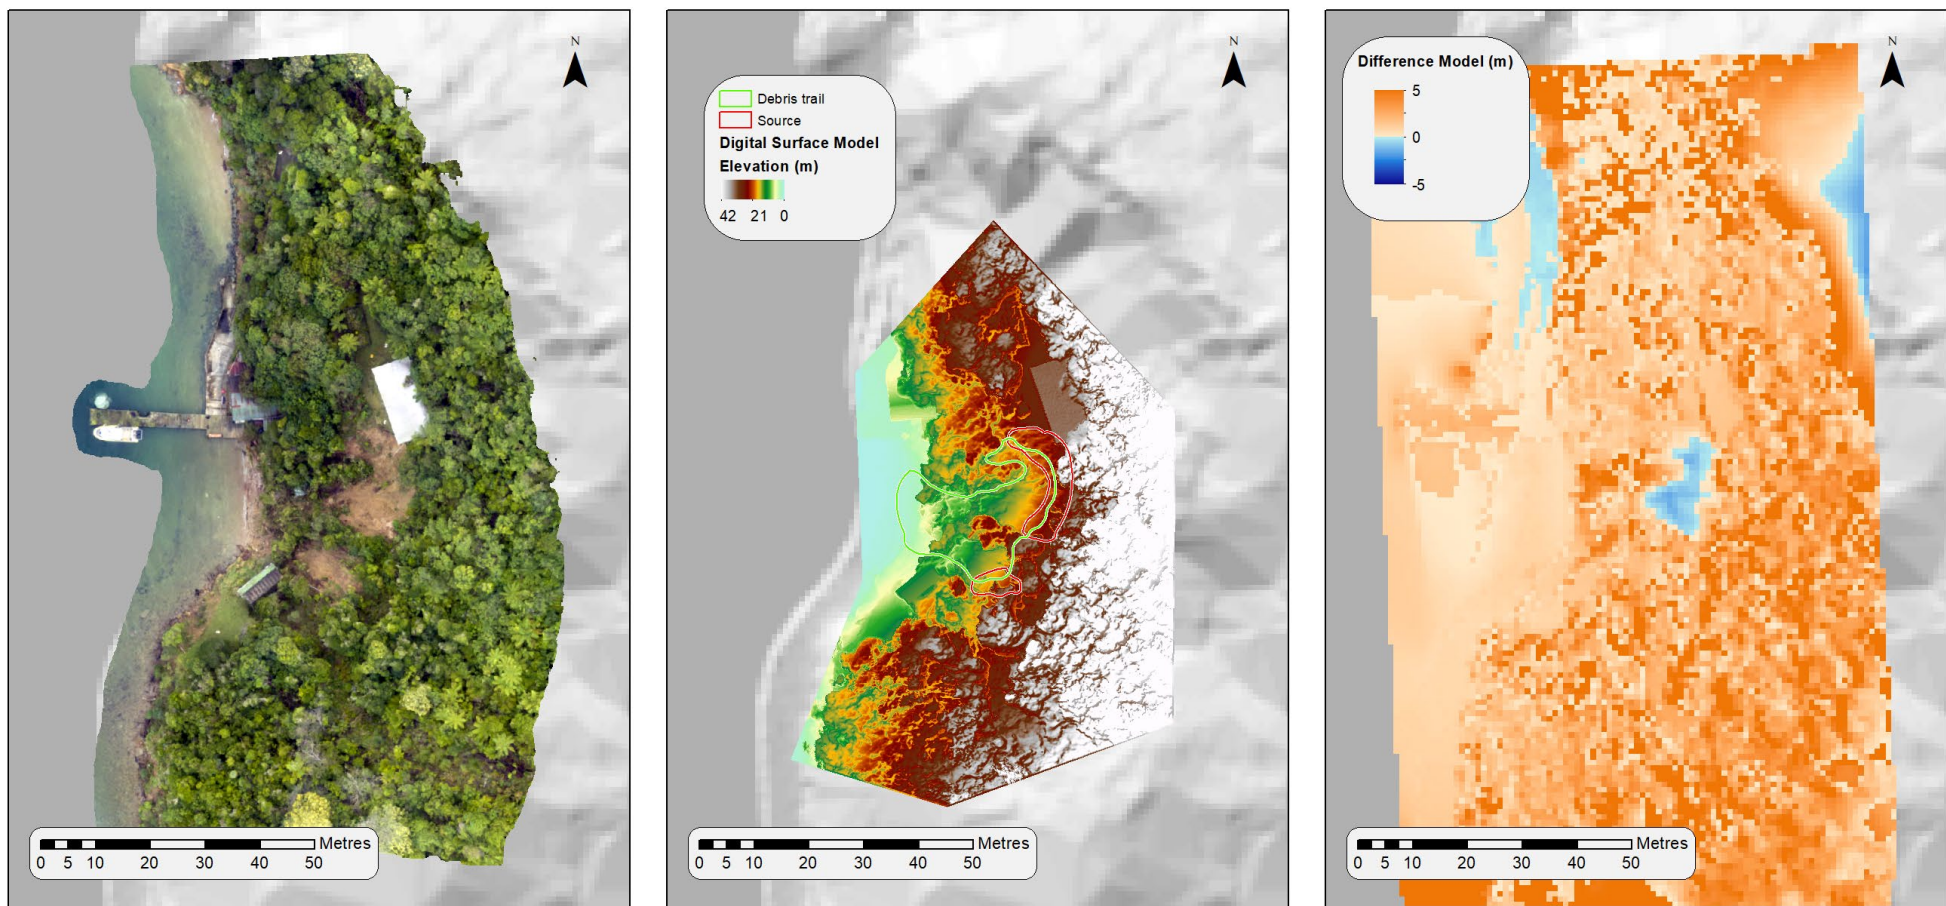
Figure A2.13 LSID 6: (Left) Orthophoto 6247x10267 pixels, 1.45 cm/pixel. (Centre) Digital Surface Model 3544x5692 pixels, 2.89 cm/pixel. (Right) Difference model.

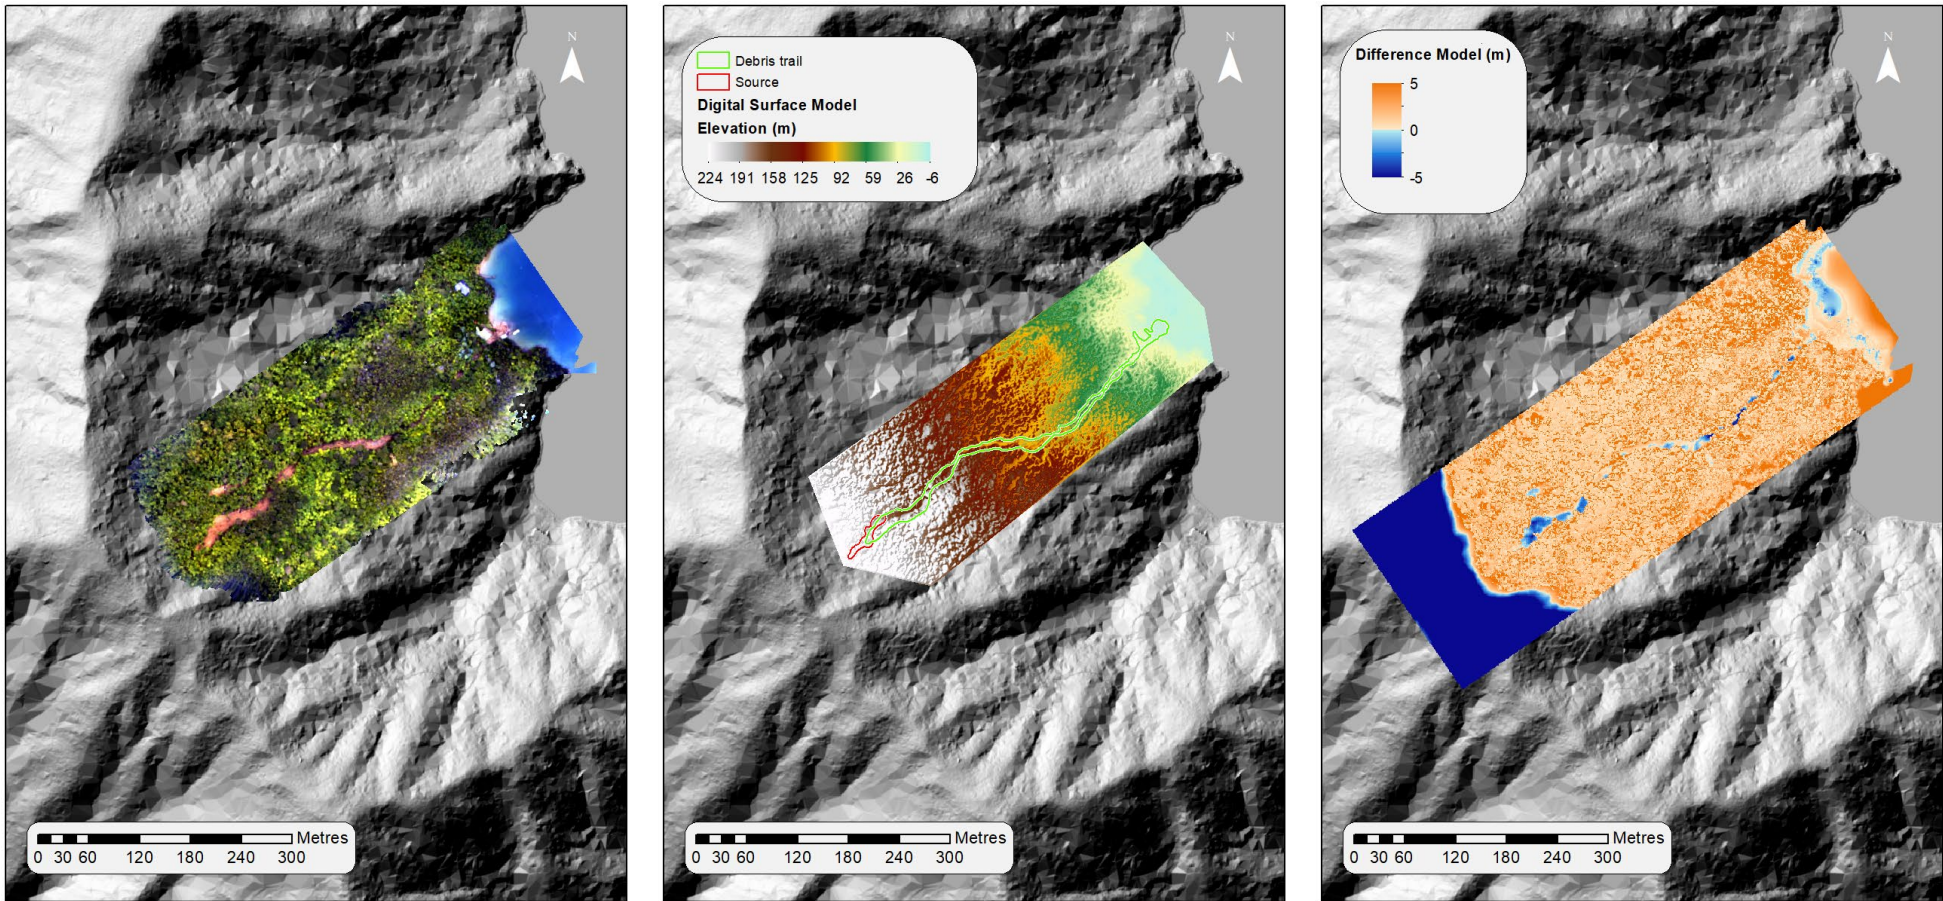
Figure A2.14 LSID 7: (Left) Orthophoto 29152x24653 pixels, 2.27 cm/pixel. (Centre) Digital Surface Model 32887x27231 pixels, 2.27 cm/pixel. (Right) Difference model.

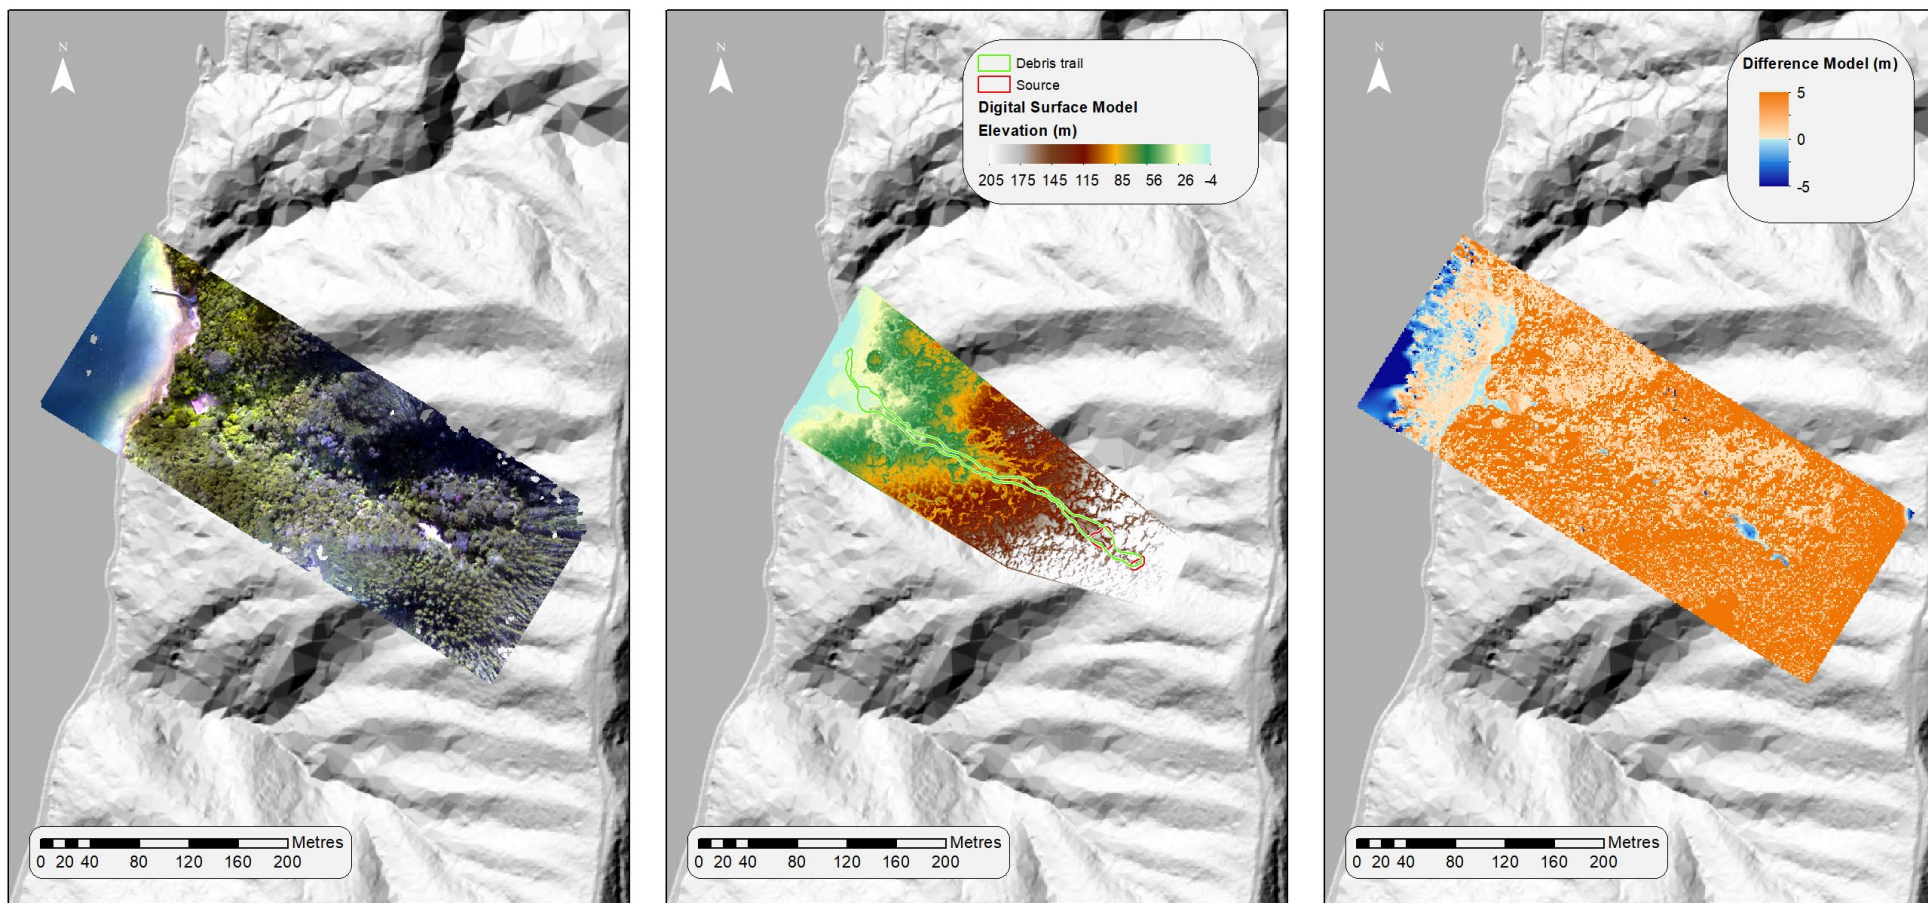
Figure A2.15 LSID 9: (Left) Orthophoto 20690x16554 pixels, 2.2 cm/pixel. (Centre) Digital Surface Model 10365x8279 pixels, 4.4 cm/pixel. (Right) Difference model.

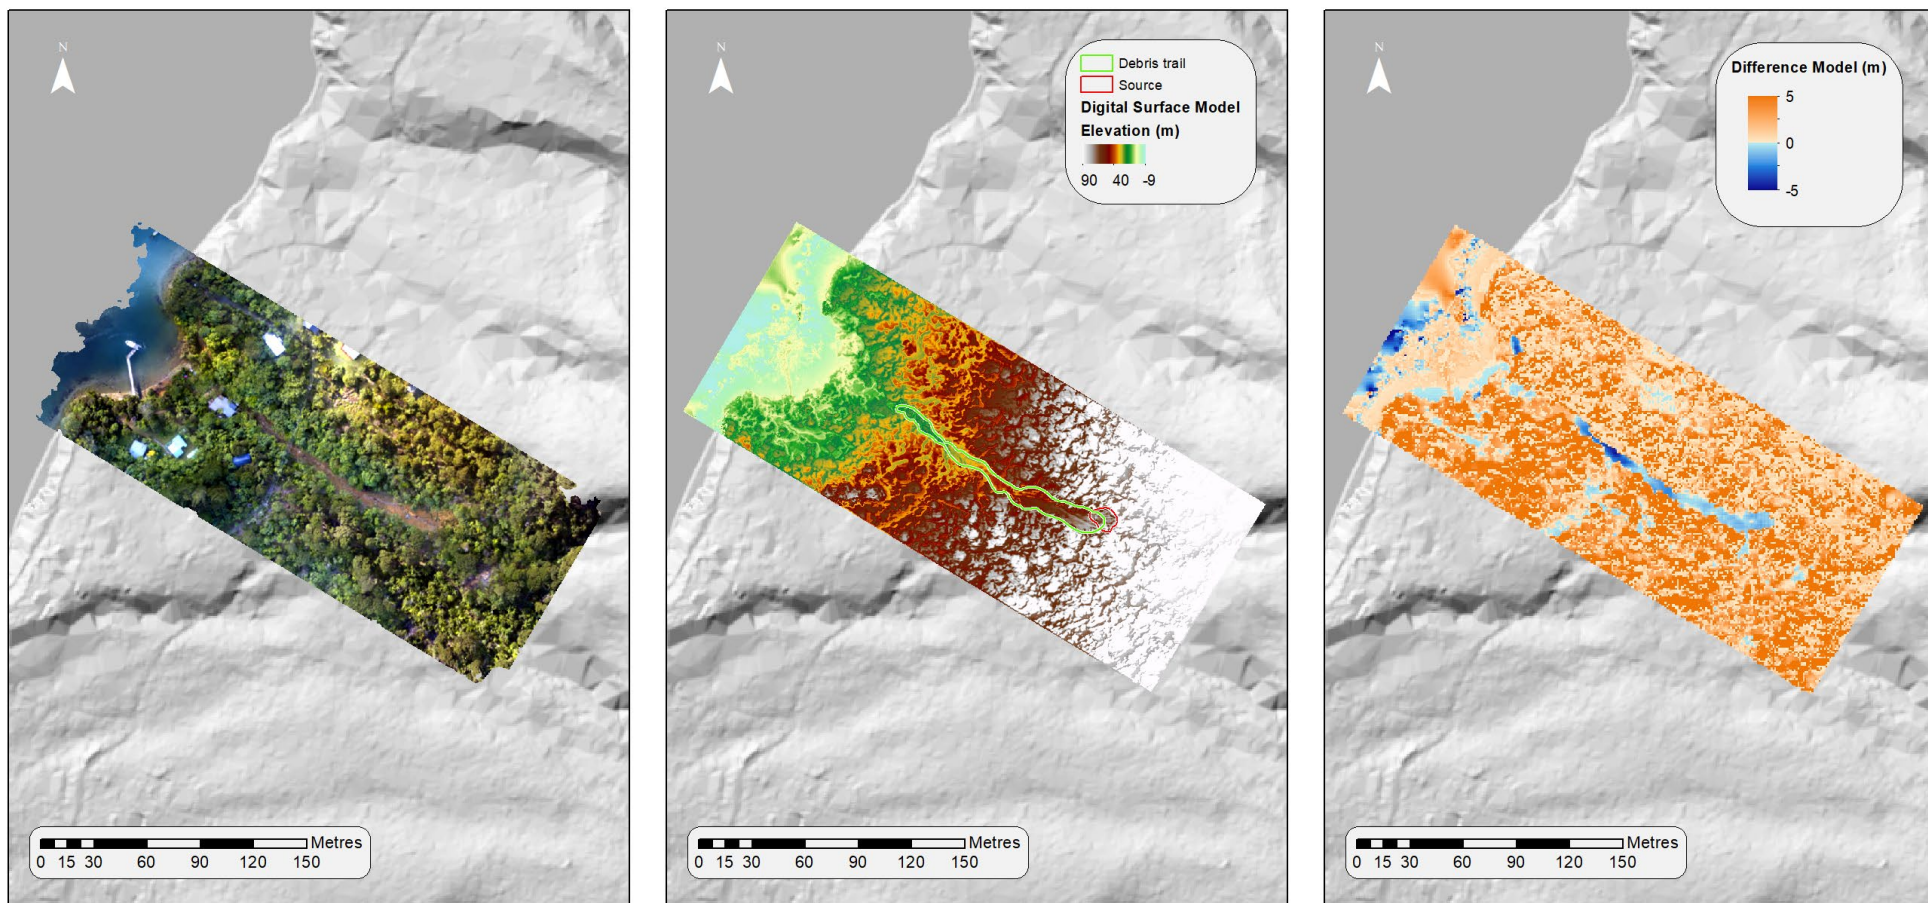
Figure A2.16 LSID 11: (Left) Orthophoto 16183x13483 pixels, 1.97 cm/pixel. (Centre) Digital Surface Model 8368x6784 pixels, 3.9 cm/pixel. (Right) Difference model.

10	Debris avalanche	-	-
11	Debris flow	Tension cracks above headscarp, 2-m-wide block hanging	Matrix-supported, saturated, silty colluvium with clasts up to 50 cm (greywacke)
