Chapter 32: Lower Waihopai Aquifer

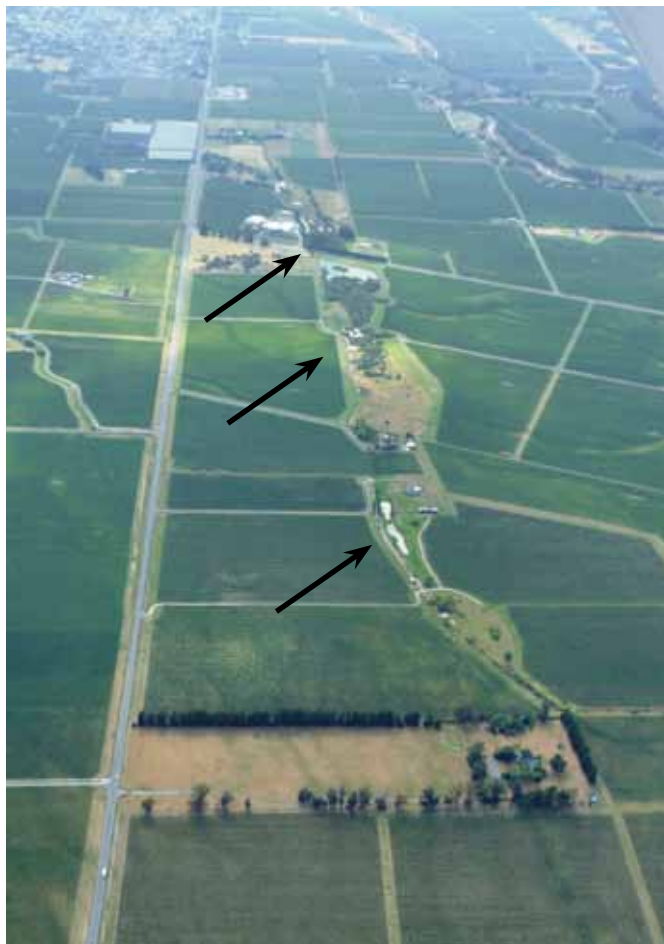
Figure 32.3: Fault associated wetlands

is defined at the surface by Fault Lake and a series of wetlands near the intersection of Waihopai Valley Road and the Grove Mill winery (Fig. 32.3). The fault cuts through Broadbridge Transport, before running eastwards and parallel to Middle Renwick Road to the south of Renwick.

The fault has a major influence on the distribution of shallow groundwater resources. In particular, the fault impedes flow and diverts it sideways to the east until there is sufficient build-up of water for it to break out northwards across the fault as a spring. Fault Lake near Grove Mill Wines on Waihopai Valley Road is an example of this.

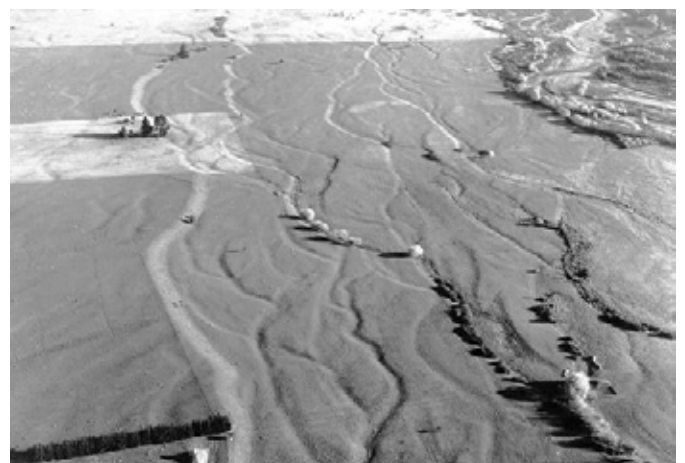
Figure 32.5: Lower Waihopai Aquifer terrace (NZGS)

Another important natural feature is the main Waihopai River terrace. The terrace separates the higher permeability gravels near the channel, from the elevated and lower yielding gravels (Fig. 32.4). The lower terrace gravels are an extension of the braided river channel material deposited over geological time (Fig. 32.5).

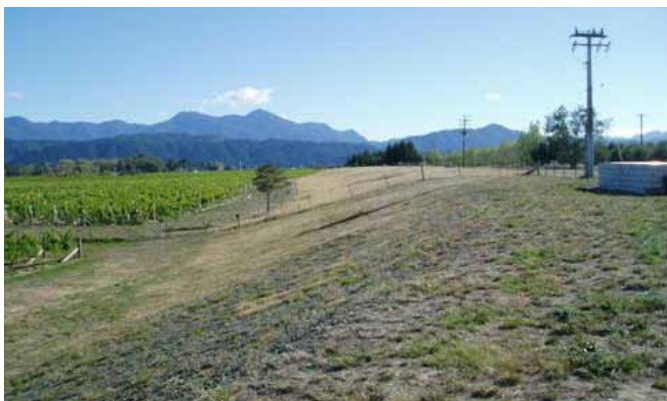
Figure 32.6: Lower Waihopai Aquifer terrace

The upper terrace aquifers are hosted by a thin veneer of more permeable sediments overlying the claybound gravels forming the terraces (Fig. 32.6). The sediments can be split between the more permeable upper five metres of clays and gravels, which are likely to represent the primary water bearing layer, and the deeper cemented gravels which have poor prospects for supplying groundwater.

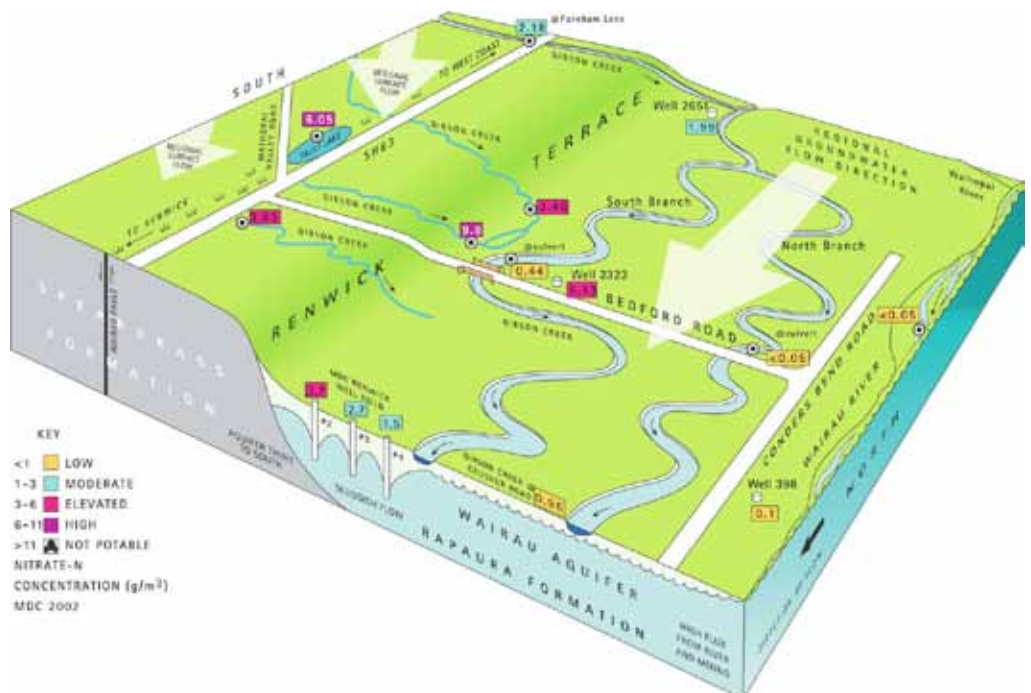
Figure 32.10: Nitrate-nitrogen distribution 2002

A survey of groundwater nitrate-nitrogen concentrations was carried out by the MDC in May 2002 at a number of wells. A range of values from natural background levels to elevated values were measured (Fig. 32.10). One of the sites affected was the Renwick municipal wellfield which consists of three wells oriented in a line extending north of the terrace.
