A Brief Scoping Study of Landscape Recontouring for Viticulture in Eastern Marlborough

Landcare Research Contract Report: LC0809/074

PREPARED FOR:
Marlborough District Council
PO Box 443
Blenheim

DATE: January 2009

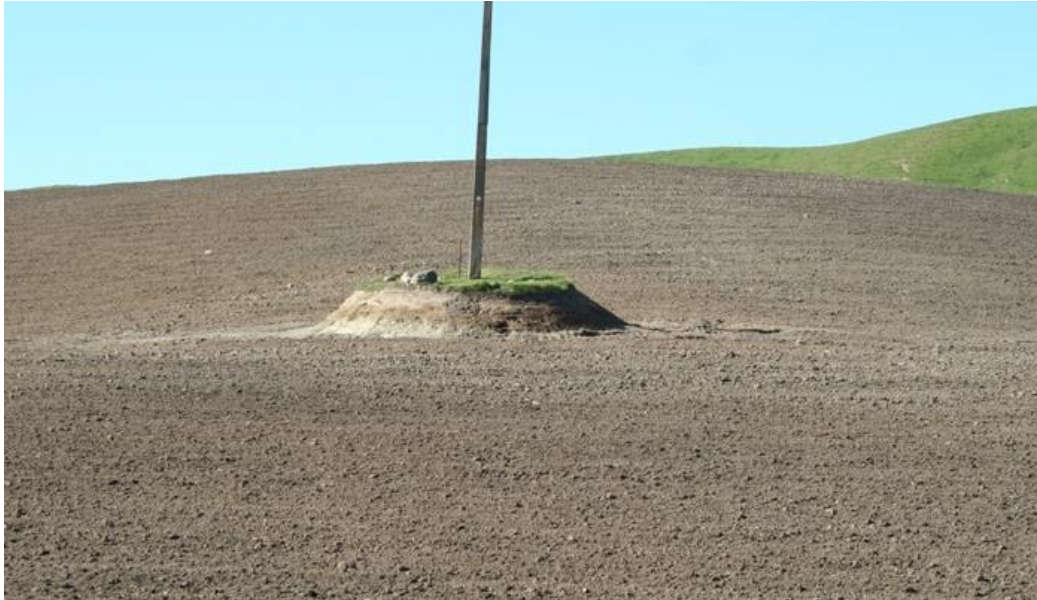
Fig. 1 Significant earthworks are involved in much of the landscape recontouring for viticulture currently being undertaken in Marlborough. An example of at least 1 m of ground surface lowering, south of Seddon; Grid reference: 2601660E; 5943426N. (Photo: Colin Gray, Marlborough District Council)

In Marlborough there has been a marked increase in the amount and type of land being developed for viticulture. As well as expansion on the flat to gently sloping floodplains and terraces, extensive viticultural development has recently been undertaken on rolling to strongly rolling hill and downland slopes. The latter often involves significant landscape recontouring (Fig. 1).

Funding was provided by the Foundation for Research, Science and Technology under the Envirolink programme. Colin Gray, Marlborough District Council, initiated the project, provided Fig. 1, and in association with other MDC staff identified the sites on Figs 2 and 3.
