Research Report 2017-04
Civil & Natural Resources Engineering

ANTICIPATING TSUNAMI IMPACTS
IN PORT MARLBOROUGH

IMPLICATIONS FOR PORT OPERATION AND HARBOUR NAVIGABILITY
JOSEPHINE M. TURNBULL & MATTHEW W. HUGHES

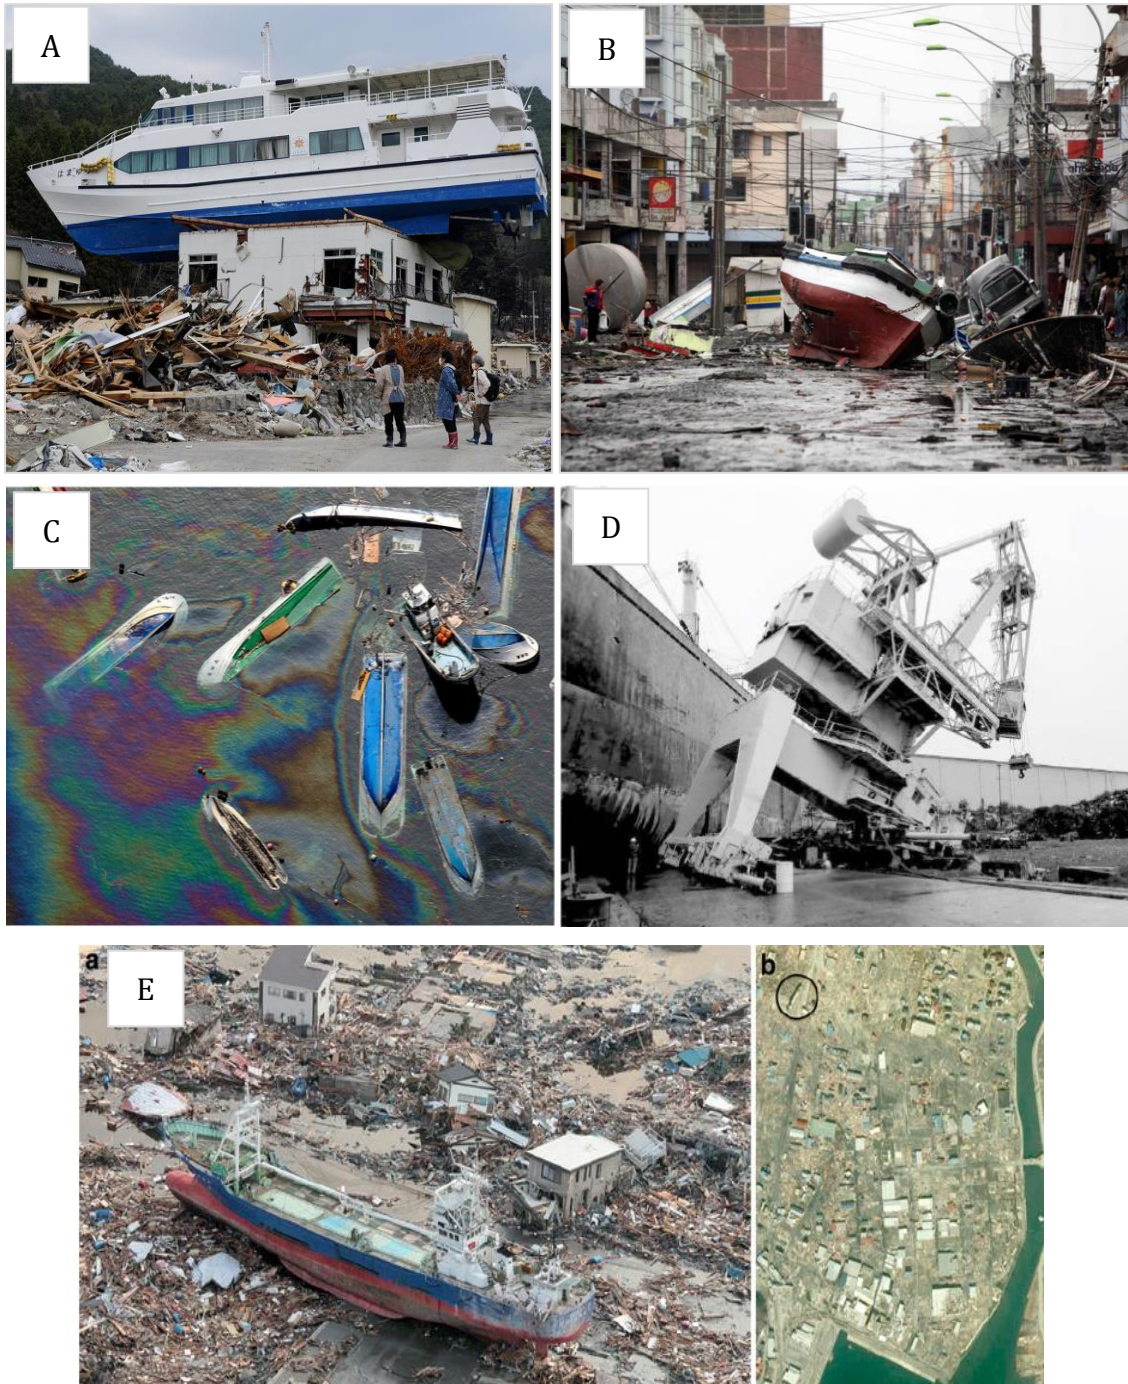
Figure 2. (A) Large vessel that has been potentially damaging debris is left on the roof of a tourist hotel in Otsuchi, Japan after the 2011 Japan tsunami. Source (<http://www.ibtimes.co.uk/2011-earthquake-tsunami-60-powerful-photos-disaster-that-hit-japan-five-years-ago-1548255>). (B) A vessel washed inland to a street in Talcahuano, Chile after the 2010 Chile Tsunami. Source (http://archive.boston.com/bigpicture/2010/03/chile_three_days_later.html). (C) Oil leaks from capsized and sunken vessels in Fudai Village, Iwate Prefecture, Japan after the 2011 Japan tsunami. Source (<http://www.ibtimes.co.uk/2011-earthquake-tsunami-60-powerful-photos-disaster-that-hit-japan-five-years-ago-1548255>). (D) An example of a drifting ship causing damage during collision with a crane in Sendai Port, Japan during the 2011 Japan Tsunami. Source (Chock et al., 2013). (E) Large fishing vessel transported 750m inland from a port in Kesennuma, Japan after the 2011 Japan Tsunami. Source (https://www.researchgate.net/figure/282949701_fig3_Fig-4-At-Kesennuma-Japan-during-the-2011-Tsunami-This-large-fi-shing-boat-the-330-t).

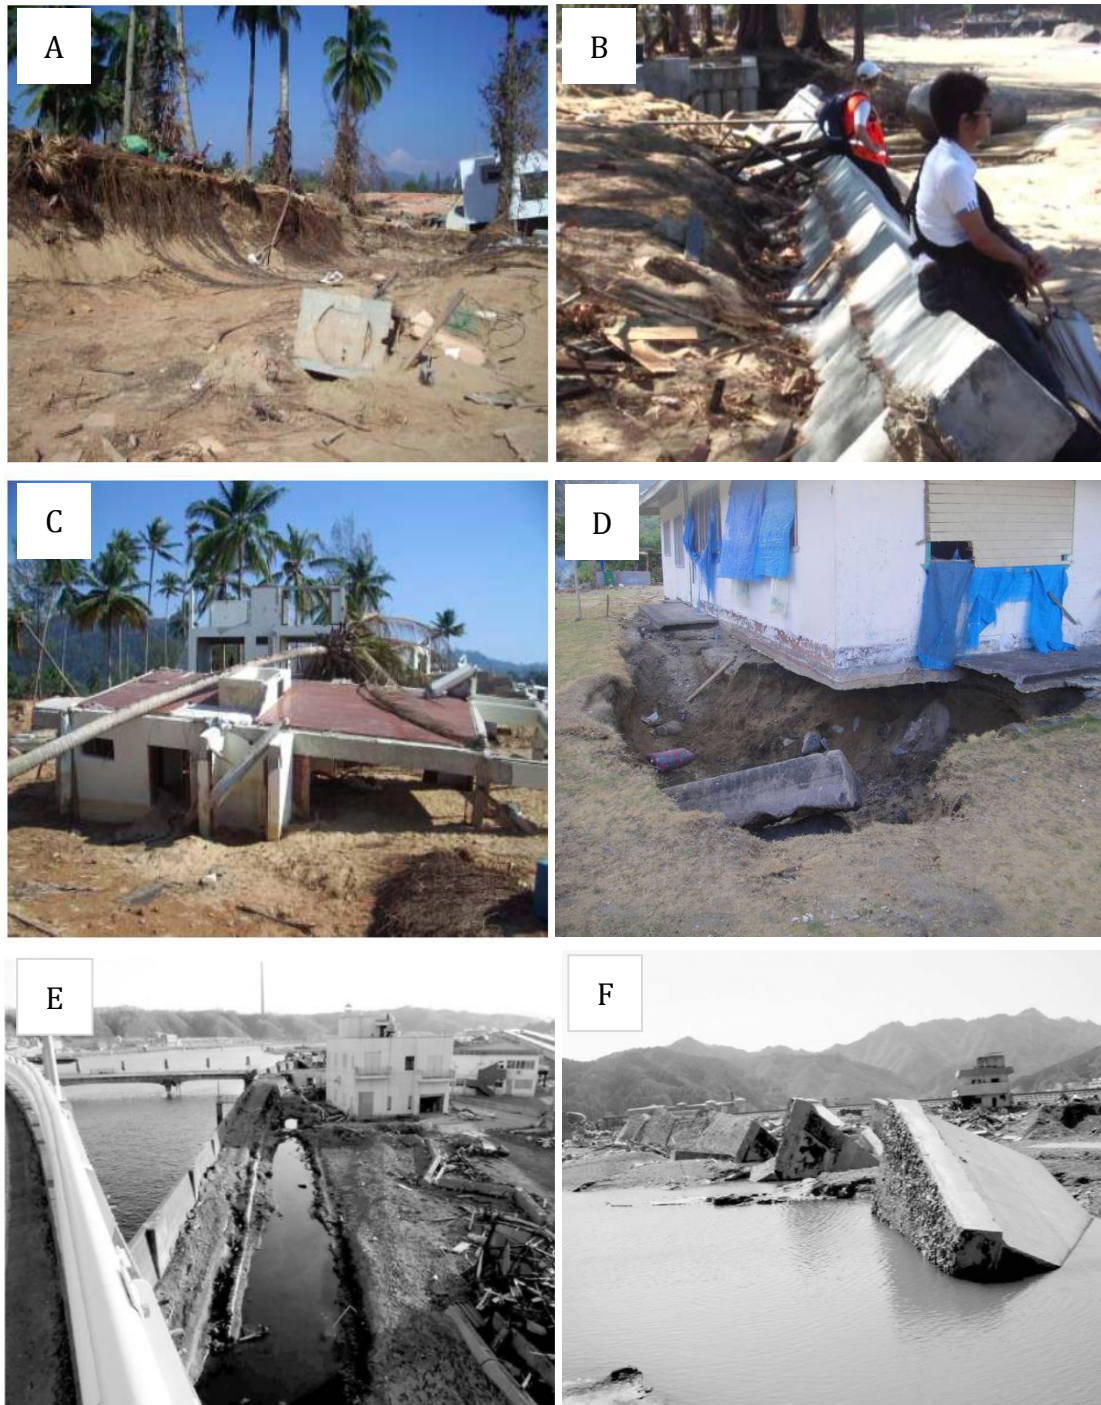
Figure 3. (A) Receding waters after waves from the 26th December 2004 tsunami scoured channels with dimensions up to 50m wide and up to 3m deep shown here, in Khao Lak, Thailand. Source (Bell et al. 2005). (B) Receding waters from the December 26th 2004 tsunami causing the collapse and tilting of most seawall defences on the Andaman Coast, Southern Thailand due to scouring on the landward side. Source (Bell et al. 2005). (C) Extensive scour from the 26th December 2004 tsunami completely undermining nearby resort buildings in Khao Lak, Thailand, source (Bell et al. 2005). (D) Tsunami induced scour around the corner of buildings in Masefau, American Samoa during the 2009 Samoa tsunami. Source (<https://walrus.wr.usgs.gov/news/samoareports.html>). (E) Scour trench formed on the landward side of a flood wall in Miyako, Japan after the 2011 Japan tsunami. Source (Chock et al. 2013). (F) Damage to a concrete gravity seawall with shallow foundations in Otsuchi Port, Japan, due to a deep scour trench forming on the landward side of the structure, resulting in collapse and dispersal of monolithic concrete blocks up to 70m inland. Source (Chock et al. 2013).

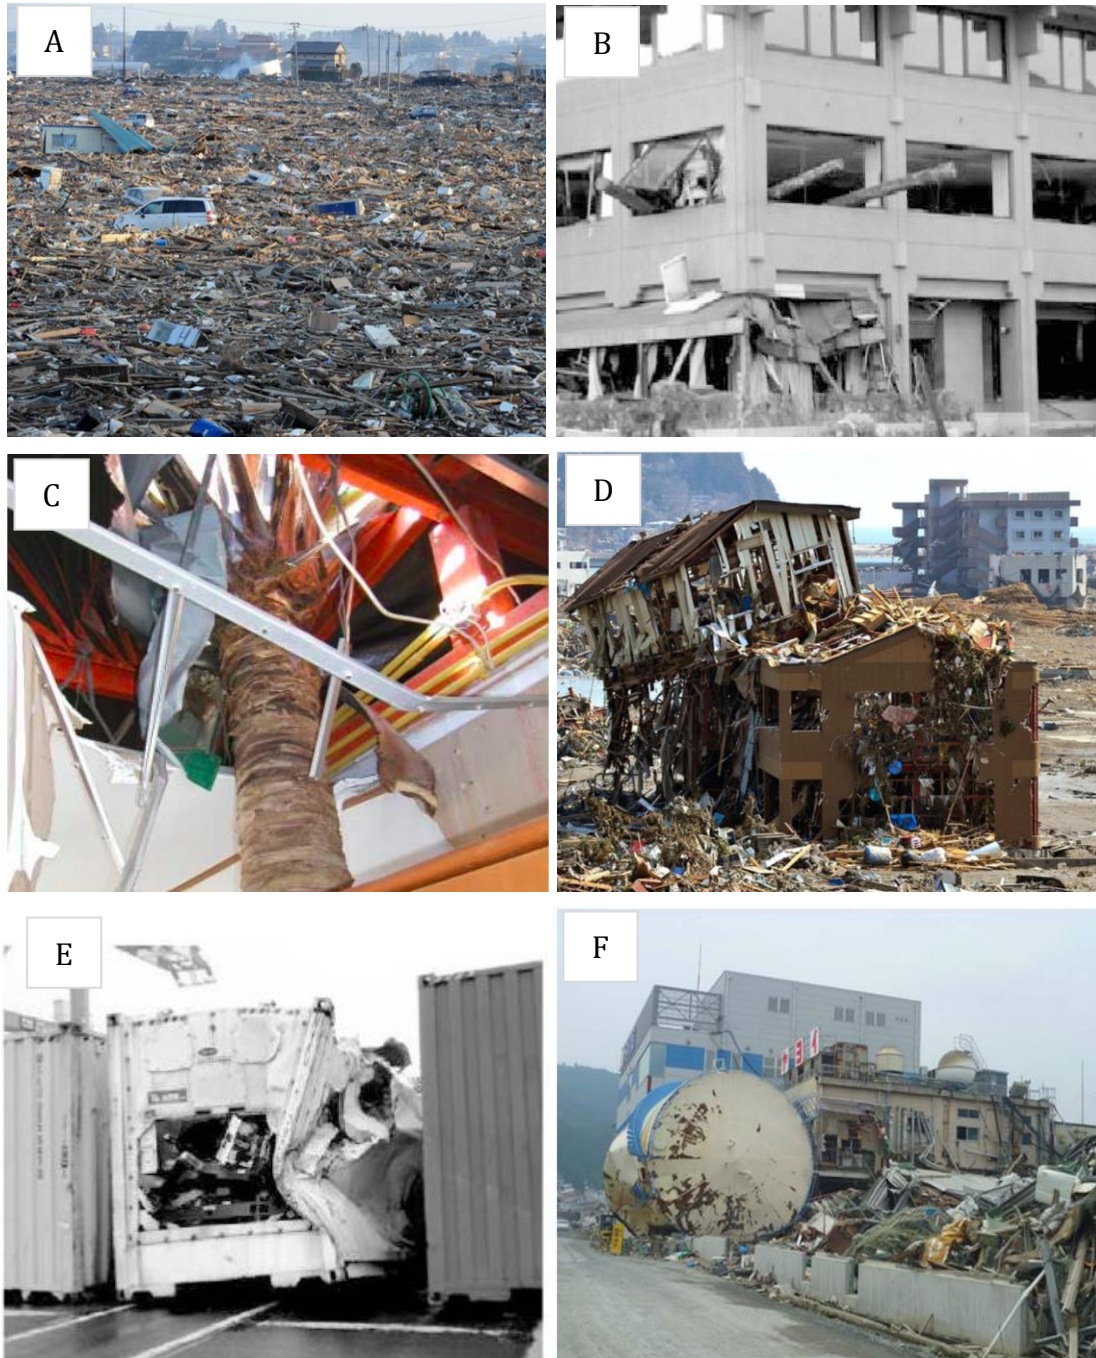
Figure 4. (A) Extensive mounds of debris in Natori, Miyagi prefecture, Japan after the 2011 Japan tsunami. Source (<http://www.ibtimes.co.uk/2011-earthquake-tsunami-60-powerful-photos-disaster-that-hit-japan-five-years-ago-1548255>). (B) An example of timber log debris in port buildings at Ofunato, Japan after the 2011 Japan tsunami. Source (Chock et al, 2013). (C) A coconut palm tree entrained by the December 26th 2004 Tsunami, see here penetrating through a roof and internal ceiling of a hotel room on Koh Phi, Thailand. Source (Bell et al. 2005). (D) A building has become unseated from its foundations and been transported in the flow as large and potentially damaging debris and finally rested ontop of another building in Minamisanriku, Miyagi prefecture, Japan. Source (<http://www.ibtimes.co.uk/2011-earthquake-tsunami-60-powerful-photos-disaster-that-hit-japan-five-years-ago-1548255>). (E) An example of damage to the debris (shipping container) due to strikes with other containers or structures. Source (Chock et al. 2013). (F) . A damaged storage tank that has been removed and transported from its original position in Kesenuma, Japan, during the Great East Japan Tsunami. Note the buckling and/or impact damage to the side of the tank nearest the road. Source (Horspool et al. 2016).

1. Damage to wharfs and piers from hydrodynamic forces, buoyancy and uplift forces, scouring and debris impact (Figure 1).
2. Breaking of vessel mooring lines, capsizing and sinking of vessels, and drifting of vessels inland and in currents that typically lasted for up to 24 hours after initial tsunami arrival; vessels have potential to become large and damaging debris (Figure 2).
3. Scouring around piers, breakwater, seawalls, building corner and along the shoreline, often causing structural collapse (Figure 3).
4. Damage to structures from debris strike, and also damage to/fragmentation of debris itself (vessels, tanks, vessels) as it impacts other debris, structures and the ground (Appendix 5.7; Figure 4).

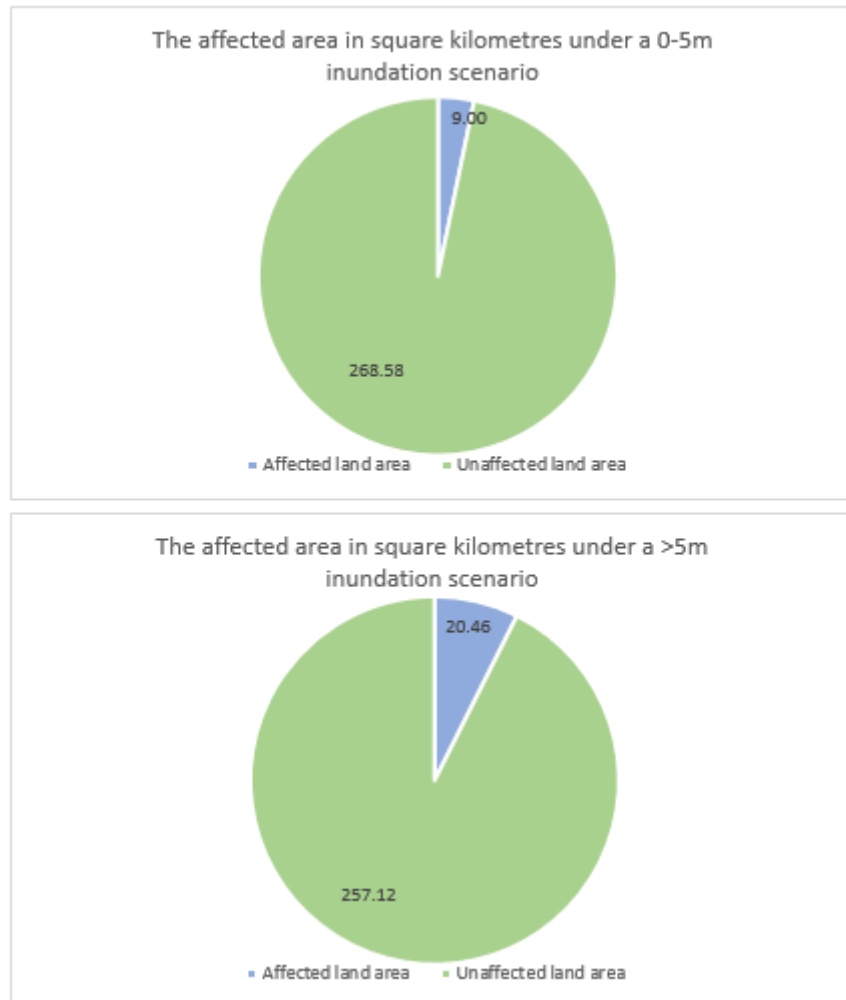
Figure 5. The cumulative affected area in square kilometers in each inundation scenario in Queen Charlotte Sound.

The Queen Charlotte Sound study area covers 541 km², with 277 km² of that area being land. Figure 5 shows the land area in square kilometers affected by each inundation scenario. Because of the steep topographic gradient throughout Queen Charlotte Sound, a small proportion of land area is inundated in both scenarios. However, because settlement has occurred in low-lying coastal areas and in pockets with a shallower topographic gradient, the areas where the worst inundation occurs are also the most populated. This results in the exposure of a significant amount of infrastructure to the hazard (Figure 6).

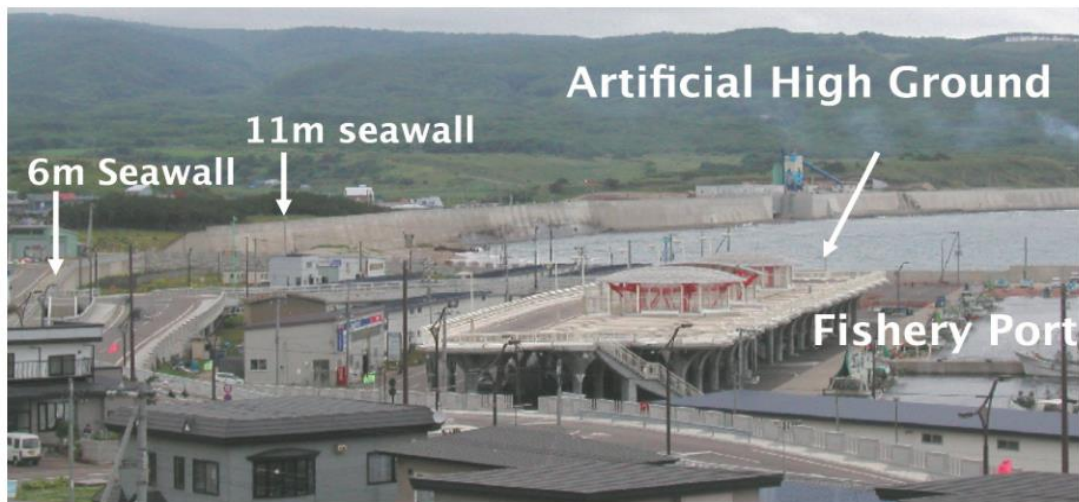
Figure 7. Artificial high ground in a fishery port. Workers can work daily on the first floor and use the second floor for evacuation purposes during a tsunami. Source (PIANC. 2010)

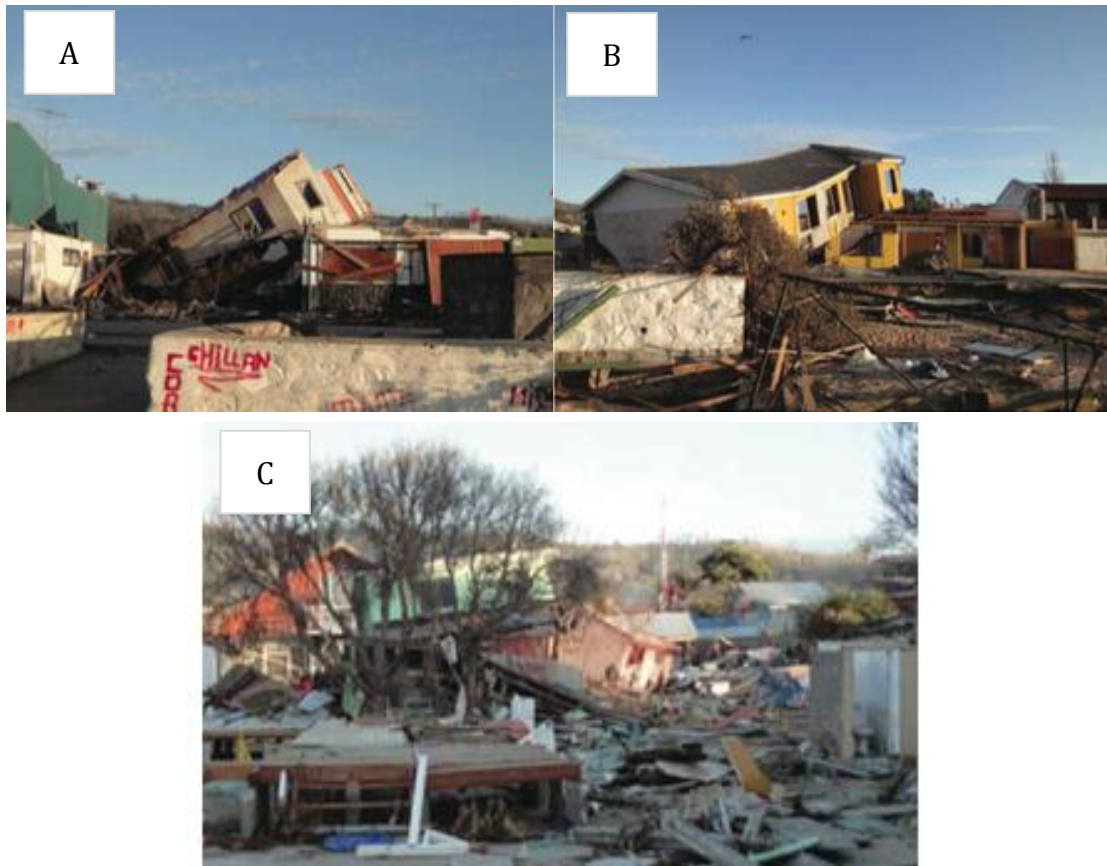
Figure 8. (A-B) Sliding and unseating of storey levels in Dichato, Chile after the 27th February 2010 Chile Tsunami. Source (Palermo et al. 2013) **(C)** Widespread damage timber homes in Dichato, Chile after the 27th February 2010 Chile Tsunami resulting in extensive timber debris. Source (Palermo et al. 2013)

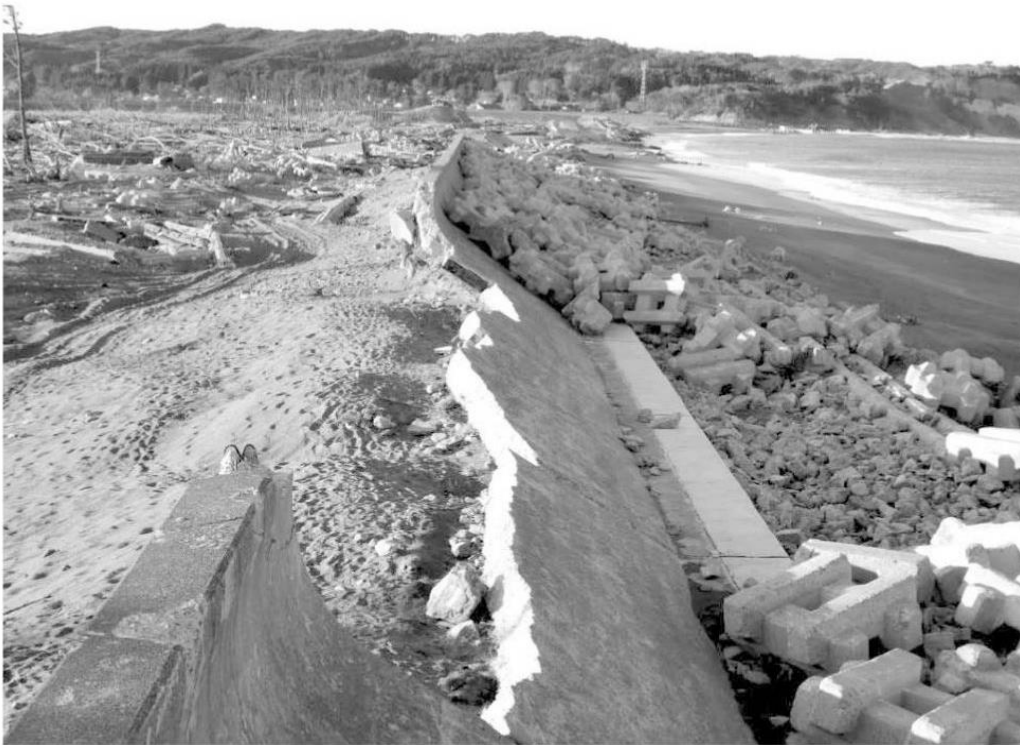
Figure 9. The front of a damaged earth filled and concrete lined seawall at Noda, Japan after the 2011 Tohoku tsunami. The seawall had a parapet lining the crest but failed in many locations due to the loss of internal earth fill from scouring. Failure also appeared to be concentrated at the junctions between adjoining segments of seawall, resulting in a large number of armour units being displaced inland. Source (Chock et al. 2013)

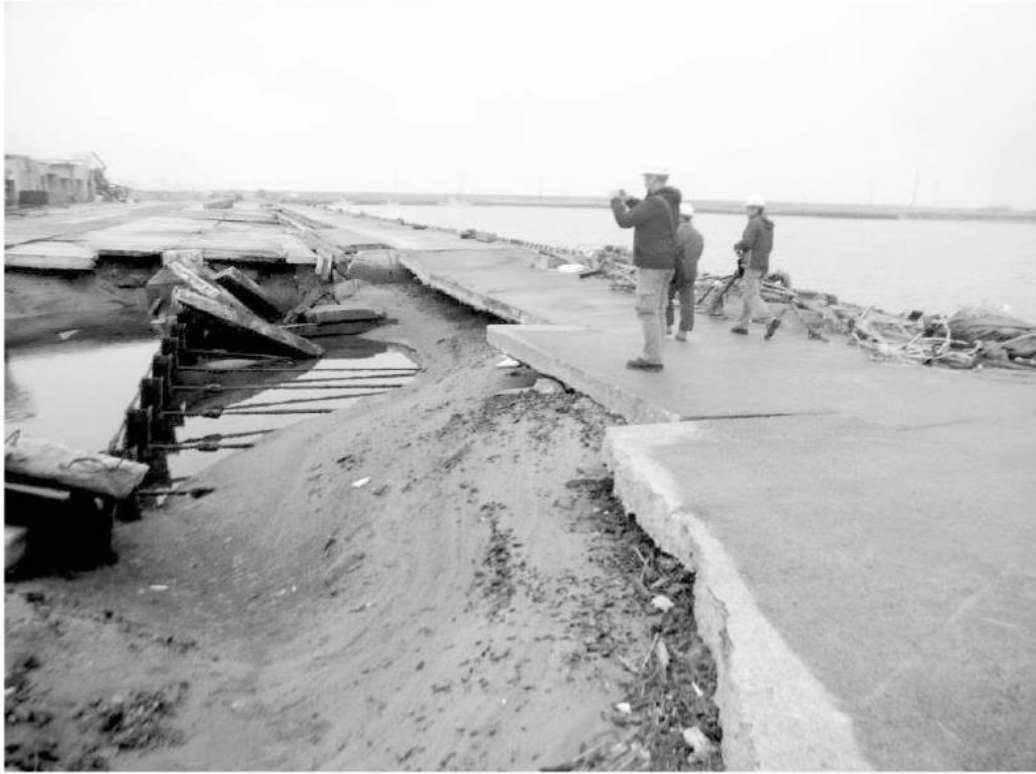
Figure 10. Significant scour behind the sheet pile-supported quay wall structures exposing the quay support sheet pile system in Otsu Fishing port, Ibaraki prefecture, Japan. Source (Chock et al. 2013)

Scouring around gravity-type piers, wharves and quays and also floating type and pile type piers, wharves and quays caused some failures in the structures (PIANC 2010; Chock et al. 2013). However, gravity-type piers, wharves and quays appear much more resilient to tsunamis than floating type and pile type piers, wharves and quays which more frequently received damage, especially from tsunami currents and water level oscillations (Appendix 5.12) (PIANC 2010). Docks often failed from buckling, tearing away from its concrete piles, shearing off of the decks from its piles and lifting of the decks off its piles (Wilson et al. 2013). Concrete and steel pile supported structures with concrete decks performed well (Chock et al. 2013). Bulkhead walls were subject to lateral failure due to soil erosion or loss of restraint wall stiffness due to scour at tieback anchorages (Chock et al. 2013). Scour commonly caused damage to sheet pile-supported quay wall structures and often resulted in the exposure of tie backs and quay support sheet pile systems (Figure 10) (Chock et al. 2013). Pressure relief grating and/or small concrete access panels served as a breakaway element between pier and wharf sections lessening damage to both. Chock et al. (2013) found that piers and quays were less susceptible to debris impact because the initial leading edge of a tsunami at the waterfront contains little debris, and a combination of the limited vertical exposure and the high inundation levels experienced in Japan in 2011 meant large debris often floated overtop of these structures. The overall design of piers wharves and quays should prevent total loss of sections of pier wharf walls and their tiebacks and restrain selected breakaway panels to provide post tsunami access.

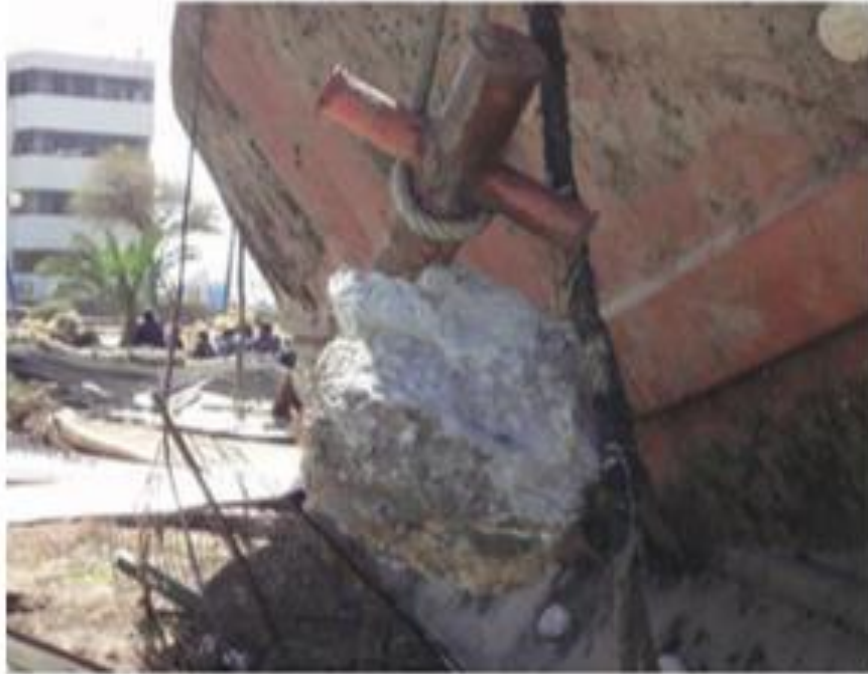
Figure 11. Uprooting of a steel-concrete mooring in Talcahuano, Chile, after the 27th February 2010 Chile. Source (Palermo et al. 2013)

Damage to docks was frequently caused by the movement of moored vessels into and away from docks, strong currents, and inundation and the related buoyant forces (Wilson et al. 2013). Edge et al. (2013) recommends the use of one line per bollard and the consideration of mooring hooks with mechanical releases where possible. If a vessel rotates even slightly there is an unequal transfer of the increased drag force on the mooring lines and the tie down anchor which could result in the breaking of mooring lines or damage to the tie down anchor (Figure

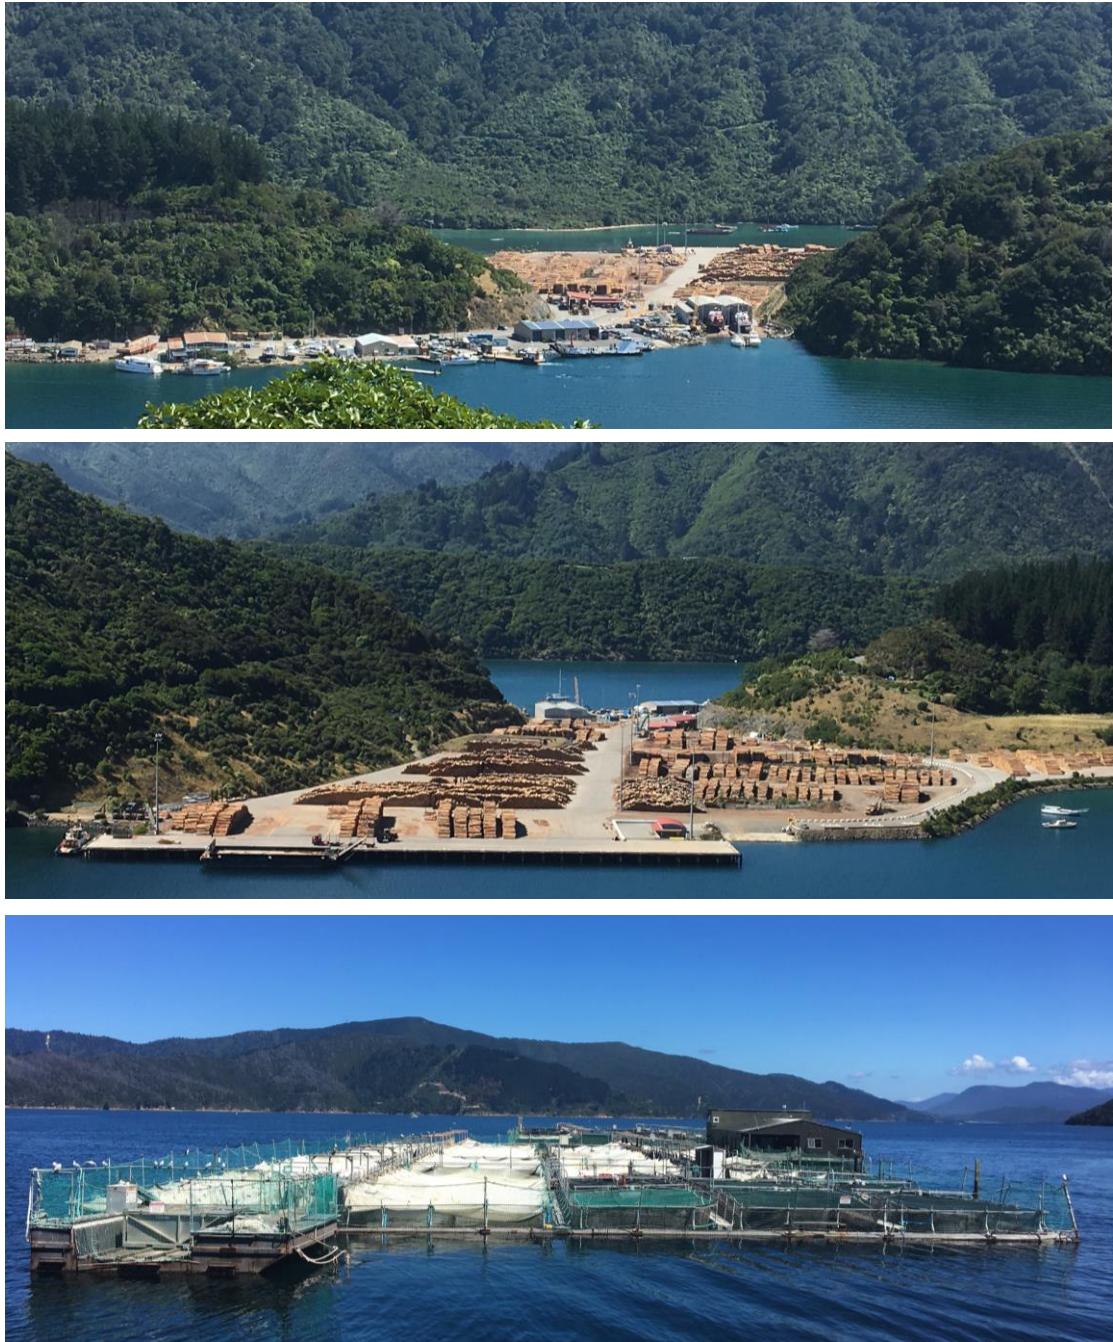
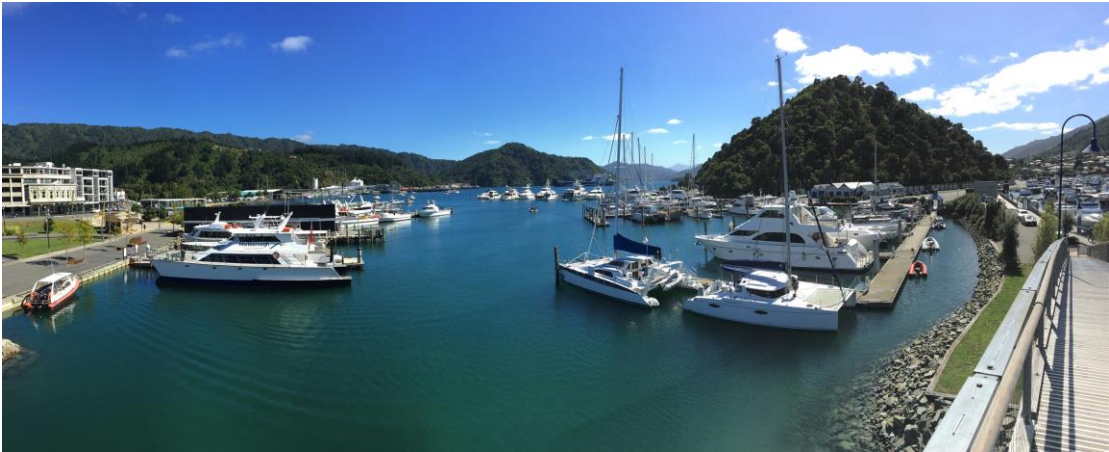
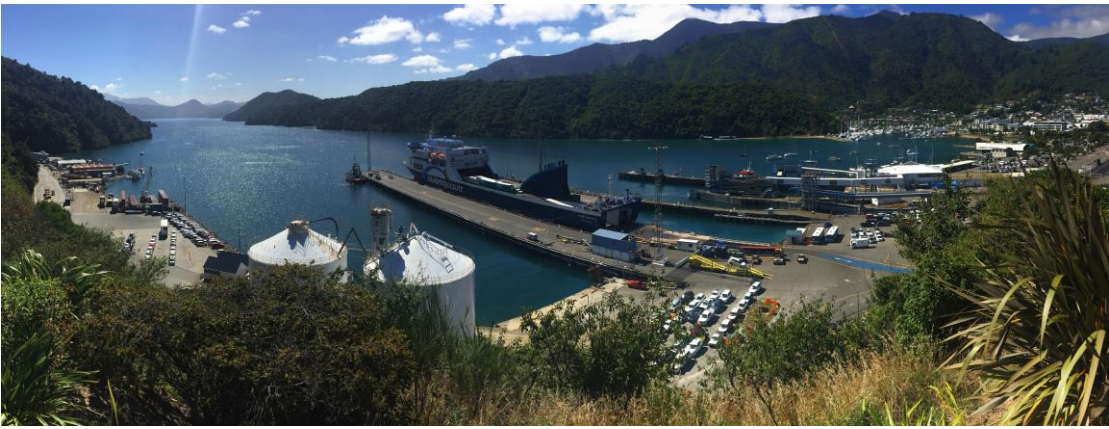
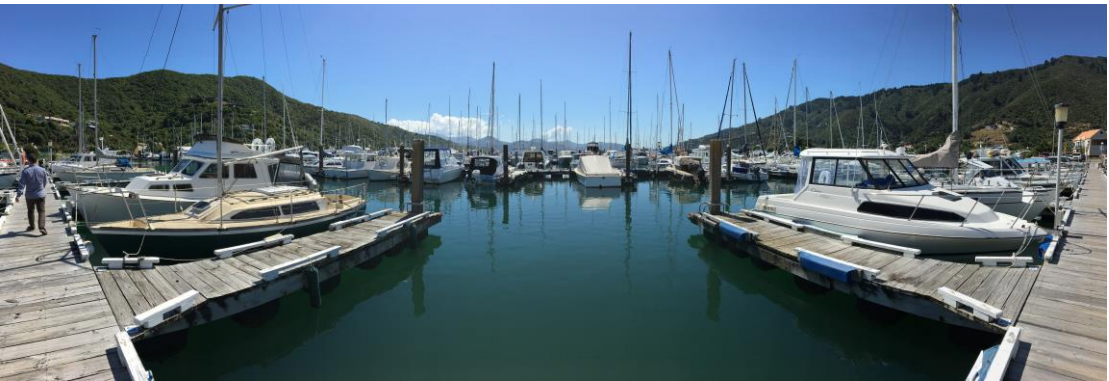
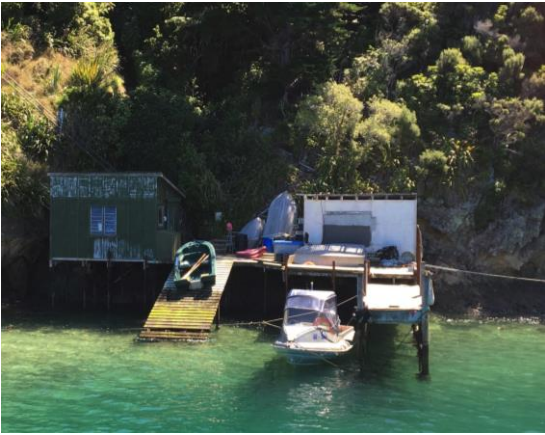
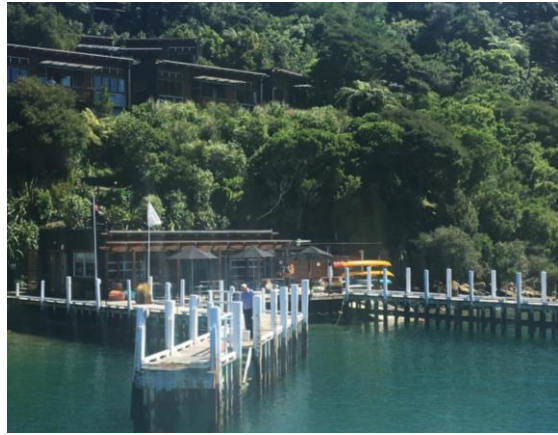
Figure 7. Examples of potential debris sources identified throughout Queen Charlotte Sound.

Debris sources are concentrated at major settlements within Queen Charlotte Sound e.g. Picton and Waikawa, and at or within the vicinity of buildings. Potential debris sources ranged from fixed or moored things such as vessels, boat sheds, boat ramps, wharves, jetties, breakwaters, pontoons etc. to loose things such as kayaks, row boats, outdoor furniture, outdoor appliances (fridges, freezers, barbeques; Figure 12). Other identifiable debris sources located across the shoreline were fallen tree logs and branches, and loose boulders which will affect the available draft (Figure 12). Overall, sediment seafloor dynamics controlling the erosion and deposition of sediment and debris, and floating and semi-submerged debris are the main concern in terms of navigation.

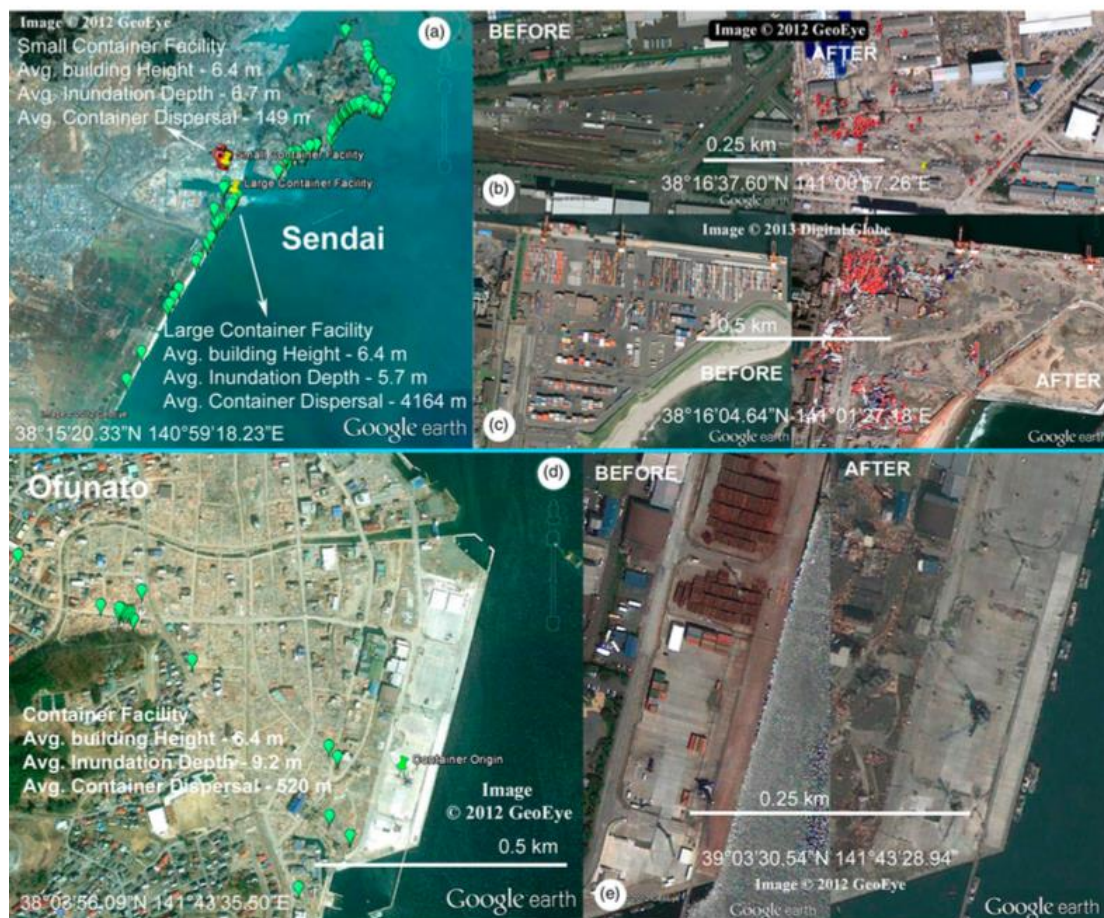
Figure 12. Looking at container dispersal from container storage facilities following the 2011 Tohoku tsunami. (a) Sendai region and port. (b) Small container facility at Sendai port before and after the tsunami. (c) Large container facility at Sendai Port before and after the tsunami. (d) Ofunato region and port. (e) Ofunato container facility before and after the tsunami. Source (Naito et al. 2014).

After the 2011 Tohoku tsunami, Naito et al. (2014) looked at the dispersal patterns of shipping containers from a large container facility in Ofunato, Japan and two container facilities in Sendai, Japan. Shipping containers were chosen because they have an identifiable origin unlike most debris such as wood, rubble and vehicles. The observed dispersal patterns of the containers from the storage facilities show good examples of how building construction type and how the height of the surrounding buildings compared to the inundation height control debris dispersal.

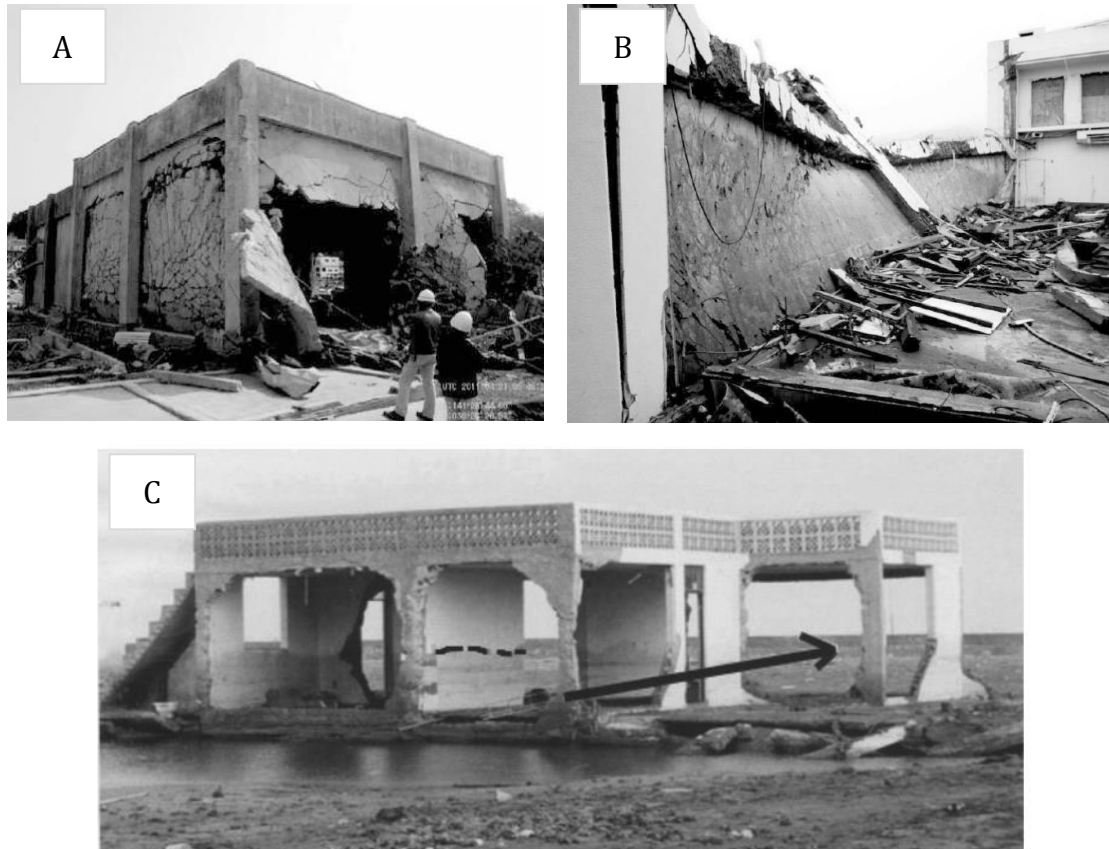
Figure 14. (A) Shear walls blown outward in a reinforced concrete building in Onagawa, Japan from the flow returning to the ocean during the 2011 Tohoku tsunami. Source (Chock et al. 2013). (B) Collapse of a steel framed multi-barrel vaulted roof due to the failure of load bearing walls (reinforced concrete pilasters and attached concrete shear walls infilled below the arch) from fluid lateral forces in Rikuzentakata, Japan. Source (Chock et al. 2013). (C) Damaged summer home in La Punta, Peru. Walls perpendicular to the direction of flow (black arrow) or parallel to the shoreline failed. Dashed lines show the stagnant water mark. Source (Okal et al. 2002)

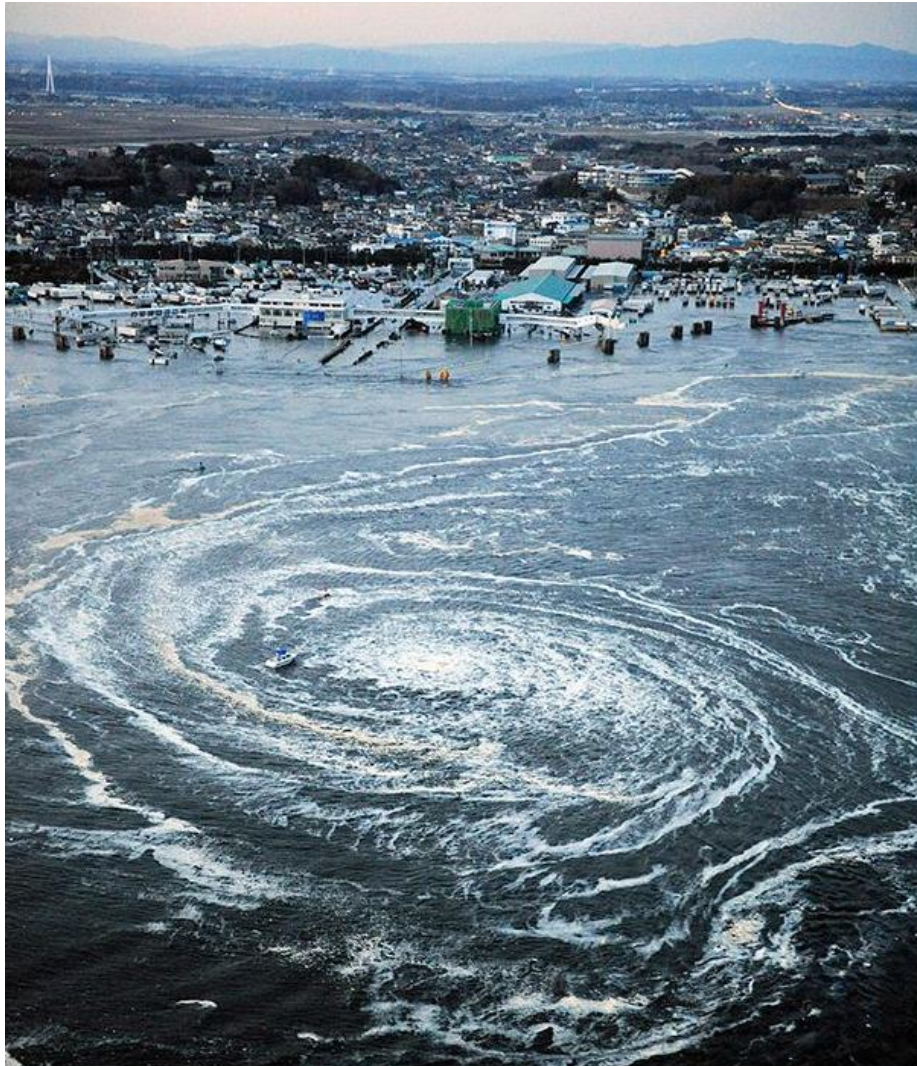
Figure 15. A huge turbulent coherent structure (TCS) is visible in the Pacific Ocean off the coast of Oarai, Ibaraki prefecture, Japan during the 2011 Tohoku tsunami. A vessel near the centre is captured trying to navigate in the TCS. Source (<http://www.ibtimes.co.uk/2011-earthquake-tsunami-60-powerful-photos-disaster-that-hit-japan-five-years-ago-1548255>).

Strong currents may not necessarily be visible turbulent coherent structures but channels or specific regions of elevated current velocities. Modelling by Lynett et al. (2014), Borerro et al. (2015a) and Admire et al (2014) showed that often the strongest currents in the direct vicinity of the port occur at the tips of breakwaters and jetties, alongside wharves and docks, through the harbor entrance and along shorelines (Appendix 5.6b) (Borerro et al. 2015b). In conclusion it seems that when the flow is constricted or interacts with coastal infrastructure the flow is often accelerated, so it is important to consider the effects of strong currents when designing coastal infrastructure to increase its resilience.

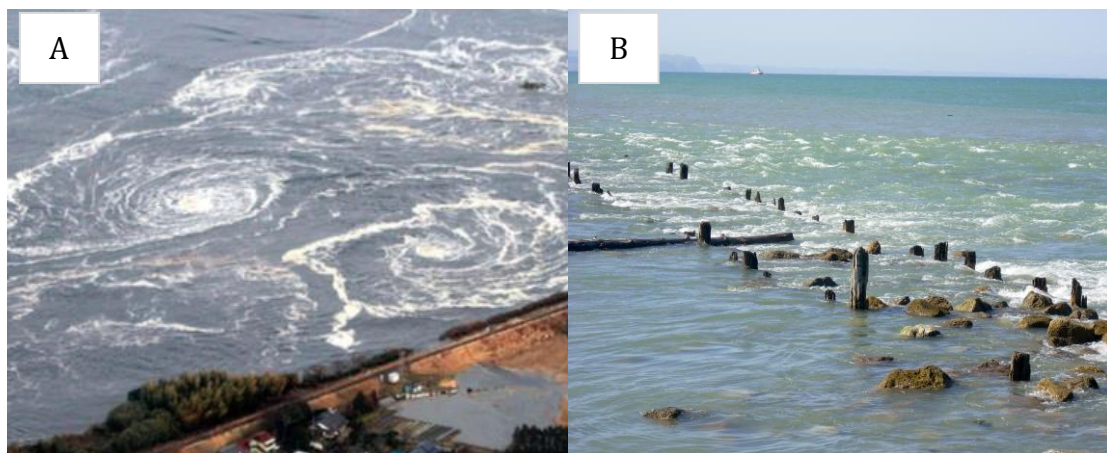
Figure 20. (A) Counter-rotating turbulent coherent structure near Iwaki city, Japan during the 2011 Tohoku tsunami. Source (Borero et al. 2015a). (B) Strong currents from the far field 2010 Chile tsunami in the Port of Napier, New Zealand. Source (<http://www.civildefence.govt.nz/resources/photo-library/tsunami/>).

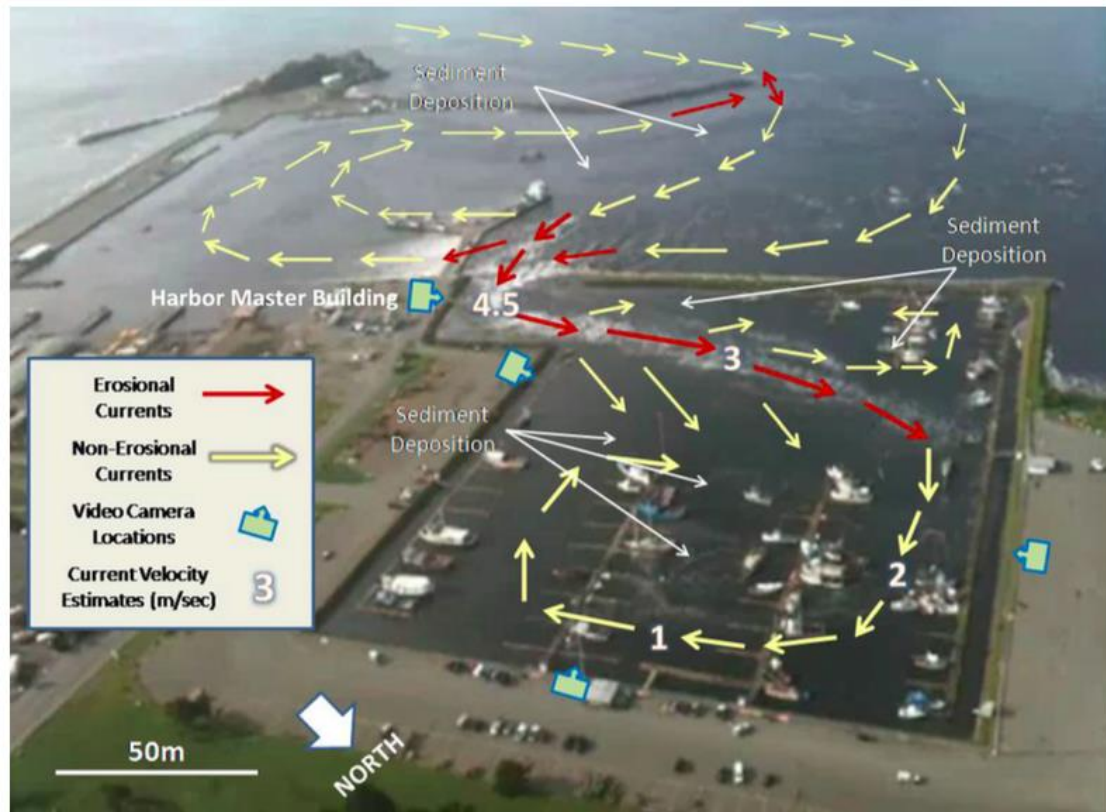
Figure 16. Tsunami in-flow regime map for Crescent City Harbor showing the maximum observed tsunami current velocity values over the span of the first 3.5h of the 2011 Tohoku tsunami. Numbers show estimated surface velocities (m/s), and arrows indicate flow direction based on 14 ground-level and aerial videos taken of the event. Source (Admire et al. 2014).

Figure 21 is an example of the tsunami flow regime in Crescent City during the 2011 Japan tsunami. The erosional and non-erosional currents highlight where sediment erosion and deposition may occur within the harbor which may have future implications on the movement of vessels and have major remediation costs.

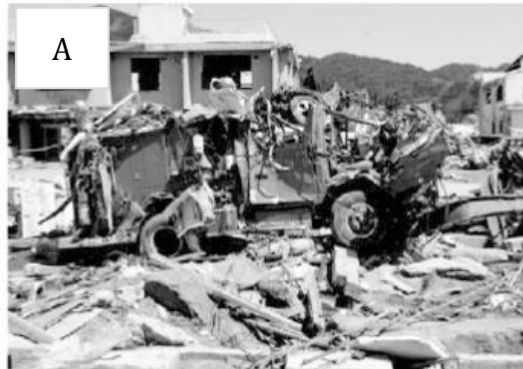
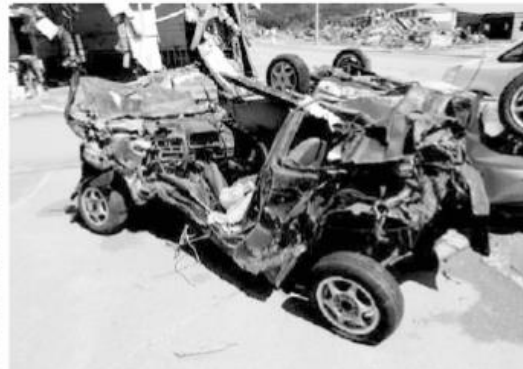
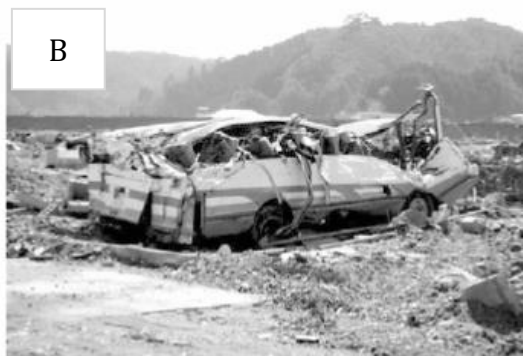
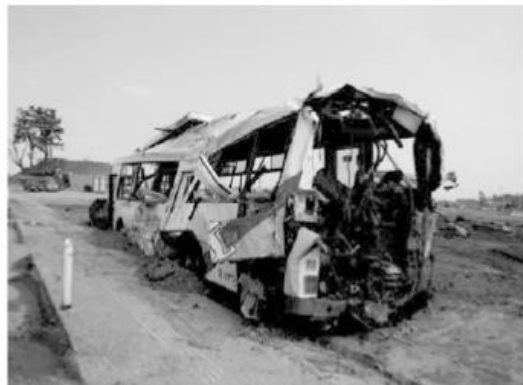
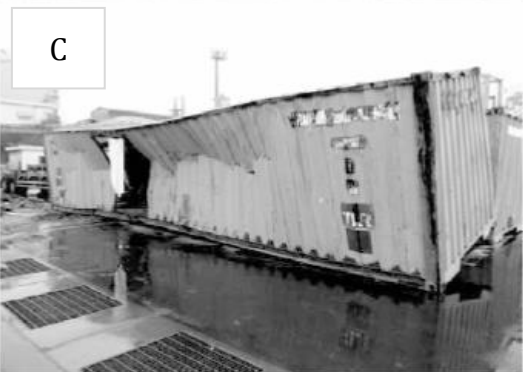
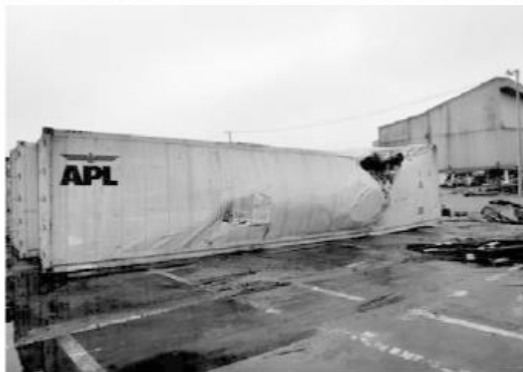
Figure 18 (over the page). (A) Fire truck (*left*) and automobile (*right*) in Otsuchi, Japan after the 2011 Tohoku tsunami. Source (Chock et al. 2013). (B) . Bus in Tarau, Japan (*left*) and in Natori, Japan (*right*) after the 2011 Tohoku tsunami. Source (Chock et al. 2013). (C) Damage shipping containers at Sendai Port, Japan after the 2011 Tohoku tsunami. Source (Chock et al. 2013). (D) Large storage tankers as floating debris in Kesenuma, Japan after the 2011 Tohoku tsunami. Source (Chock et al. 2013).

As debris such as vessels, tanks, vehicles and containers are transported in the flow they have the potential to cause damage to structures from debris strike. However the debris itself can also sustain damage as it impacts with structures, other debris or the ground. Depending on the type of debris and the sustained damage to things such as forklifts, cranes and other heavy machinery, this could have major implications in terms of response and recovery after a tsunami disaster.
