Research Report 2017-04
Civil & Natural Resources Engineering

ANTICIPATING TSUNAMI IMPACTS
IN PORT MARLBOROUGH

IMPLICATIONS FOR PORT OPERATION AND HARBOUR NAVIGABILITY
JOSEPHINE M. TURNBULL & MATTHEW W. HUGHES

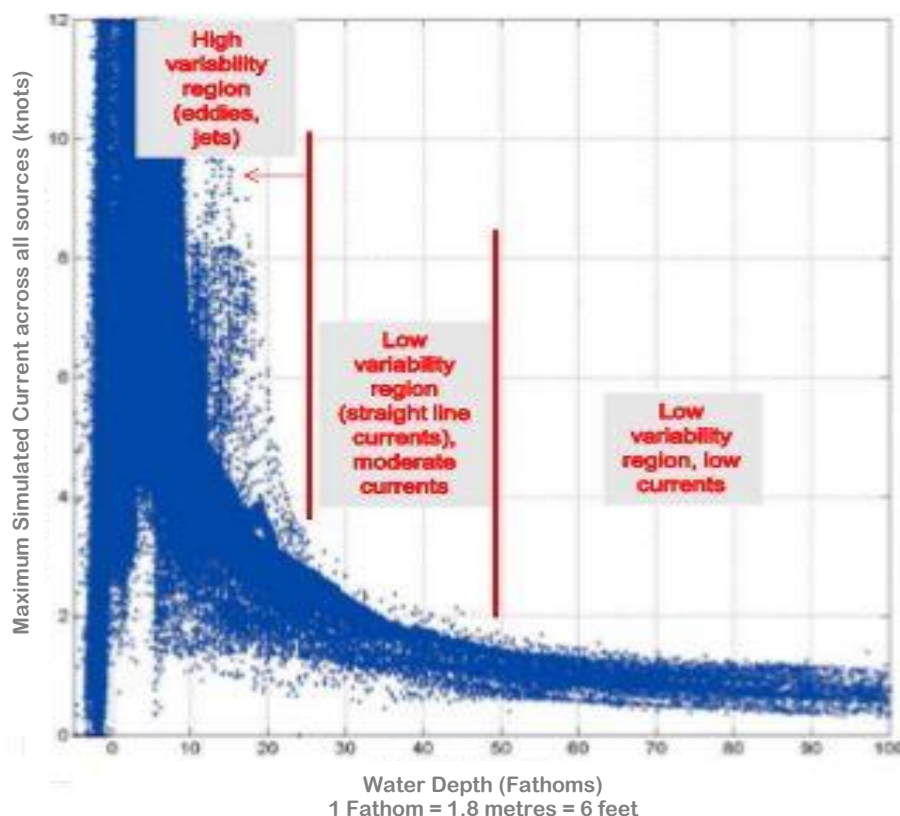
Figure 19. Scatterplot of maximum simulated current speeds as a function of water depth for all sources, all grid resolutions and all models. Source (Lynett et al. 2014).

Evacuation safe depths are an option for vessels during regional and far-field tsunamis depending on the travel time and the time information takes to be processed and distributed. Lynett et al. (2014) used a current model to produce a scatterplot of current velocities in near shore and offshore areas of Northern California as a function of water depth. Mean and maximum current velocities can be depicted from this plot. This plot aims to provide vessel with “safe” evacuation depths which is classified as no chance of vessel grounding, negligible wave steepness and readily navigable currents. Lynett et al. (2014) found that maximum tsunami currents of 1 knot (0.5m/s) are expected at a depth of 100 fathoms (~180m). Up to depths of 25 fathoms (~45m) the maximum current speed is highly variable indicating that this is the greatest depth that large eddies or jets might extend to. Once depths greater than 30 fathoms are reached (~55m) it will generally be safe, particularly for dispersed and larger vessels.

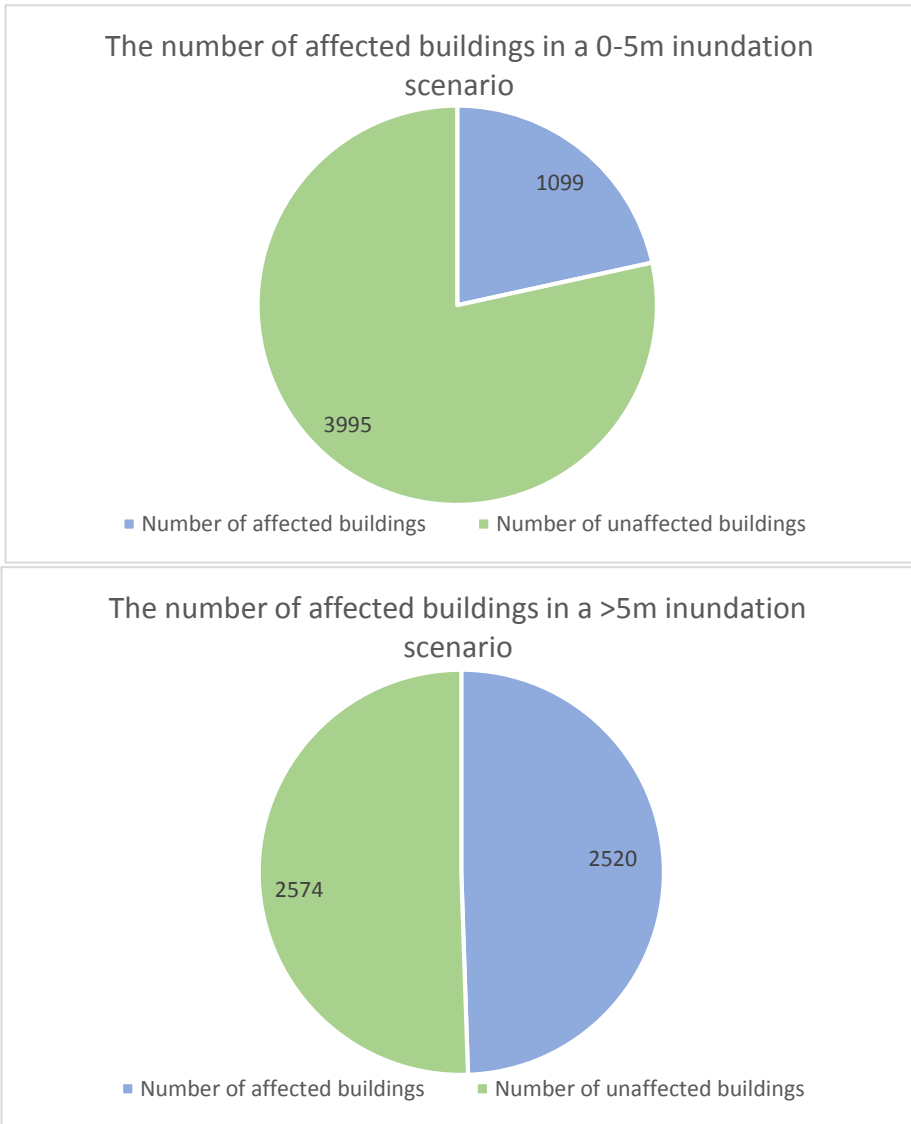
Figure 21. The cumulative number of affected buildings under each inundation scenario in Queen Charlotte Sound

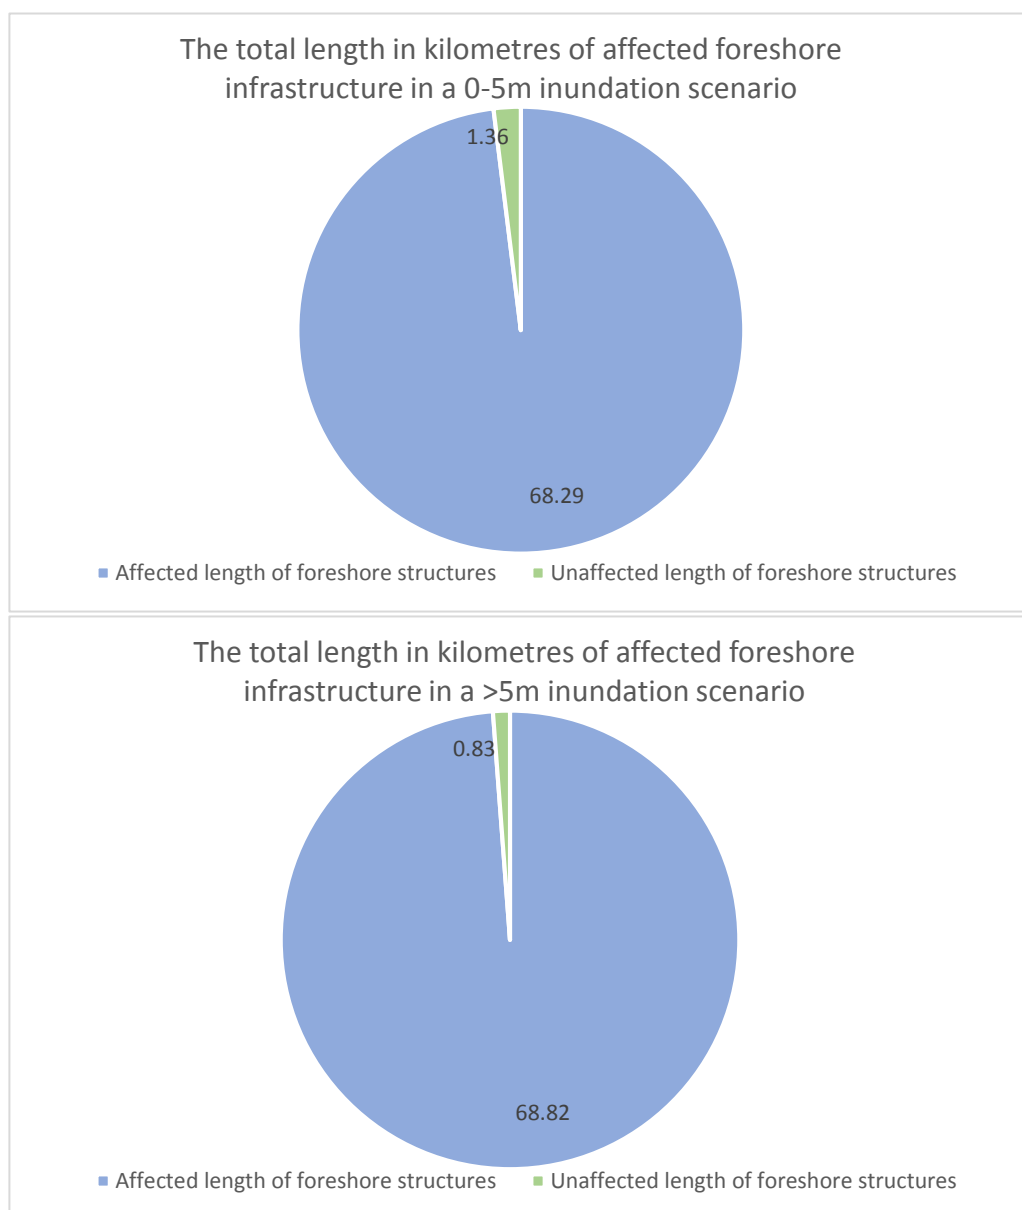
Figure 23. The cumulative affected length in kilometres of foreshore infrastructure in the Marlborough Sounds.

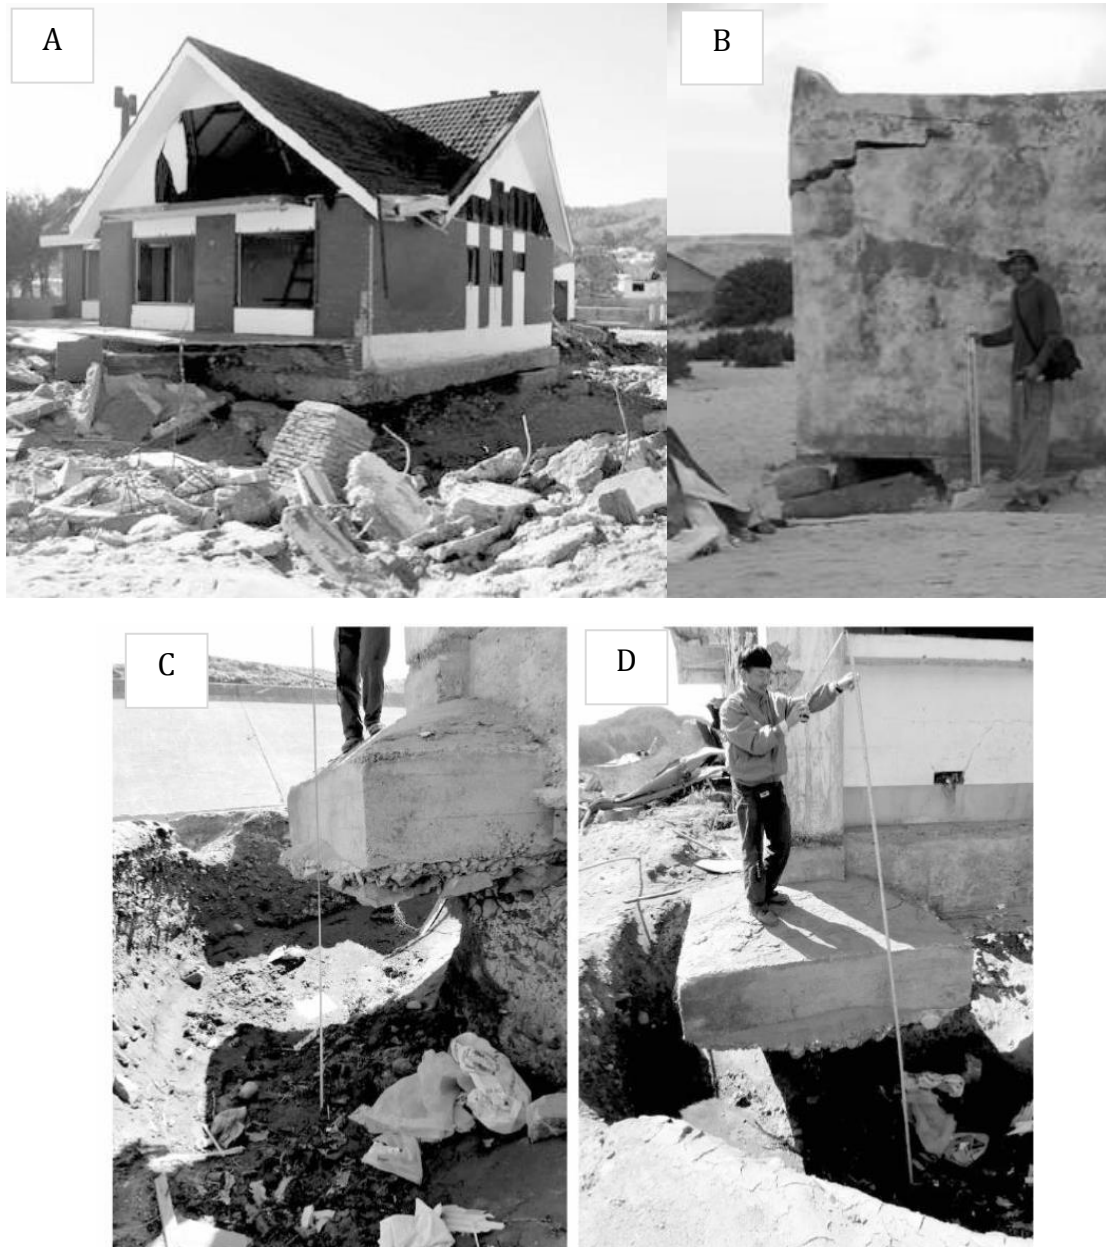
Figure 137. Examples of corner scour: (a) damage to a home in Dichato, Chile. Source (Edge et al. 2013). **(b)** Far-field effects from the 26th December 2004 tsunami in Xaafun, Somalia showing scour damaged a house corner. Source (Fritz & Borerro 2006). **(c-d)** 1.4m deep scour pit below a buildings foundations behind a failed seawall in Tarou, Japan. Source (Chock et al. 2013).

Scour is characterized by sustained shear flow around obstacles and includes plunging scour during seawall overtopping (Chock et al. 2013). The most predominant scour from past tsunamis is corner scour around foundations resulting in structural failure in some cases and also plunging scour on the landward side of tsunami barriers as they are overtopped.

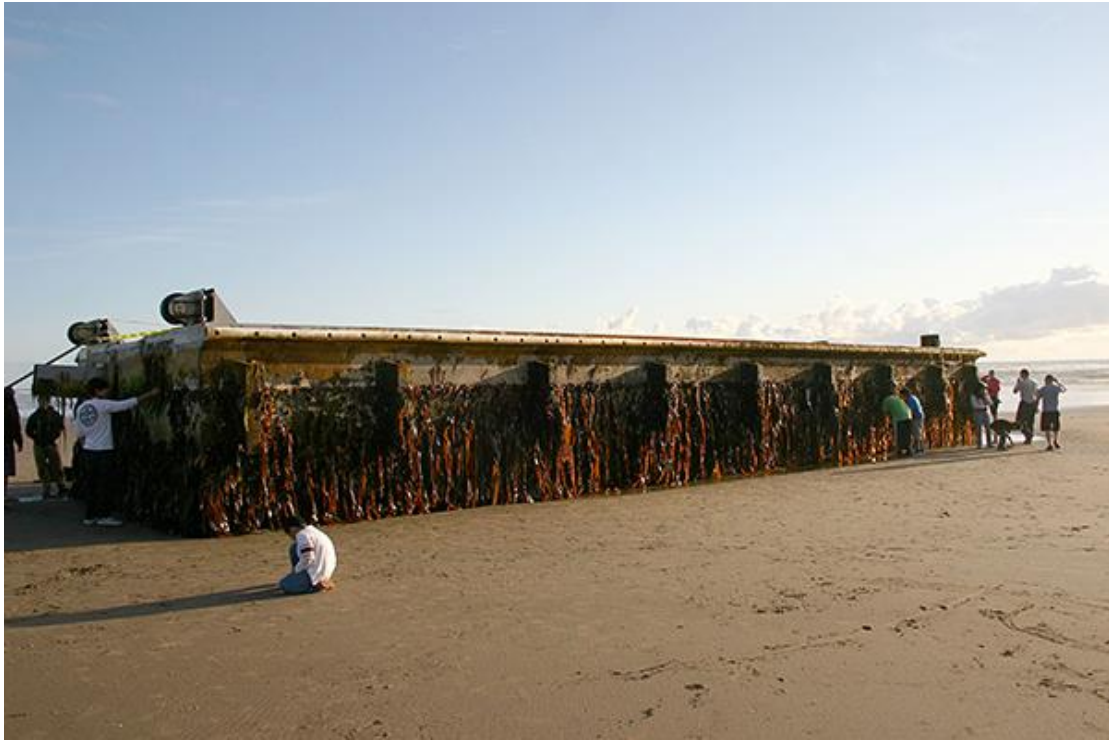
Figure 138. A 66-foot floating dock from the Port of Misawa, Japan drifted across the Pacific Ocean and beached 15 months later on Agate Beach in Oregon, US after the 2011 Tohoku Tsunami. Source (<https://usresponserestoration.wordpress.com/2012/12/>)
