Kapiti Views Trust
Maxwell Hills Development
Plan Change Landscape Report

Landscape Assessment
Graphic Supplement

08 Feb 2011

Prepared By:
Chris Glasson Landscape Architects Ltd
BNZ BUILDING, 137 Armagh St.
Christchurch 8141, NEW ZEALAND
P.O Box 13162
Ph. 03 3654599
www.chrisglasson.com

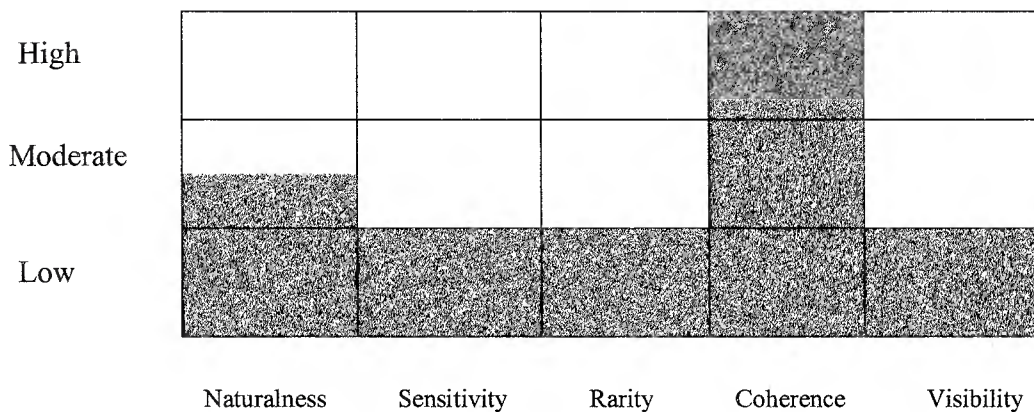
Fig 1. Summary of effects on the character and quality of the landscape

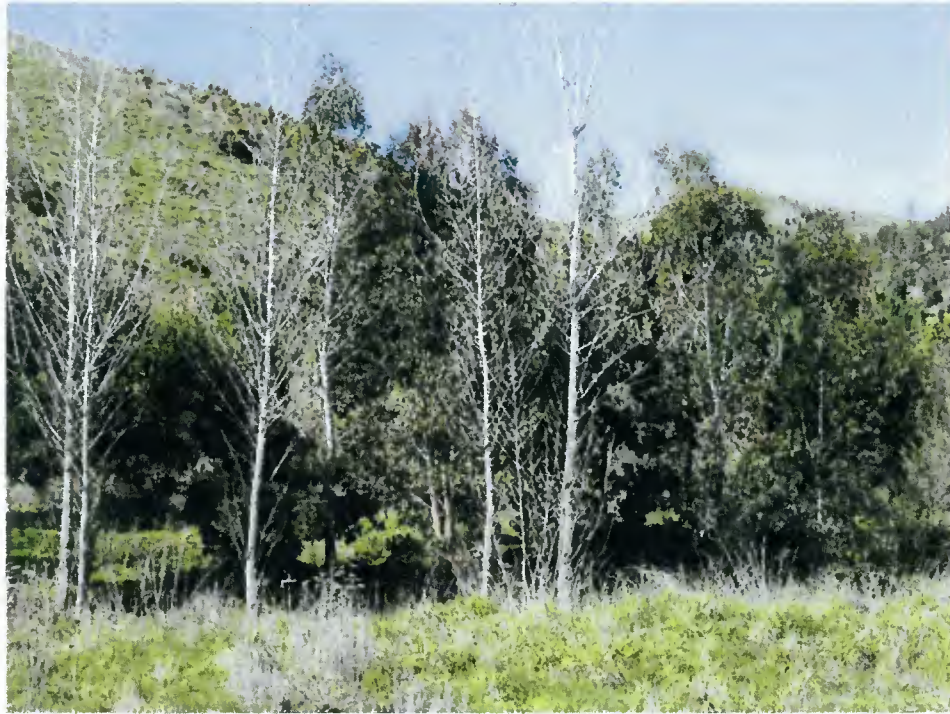
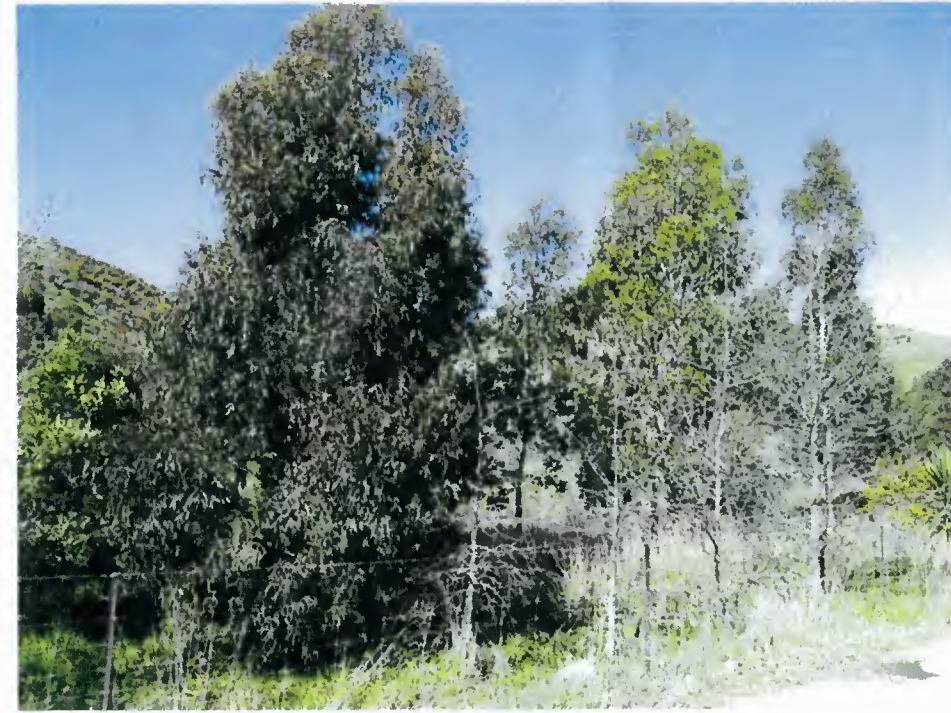
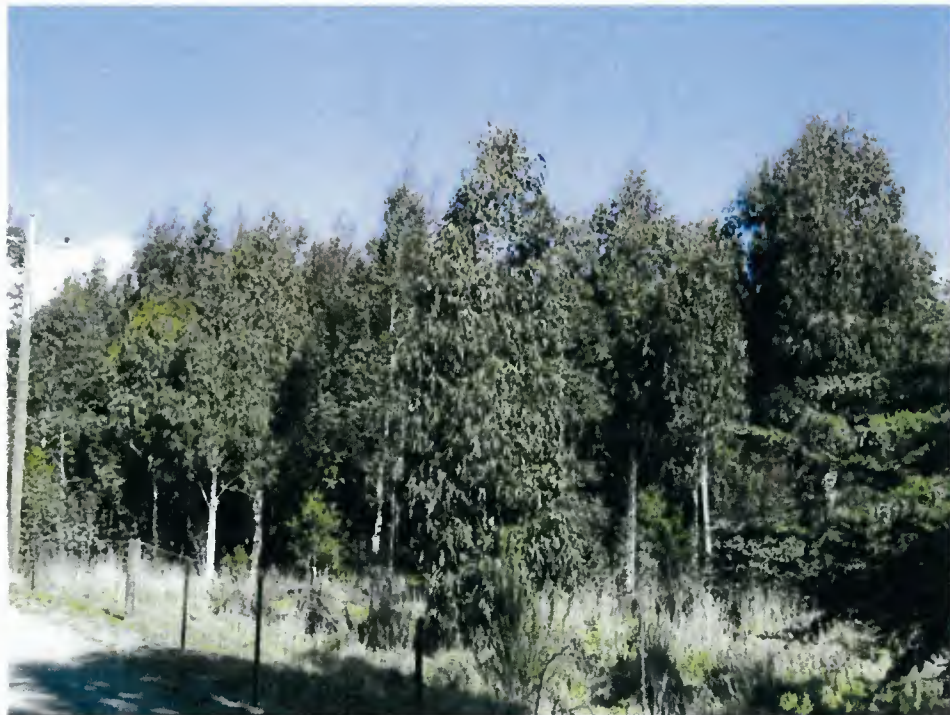
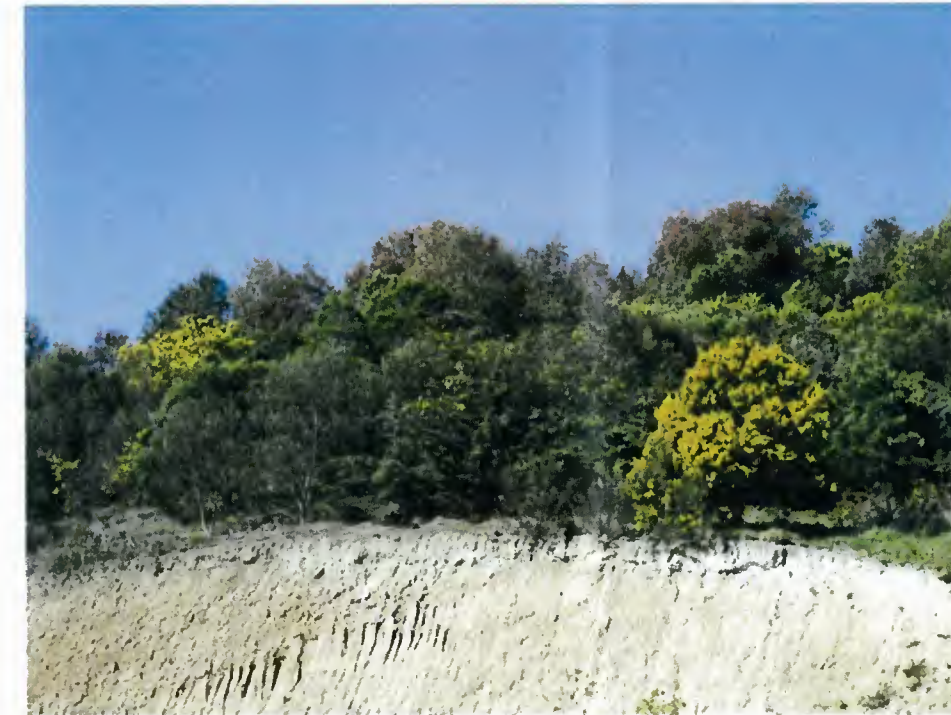
10.0 Examples of successful planting, Blenheim Landfill

(see also images 10.1-10.4 in Graphic Supplement).
