**MARLBOROUGH
DISTRICT COUNCIL**

Taylor River Catchment Characterisation - Doctors Creek

**Technical Report No: 15-001
March 2015**

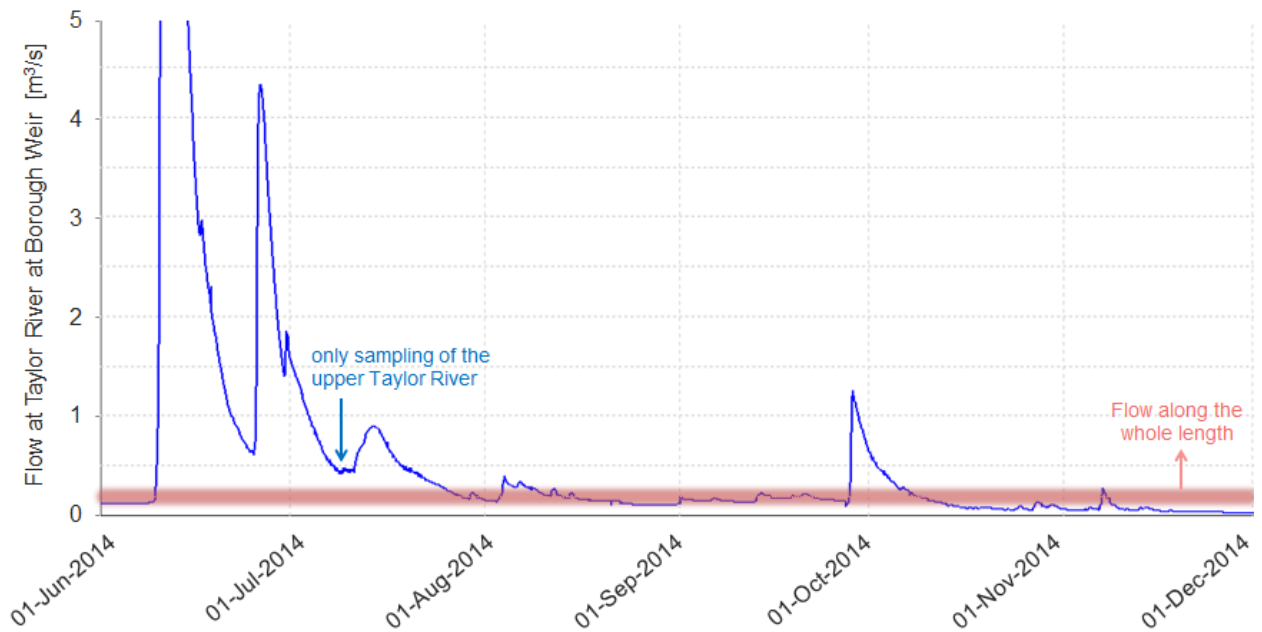
Figure 2: Taylor River flow at Borough Weir. Flows above the red line indicated continuous surface flow along the whole length of the river, downstream of the flow site.

Unfortunately, after the first sampling round of the upper Taylor catchment was carried out in July 2014, a dry winter resulted in no other sampling opportunity at base-flow (Figure 2).

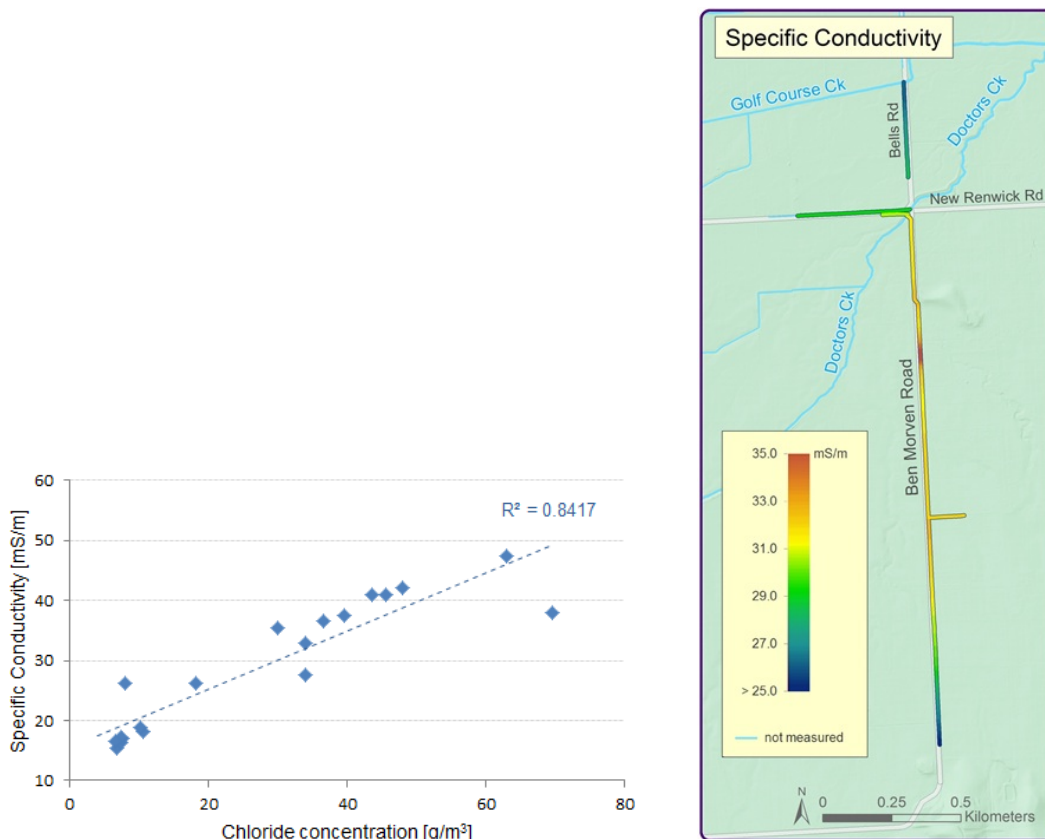
Figure 9: Correlation between Specific Conductivity and Chloride concentrations for samples from the Doctors Creek catchment. On the right: Specific Conductivity in road drains along Ben Morven Road, Bells Road and New Renwick Road.

Specific conductivity³ can also be used as an indicator of groundwater age. The higher the ion concentration of groundwater, the higher the conductivity. There is a good correlation between the chloride concentration and specific conductivity of samples taken from Doctors Creek (Figure 9). To investigate if the change in the age of emerging groundwater is gradual or if older groundwater is rising in defined areas, specific conductivity was measured in the Ben Morven Road Drain. The measurements were taken after a prolonged period without significant rainfall, when groundwater levels in the area were low enough, so that none of the tile drains were adding any water from adjacent vineyards, but the main drain was still carrying water for nearly the entire length. Apart from a small surface inflow about half-way, any flow increase was due to groundwater inflow through the bed of the drain. The nearly perfectly straight morphology and northerly direction made it perfect for the investigation. The specific conductivity of other road drains along New Renwick Road and Bells Road was also measured. The results are shown in Figure 9. The water furthest south is actually quite young suggesting a dominance of subsurface inflows that are remnants of rainfall that had fallen some months earlier. The age of the inflowing groundwater increases in a downstream direction, reaching a peak about 400m upstream of the New Renwick Road Bridge and decreases again further downstream. The area with the highest conductivity is close to an inferred fault [6]. This indicates that older water from the deeper aquifer is entering the shallower aquifer in distinct locations, in areas where impermeable layers are damaged, rather than through relatively even seepage.

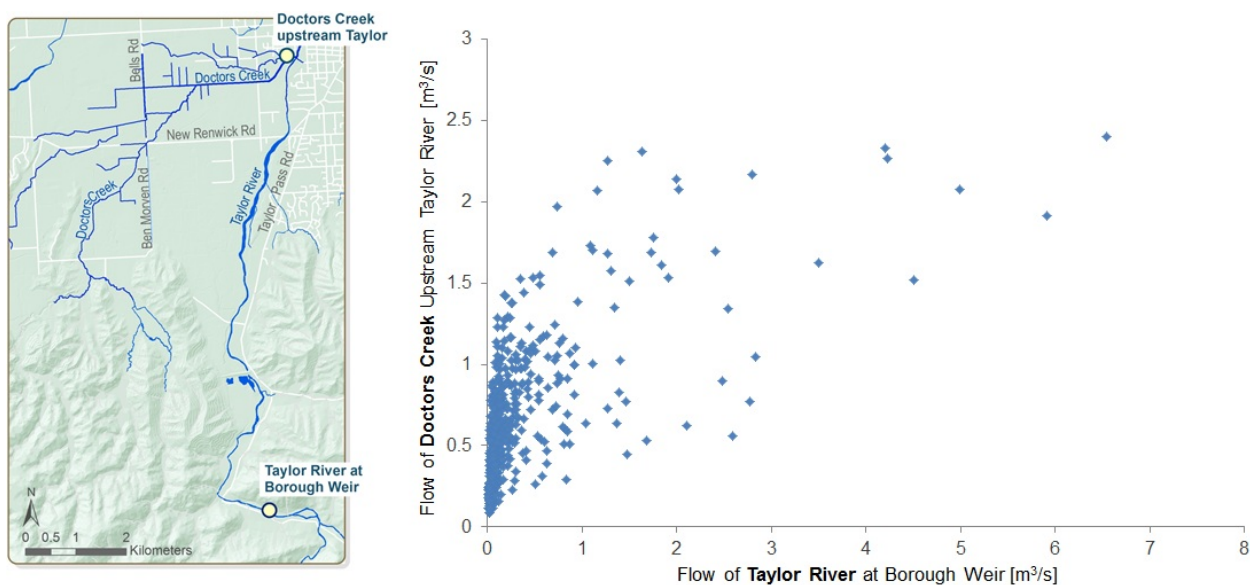
Figure 11: Correlation between the flow in Doctors Creek upstream of the Taylor River and the Taylor River at Borough Weir.

Unfortunately we do not have continuous flow measurements for Doctors Creek, but a large number of gaugings were carried out just upstream of the confluence with the Taylor River. The closest continuous flow recorder is located on the Taylor River at Borough Weir. However, due to the significant effect groundwater inflow has on the hydrology of Doctors Creek, but not the Taylor River, the flows at the two sites do not correlate well (Figure 11).

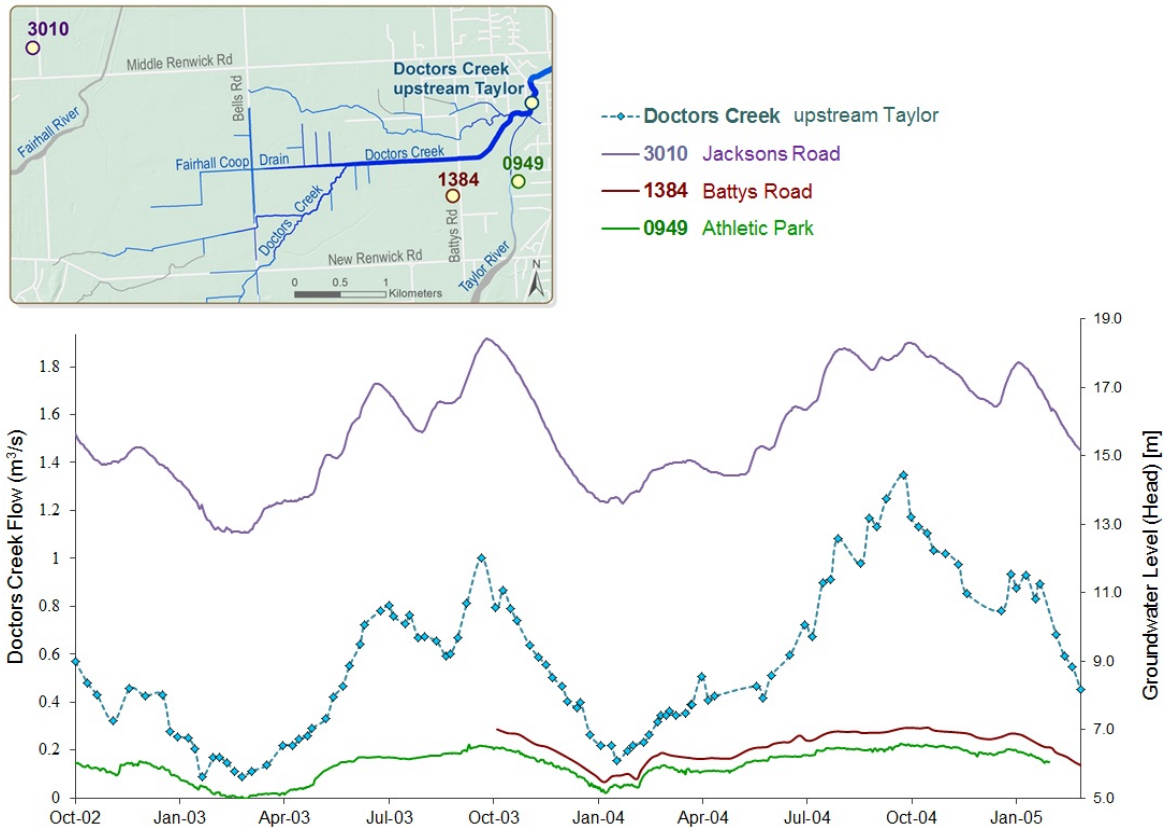
Figure 12: Flow in Doctors Creek upstream of the Taylor River compared to groundwater levels measured in nearby wells.

The flow in Doctors Creek does, however, follow the water levels in nearby wells; particularly bore 3010 to the west of the catchment (Figure 12). The good match with this well also indicates the larger contribution of water from the Wairau aquifer in the north to the overall flow in Doctors Creek.

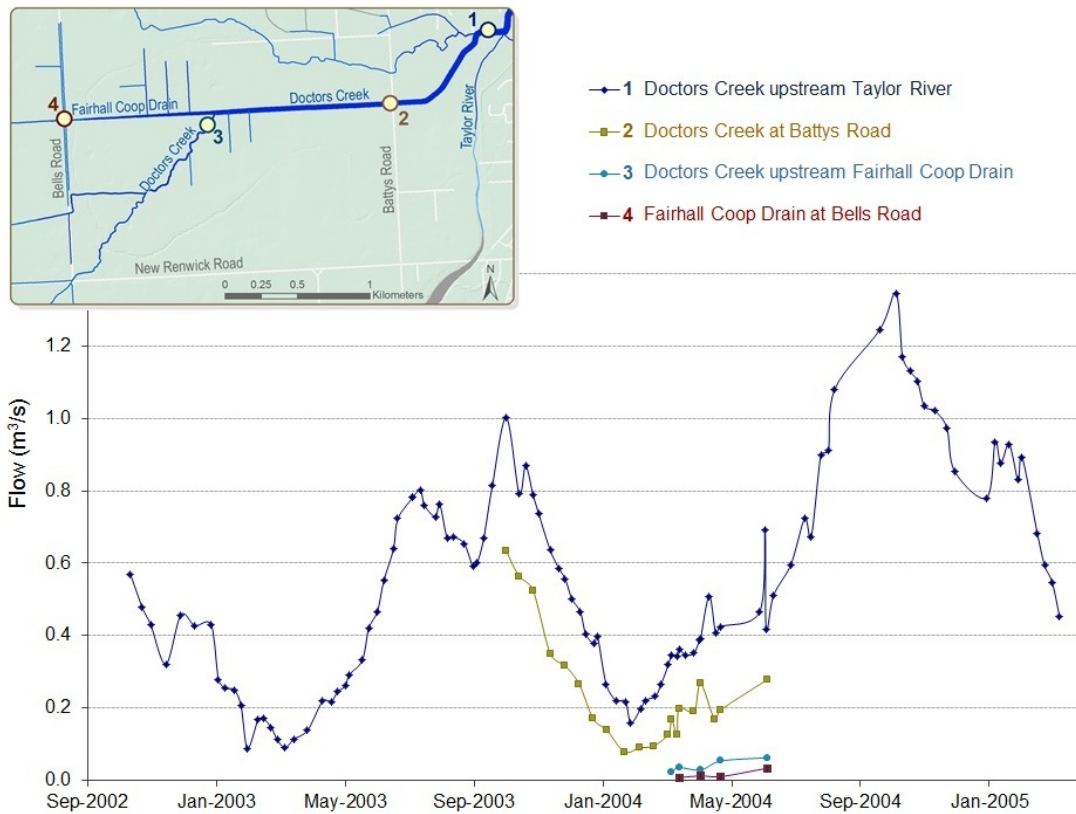
Figure 13: Results from flow gaugings in the northern part of the Doctors Creek catchment.

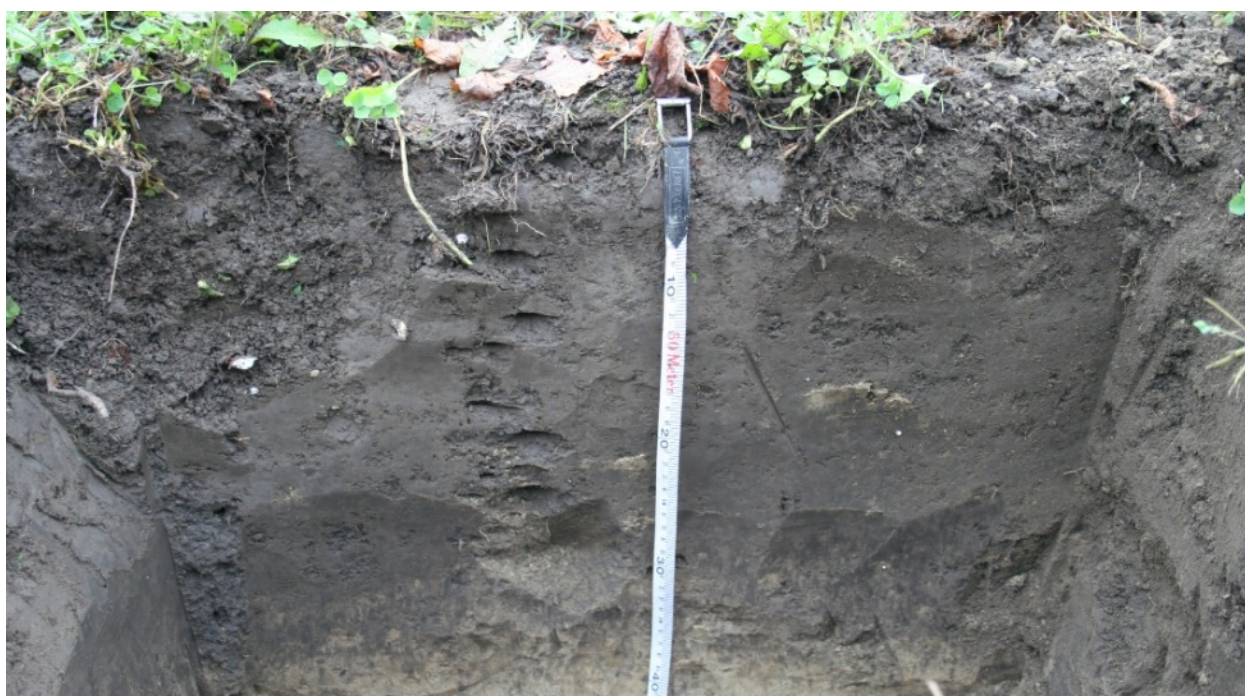
Figure 14: Profile of a Paynter soil.

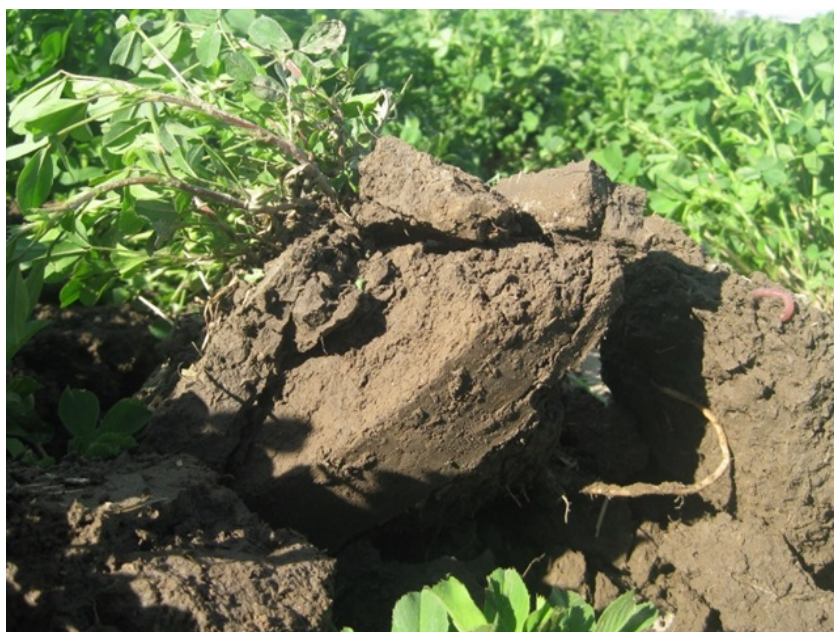
Figure 17: Compacted soil with low Total Carbon content under cropping at site MDC-5.
