WAIRAU
RIVER
FLOODWAYS
MANAGEMENT
PLAN

Marlborough District Council

Operative Date - 25 August 1994

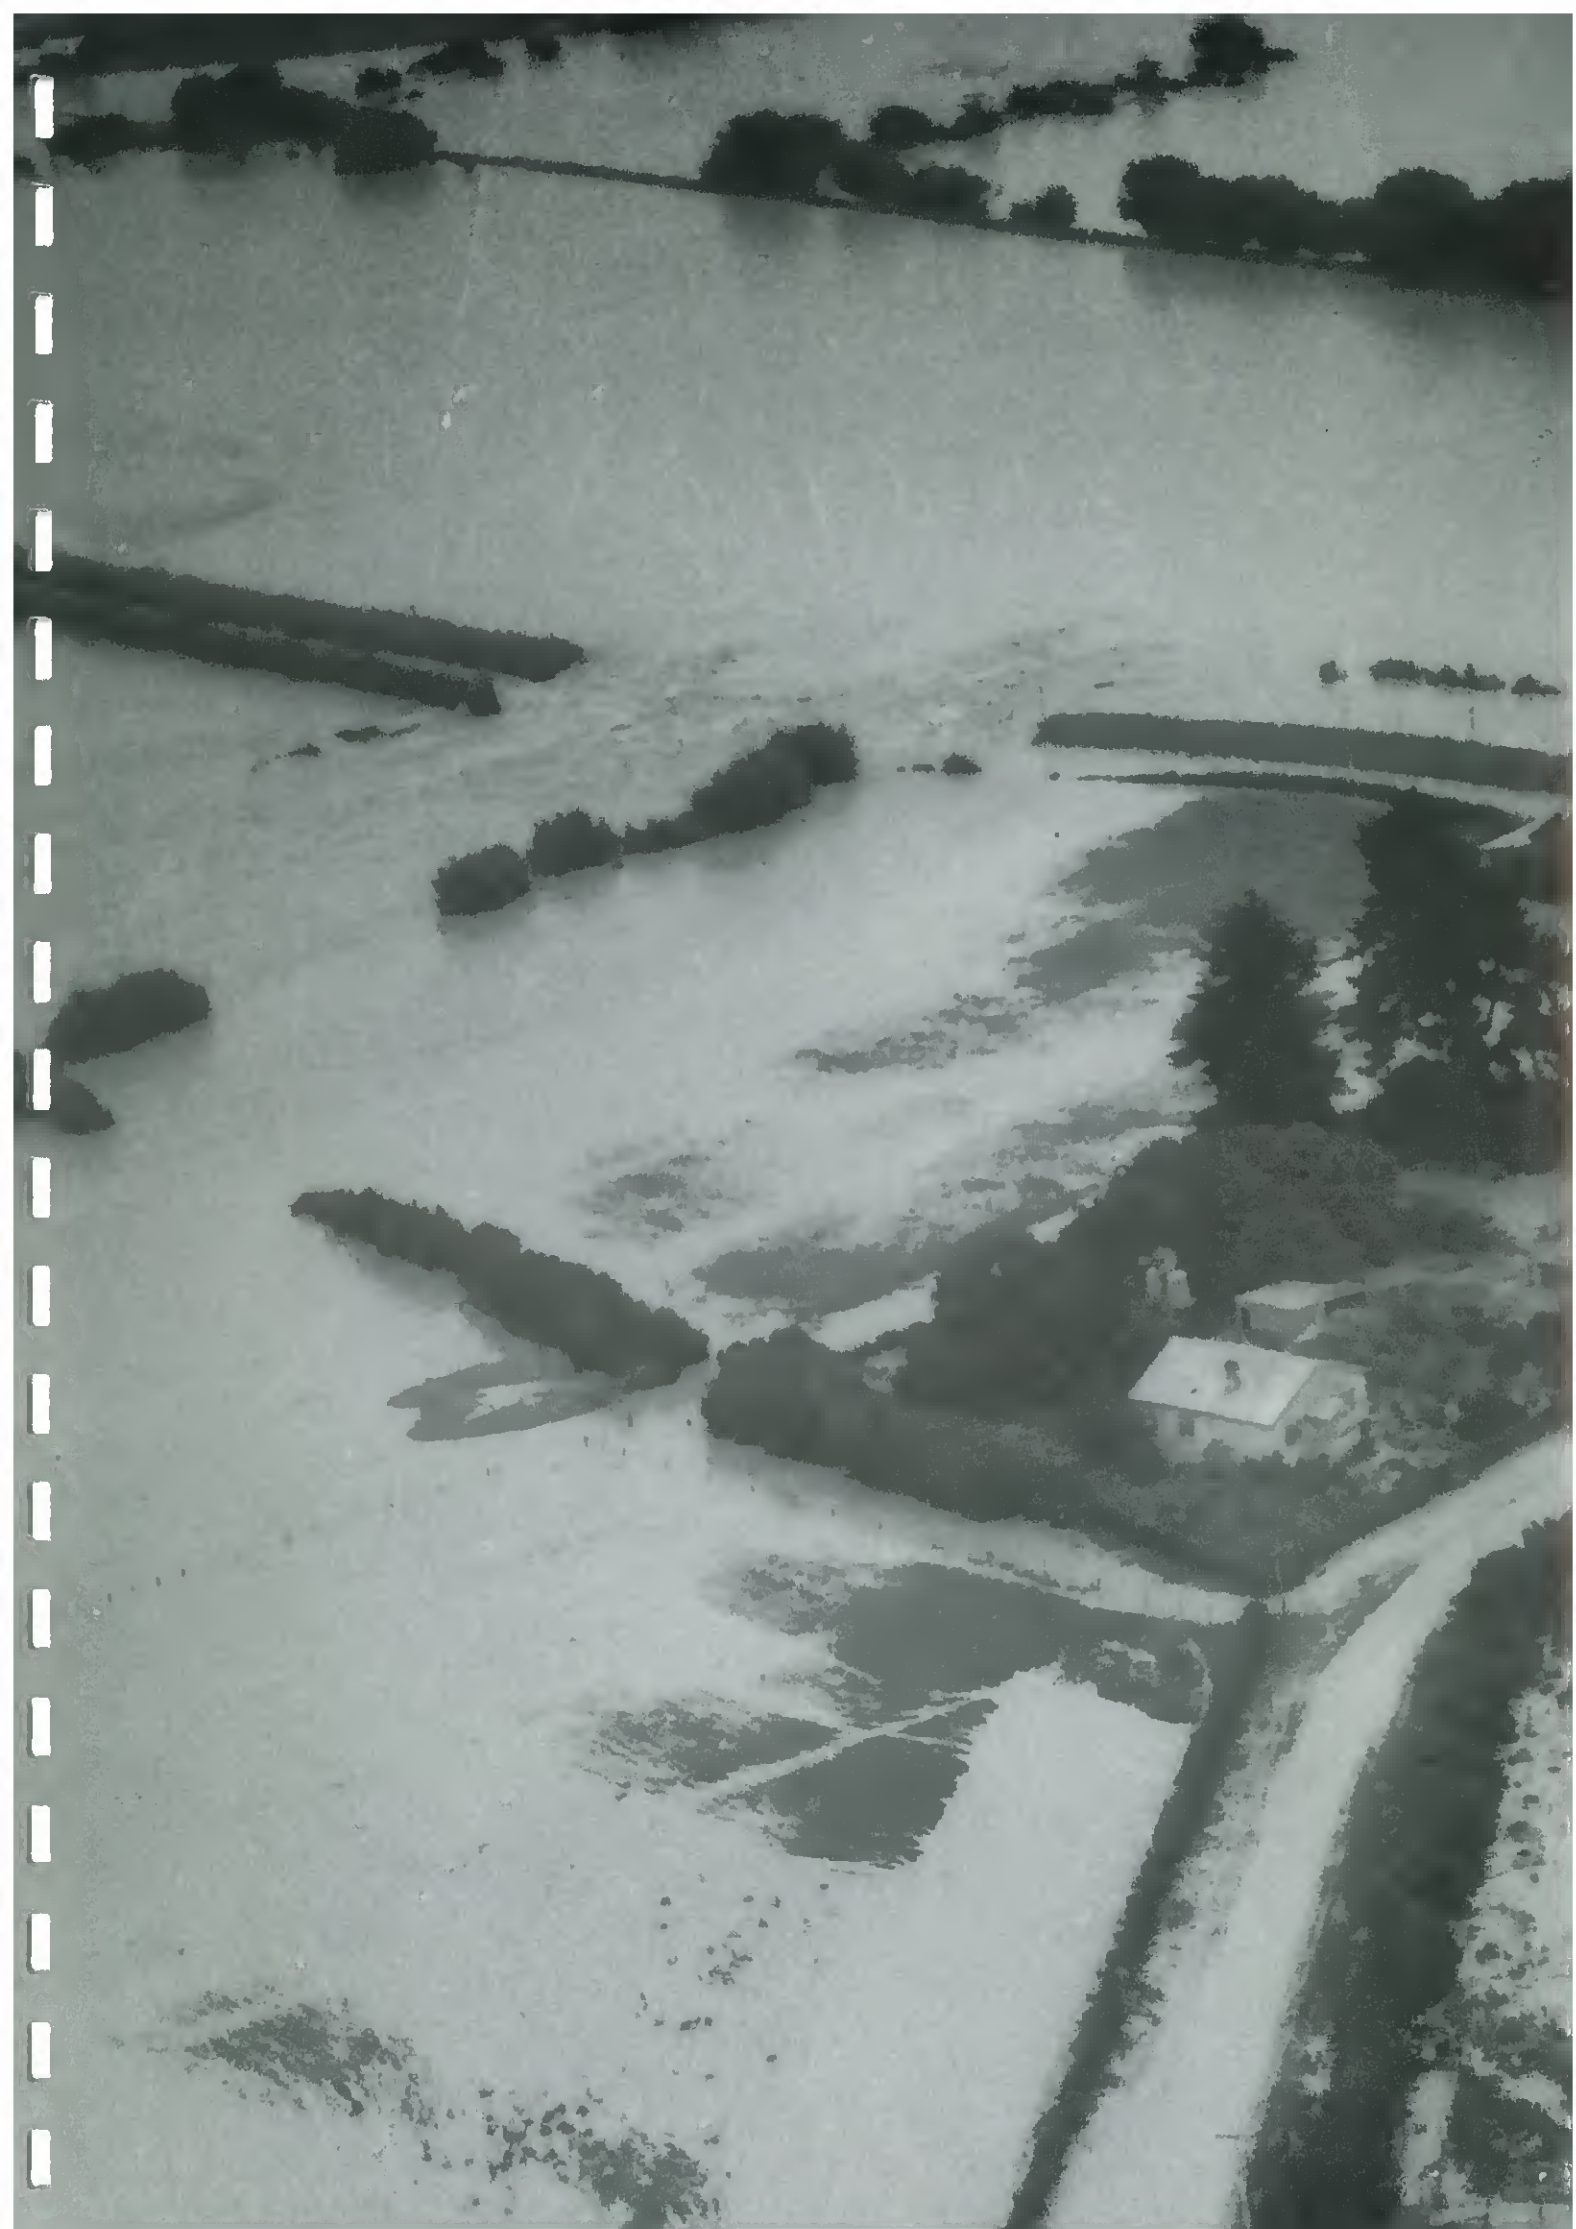
Photograph : Breach in lower Wairau stopbanks near Dicks Road - 2 December 1939

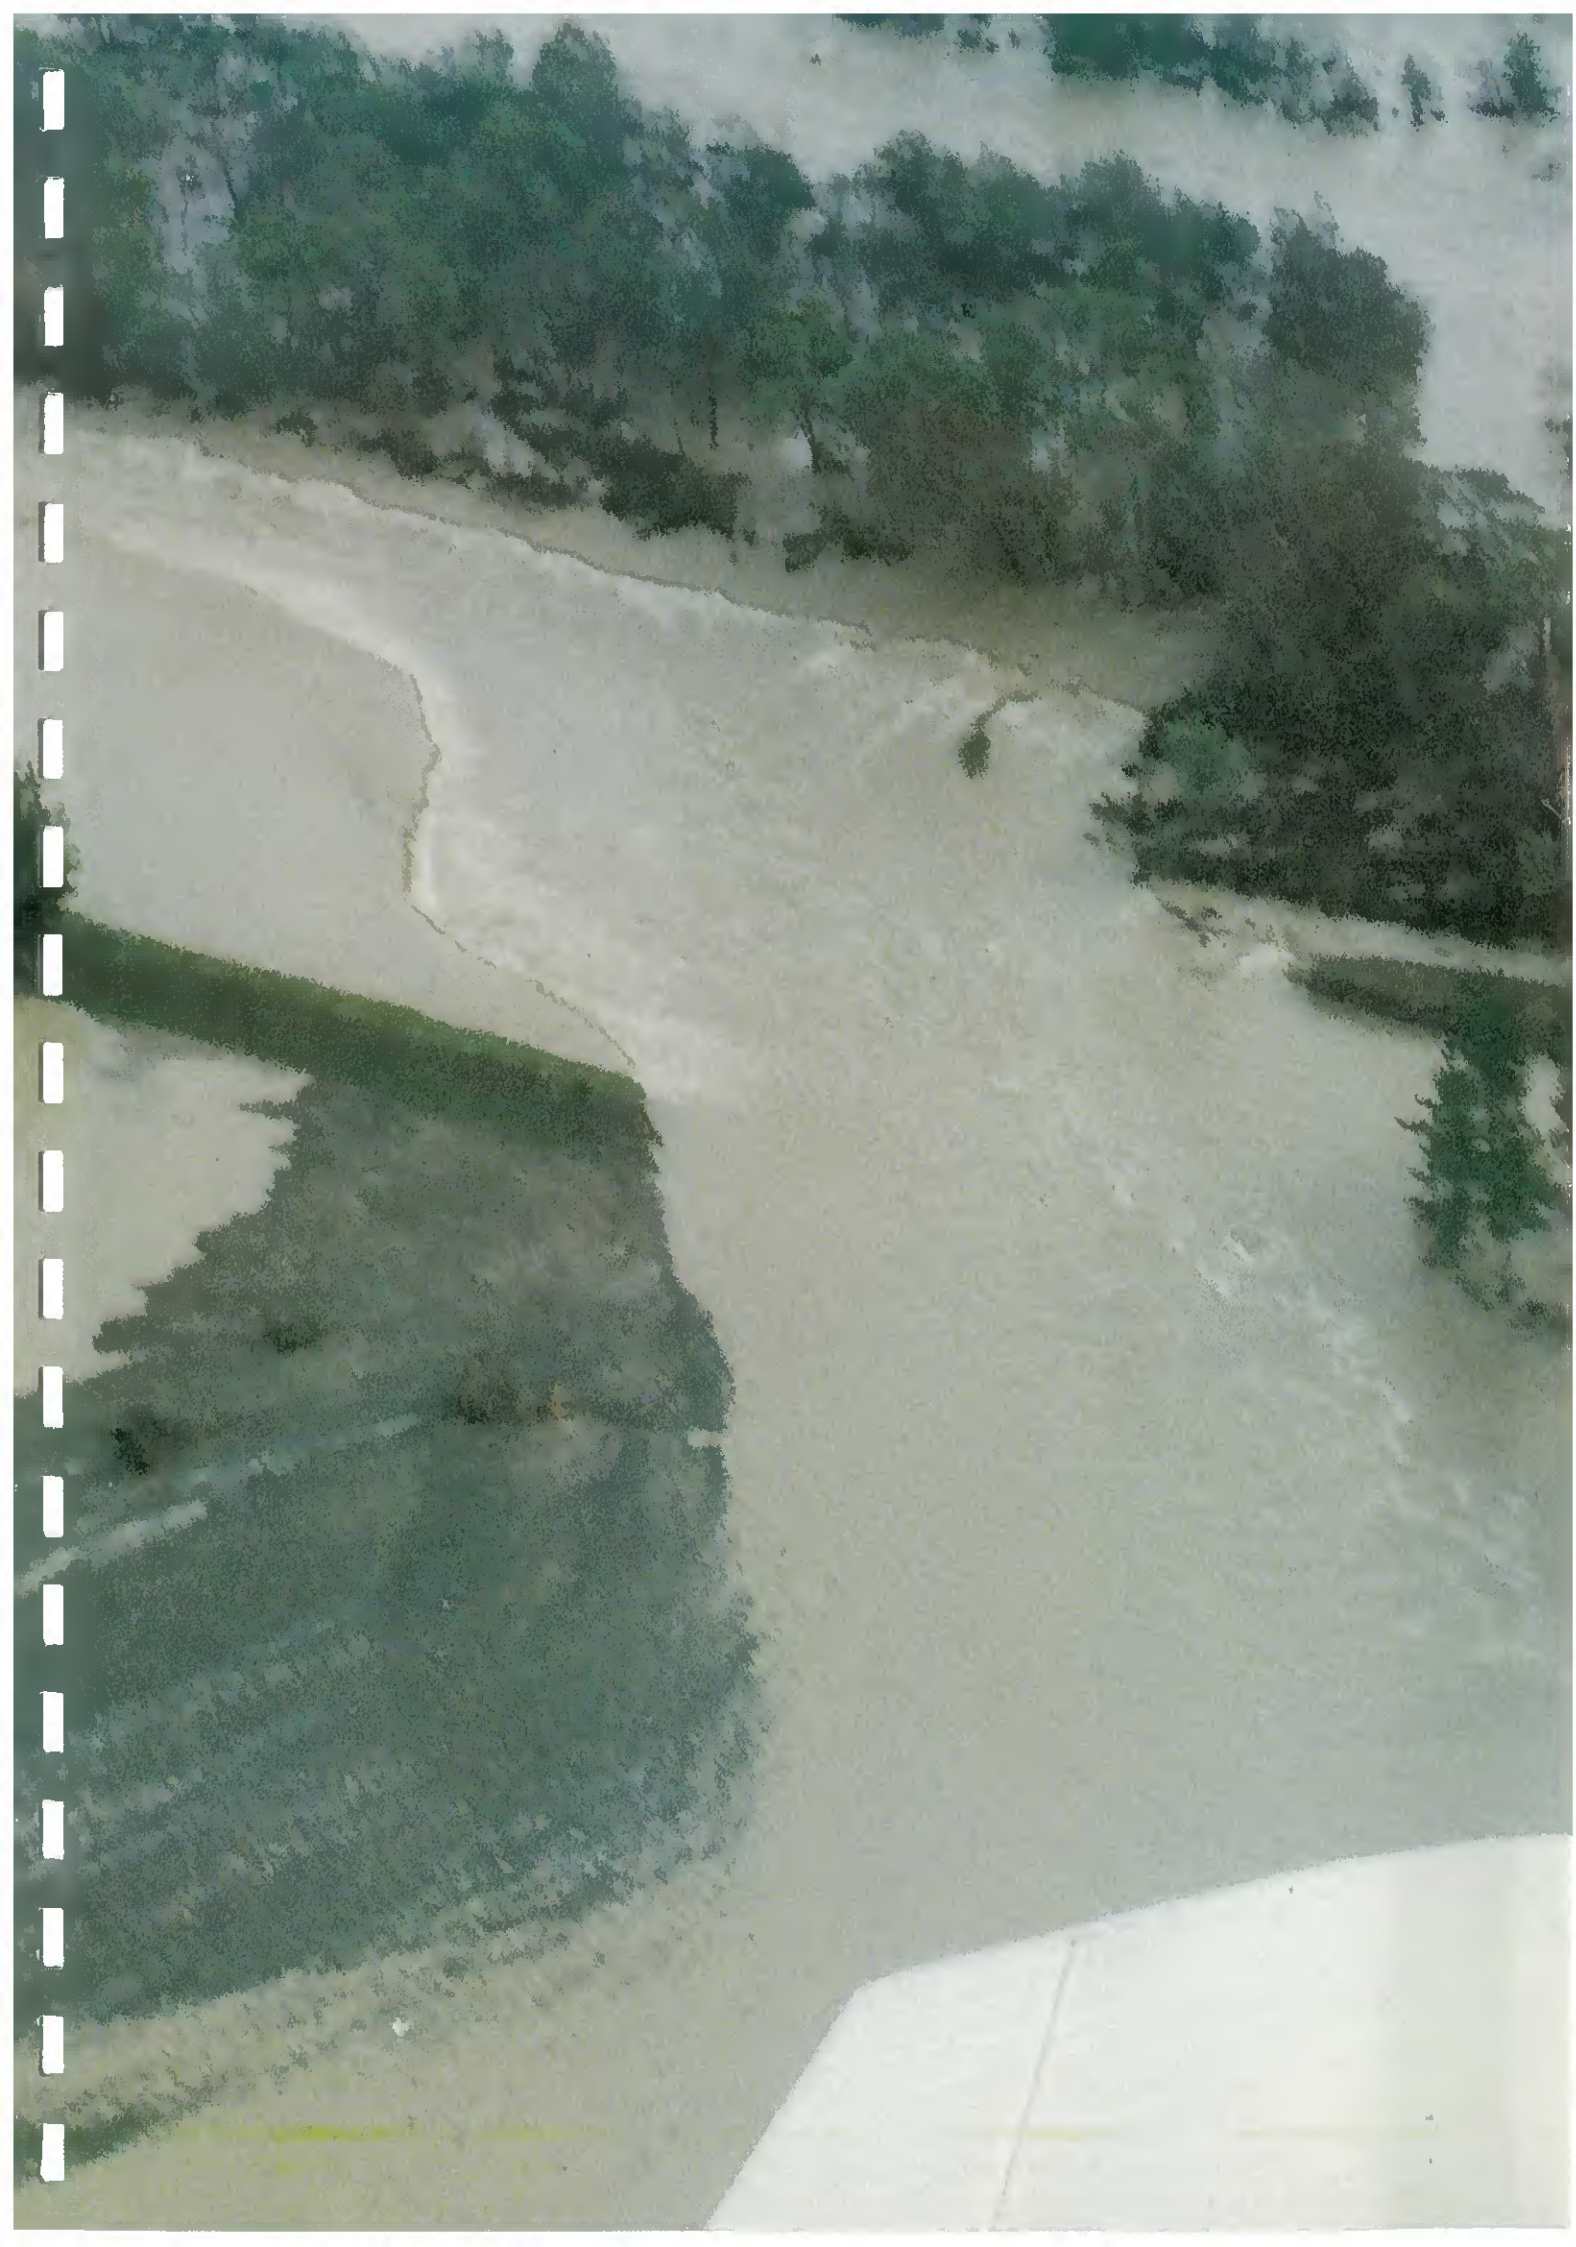
Photograph : Breach of stopbank into old Opawa channel at Conders Groyne - 10 July 1983

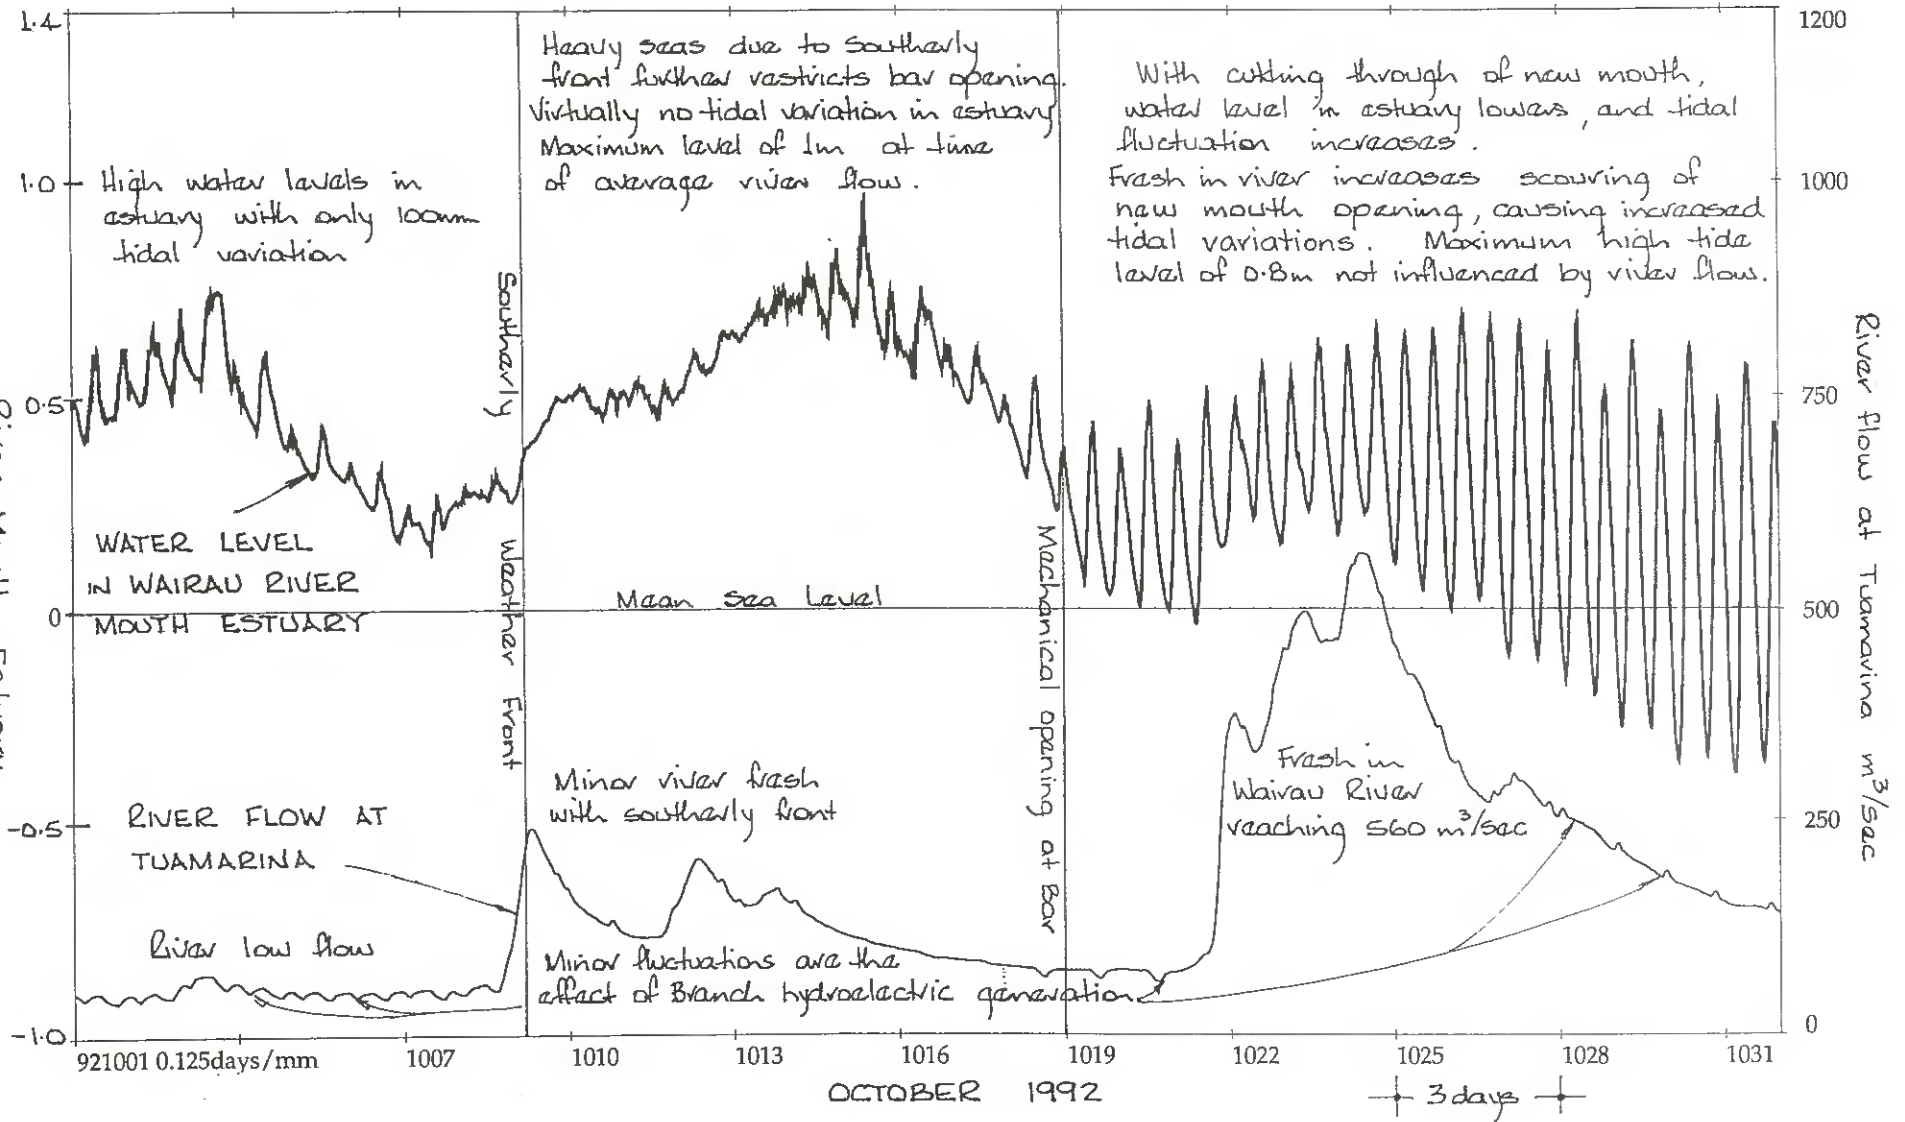
Figure D2

River Mouth Estuary
Water Level in Estuary

FIGURE D2

WAIRAU RIVER MOUTH.

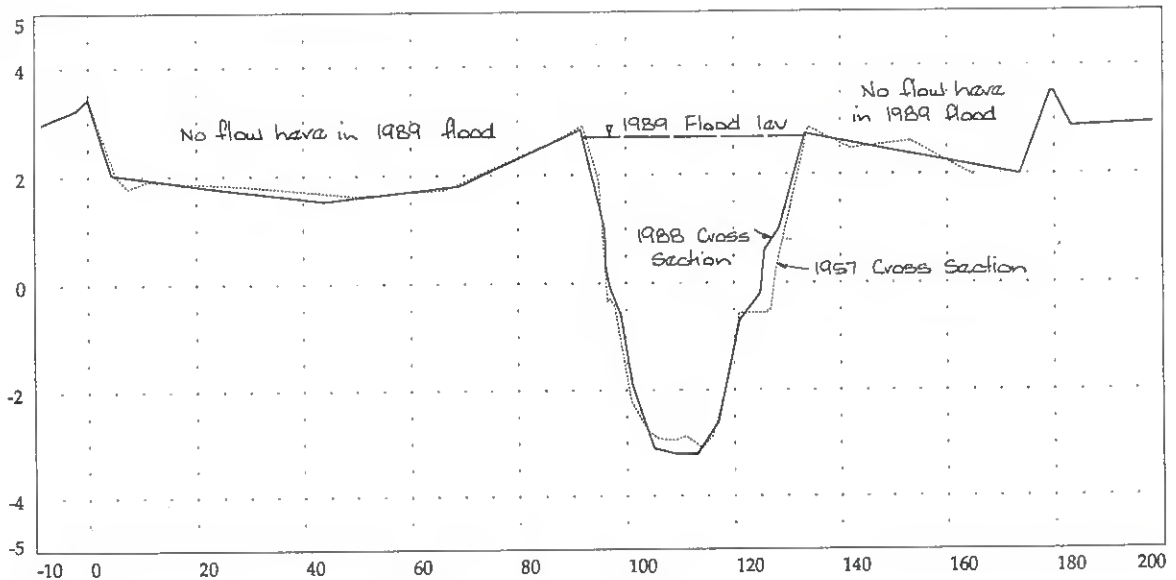
FIGURE D10 LOWER OPAIA RIVER

Cross section 24 near Matthouse Road
 In sept 1989 high flood levels occurred in main channel but no flow on berms. Also note similarity of 1988 and 1957 cross section profiles.
