Project update

20 October 2021

Awatere Valley

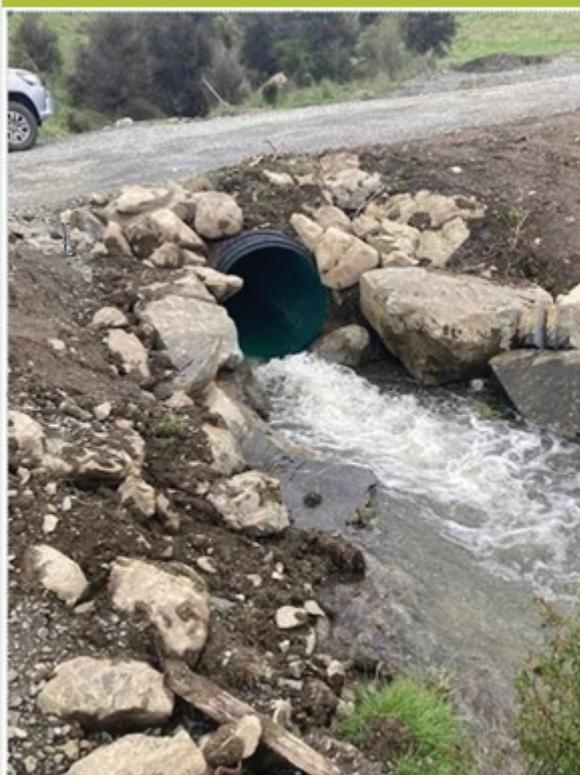
Rock armouring at the inlet and outlet of a 900mm culvert at 6.7km

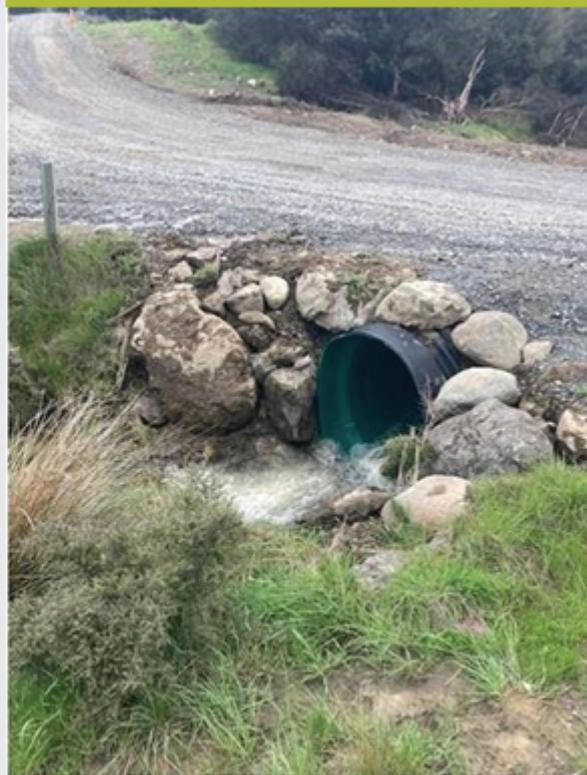
This culvert was installed during emergency work

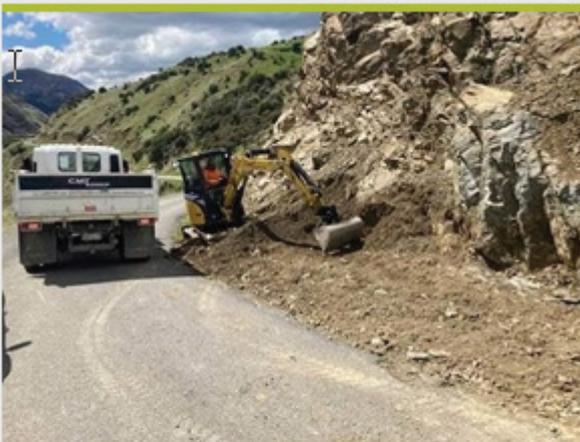
At 13.3km, an overslip has been cleared

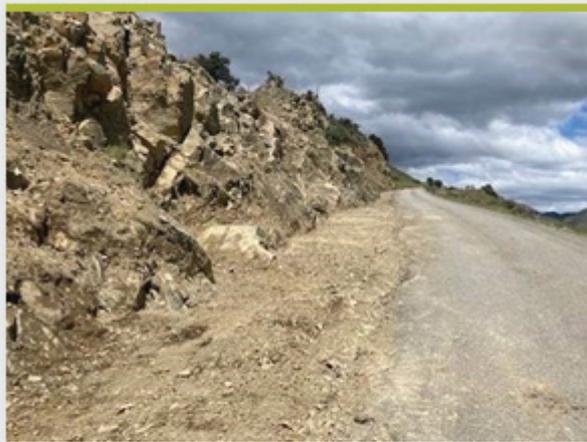
The damaged rock face has been tidied up

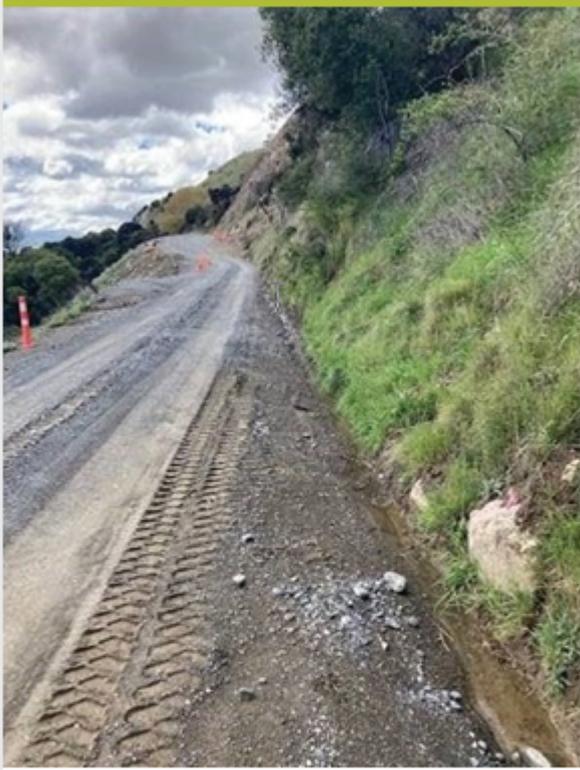
Between 7.4km and 7.8km, water tables have been reinstated

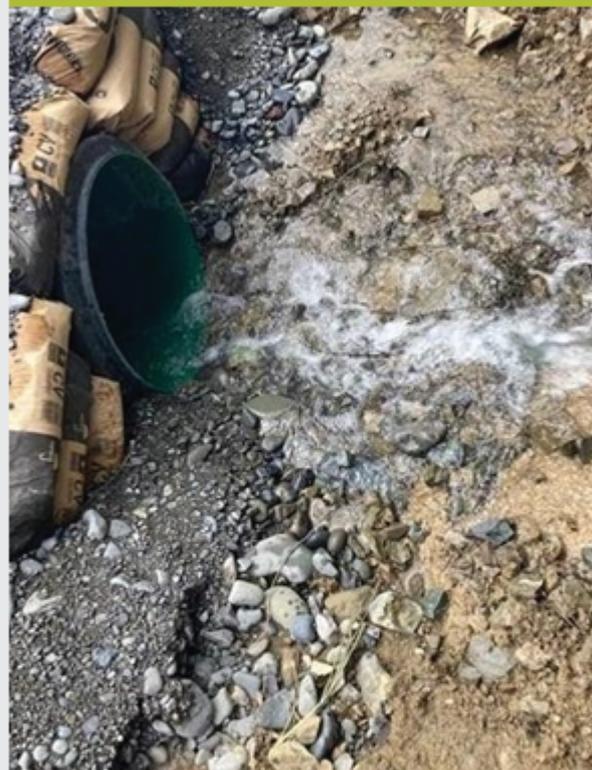
At the same location, four new culvert inlets were completed

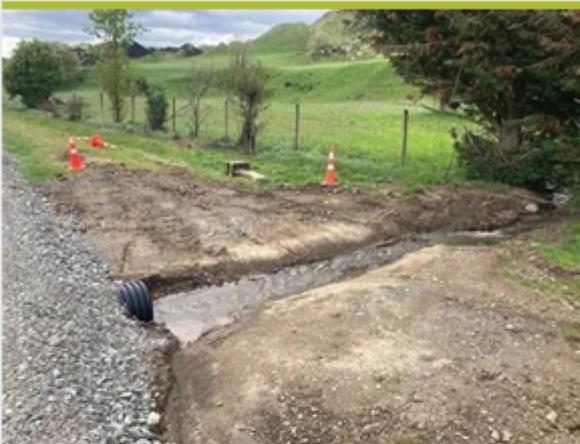
A blocked and damaged 300mm culvert at 11.8km was replaced with a 450mm culvert

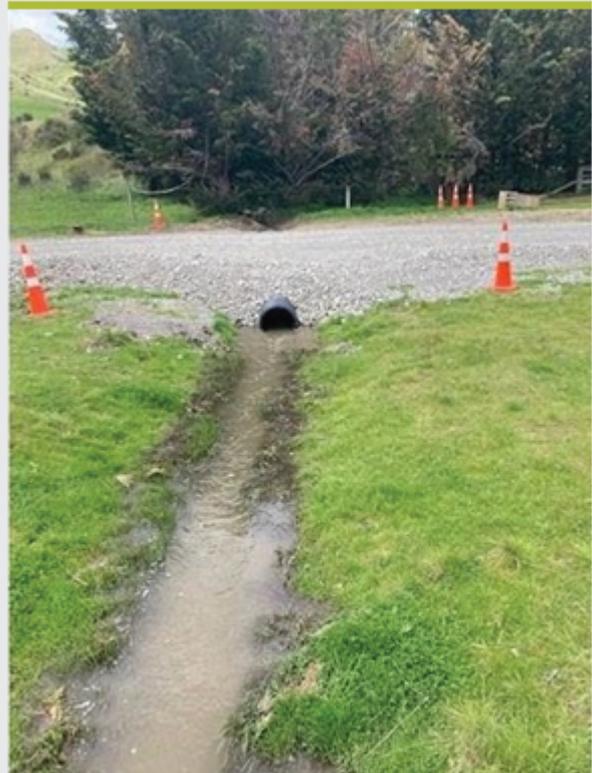
At the same location, the water tables were tidied and reshaped
