SOME IMPACTS OF ROADING AND FLOOD DAMAGE ON SOUNDS ROADS

Part only - Queen Charlotte Drive and Kenepuru Road

Period 1985 - 2010

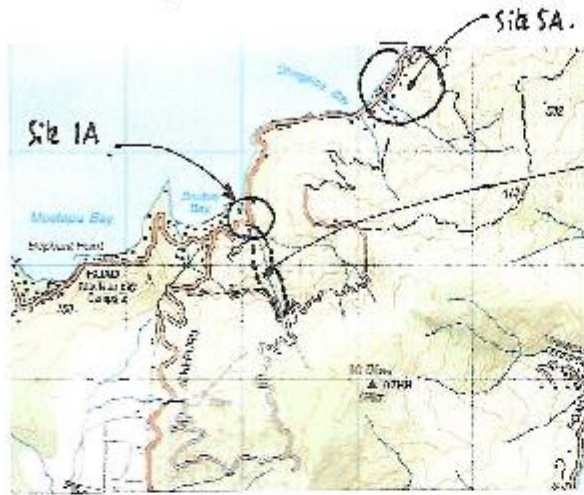
KENEPEHU ROAD - EASTERN SIDE
 SITE 1A - 5.2 KM FROM LINKWATER
 2583106 / 5994111

**NOTE photo is looking
back towards Linkwater
and culvert**

Following clearing
 this whole section collapsed.
 Watercourse was completely bare
 and Arroso pipe arch
 app. 9 x 5 m was completely full
 (estimated velocity > 4 m sec!!)

There was > 2000 m³ of slash and material went thru' culvert.
 (following event it was possible to drive a large 4wd vehicle from
 coast right through culvert!)

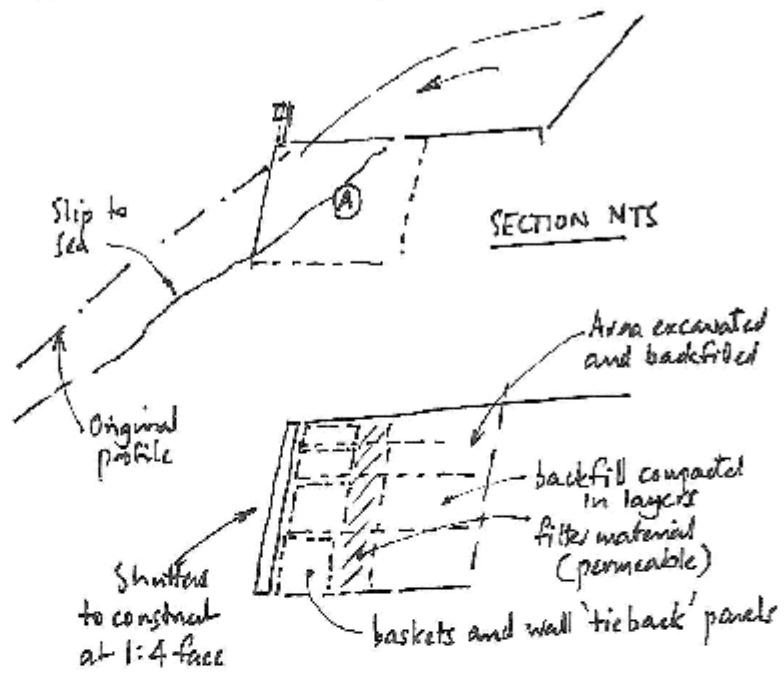
SITE 13A

DETAIL AT (A) NTS

Sketches of wall (typical.) NTS.

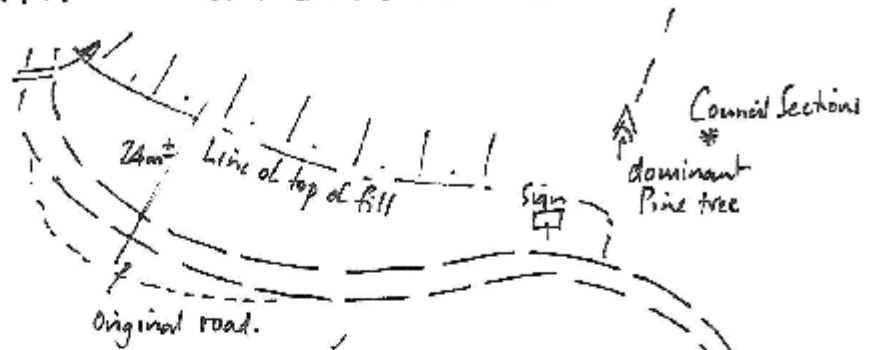
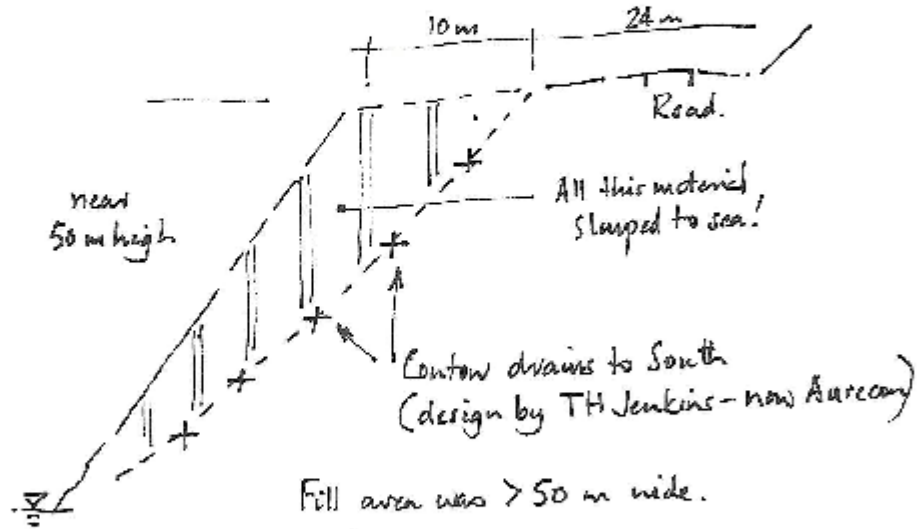
PT PLAN NTS

* Council sections are accessed off Tawa Bay Rd.

Fill area was > 50 m wide.

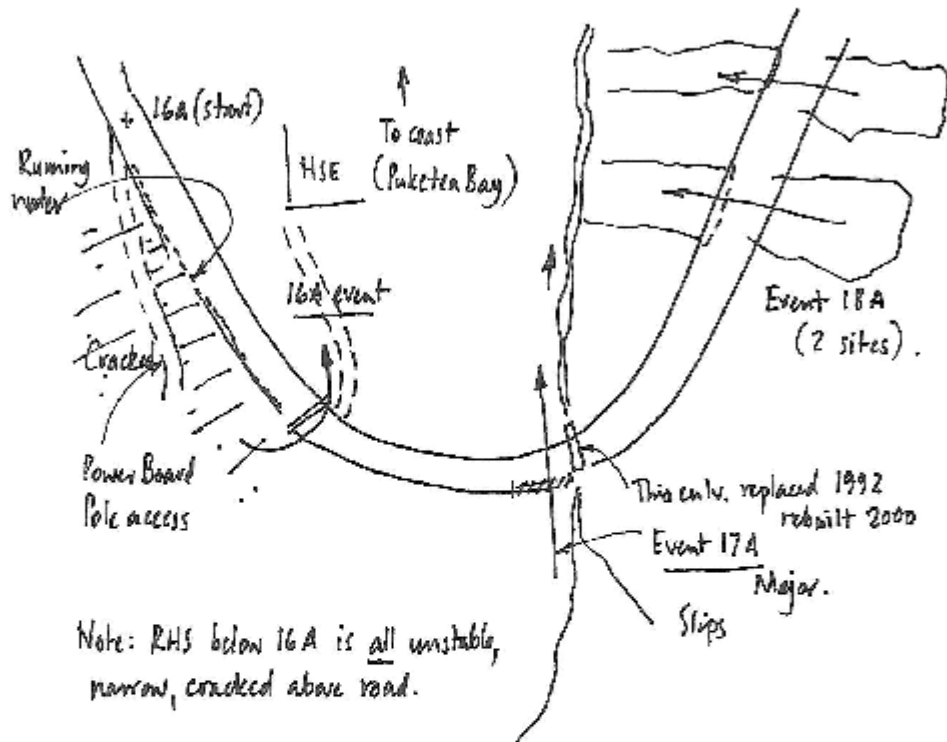
SITE	16A	17A	18A
FROM LINKWATER	25.3*	25.45	25.55 / 25.60

SKETCH PLAN
N.T.S.

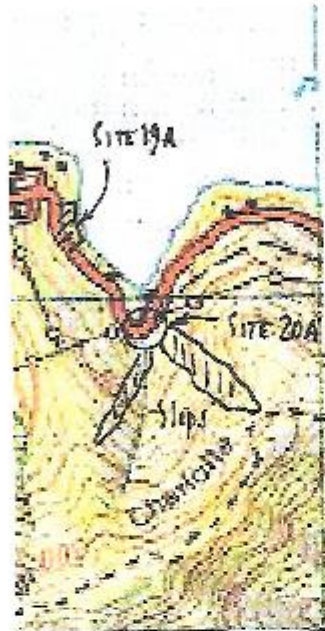
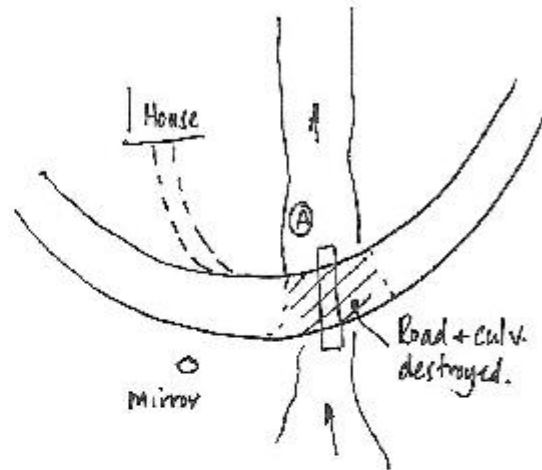
DISTANCE FROM LINKWATER 26.85 KM

Ⓐ Evidence of original steel Armo pipe in watercourse near here

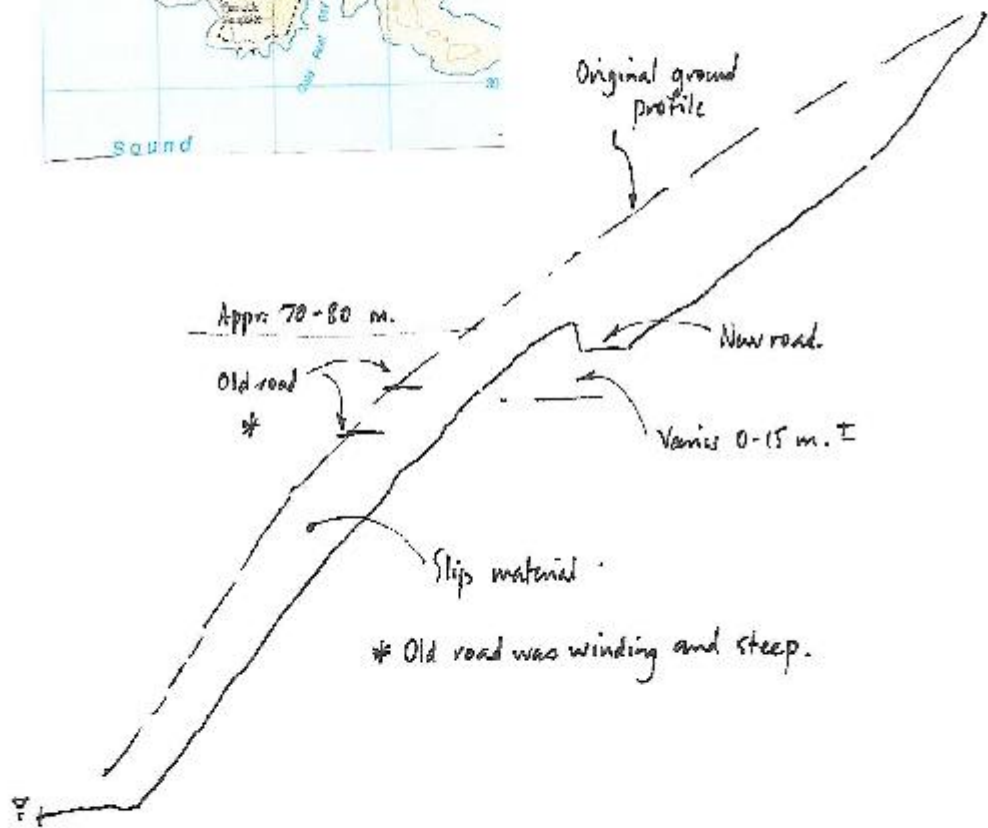
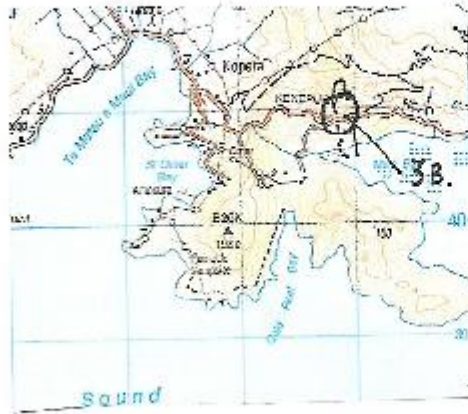
APP. 21.6 Km from 'Heads'

It is difficult to believe the scale and scope of this event with the growth of Gorse and Broom etc. covering virtually all evidence of the damage.
